**Materials, Corrosion and Inspection.  
(Civil/Structural Asset Integrity &  
Maintenance Team)**

**Structural Integrity Assessment of  
Foundations and Pipe Supports in Spiking  
Pumps Area of SOKU Gas Plant**

4<sup>th</sup> February 2021

SPDC-2021-02-00000031

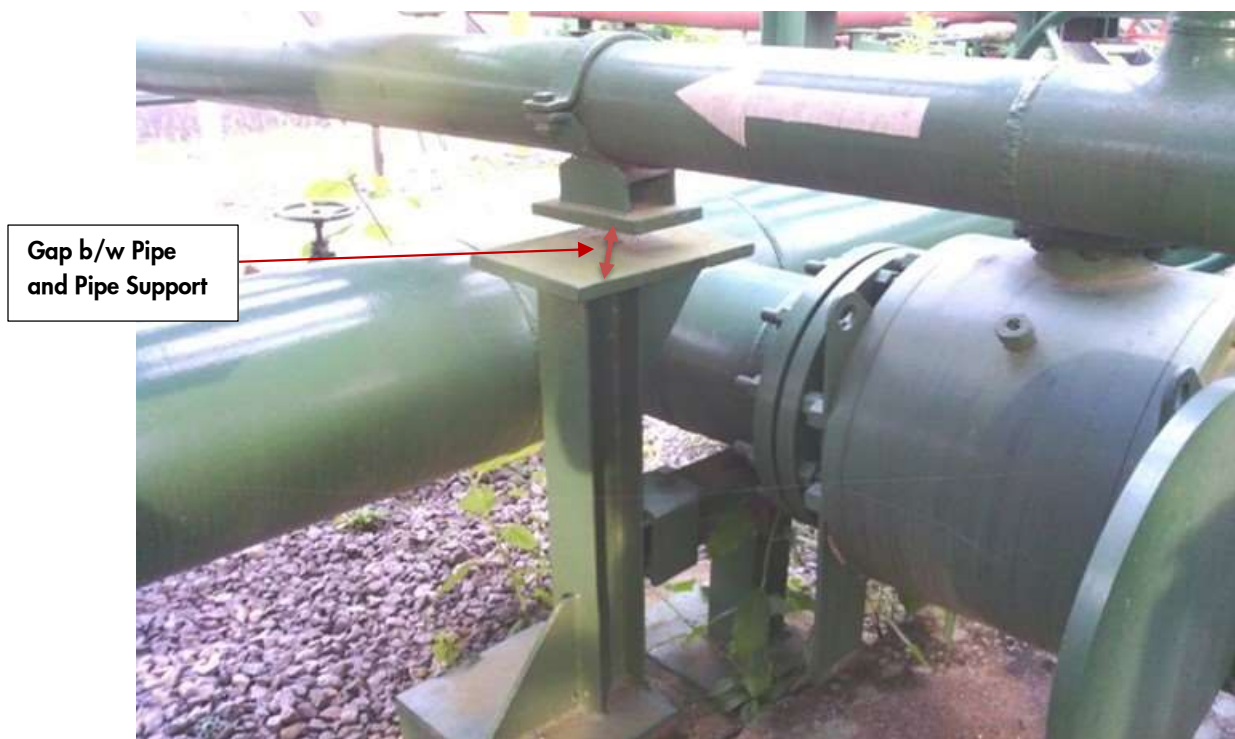
However, in the discharge header of Spiking Pump B, there is a 35mm gap between the Pipe Supports and the Pipe. See pictures below.

**Gap between Pipe and Pipe Support due to Consolidation Settlement of Shallow Foundation**

Assessments carried out earlier on foundations at the Gas Plant showed that due to underlying silty clay materials in the area, shallow foundations therein undergo consolidation settlements. As shown in the gaps between the Pipes and Pipes supports, there are different levels of settlements within the Spiking Pumps area, ranging from 35mm to 100mm..

Hence, it is recommended use **Neoprene Bearing Pads** or **Electrometric Bearing Pads** This will effectively reduce the vibration in the Pumps by providing a damping effect at the support positions.

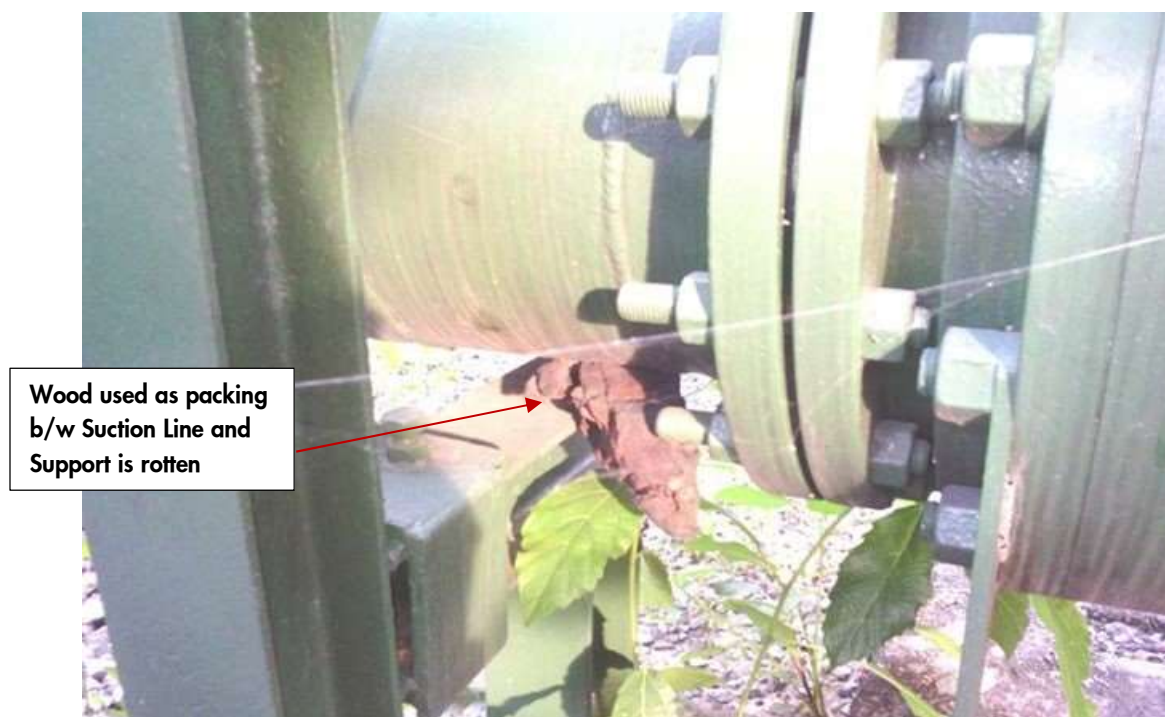
Wooden packing (80mm thick) placed in the gap between the Suction Line of Spiking Pump B and its support has deteriorated. This has rendered the packing non-functional – see picture below.

**Deteriorated Wooden Packing between Suction Line of Pump B and and Support**

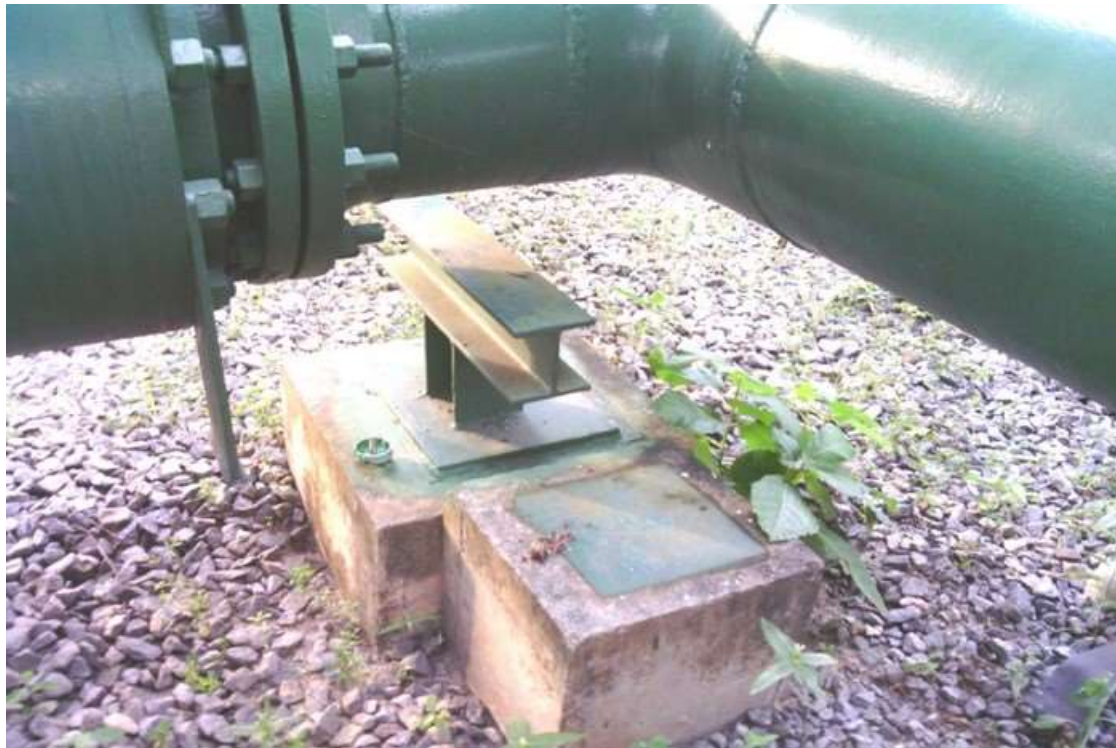
The Suction Line of Spiking Pump A has detached from its support with a gap of 100mm – see picture below.

**Gap between Pipe and Pipe Support due to Consolidation Settlement of Shallow Foundation**

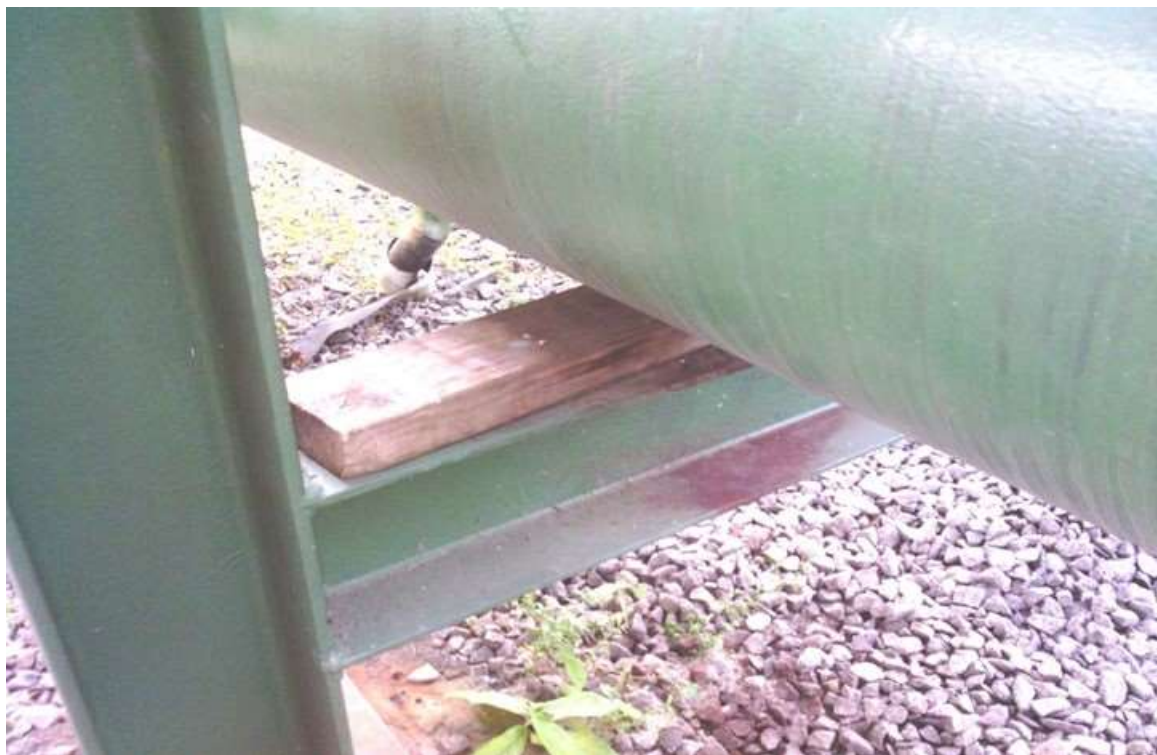
**Wooden Packing used to close Gap between Suction Pipe of Pump A and its Pipe Support**
