# Failure Analysis Report

**Well:** RM40-150-1  
**Rig:** WildDesert4  
**Installation Date:** 21-Dec-19  
**Date Received:** 30-May-20  
**Failure Date:** 13-Jan-20  
**Tubing:** 2-3/8" EUE 4.7lb/ft

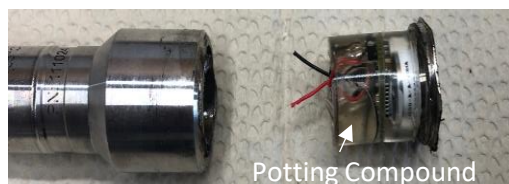
Gauge, Vibration sleeve removed, no sign of corrosion.

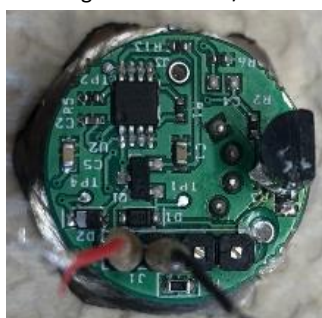
Electronics Board

Gauge cut open showing electronics. 1/4" NPT end cut off

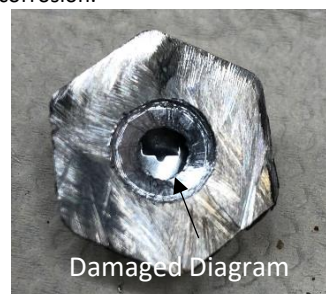
Damaged Diagram

**Comments:** No corrosion visible on any part of the gauge. Gauge failed due to failure of the diagram, suspected from the failure of the glass feed-through. Gauge reading 2.674mA (-124psia) on inspection 30-May-20. Gauge reading >20mA at the time of wellsite inspection.

Diagram view showing damage after 1/4" NPT cut off
