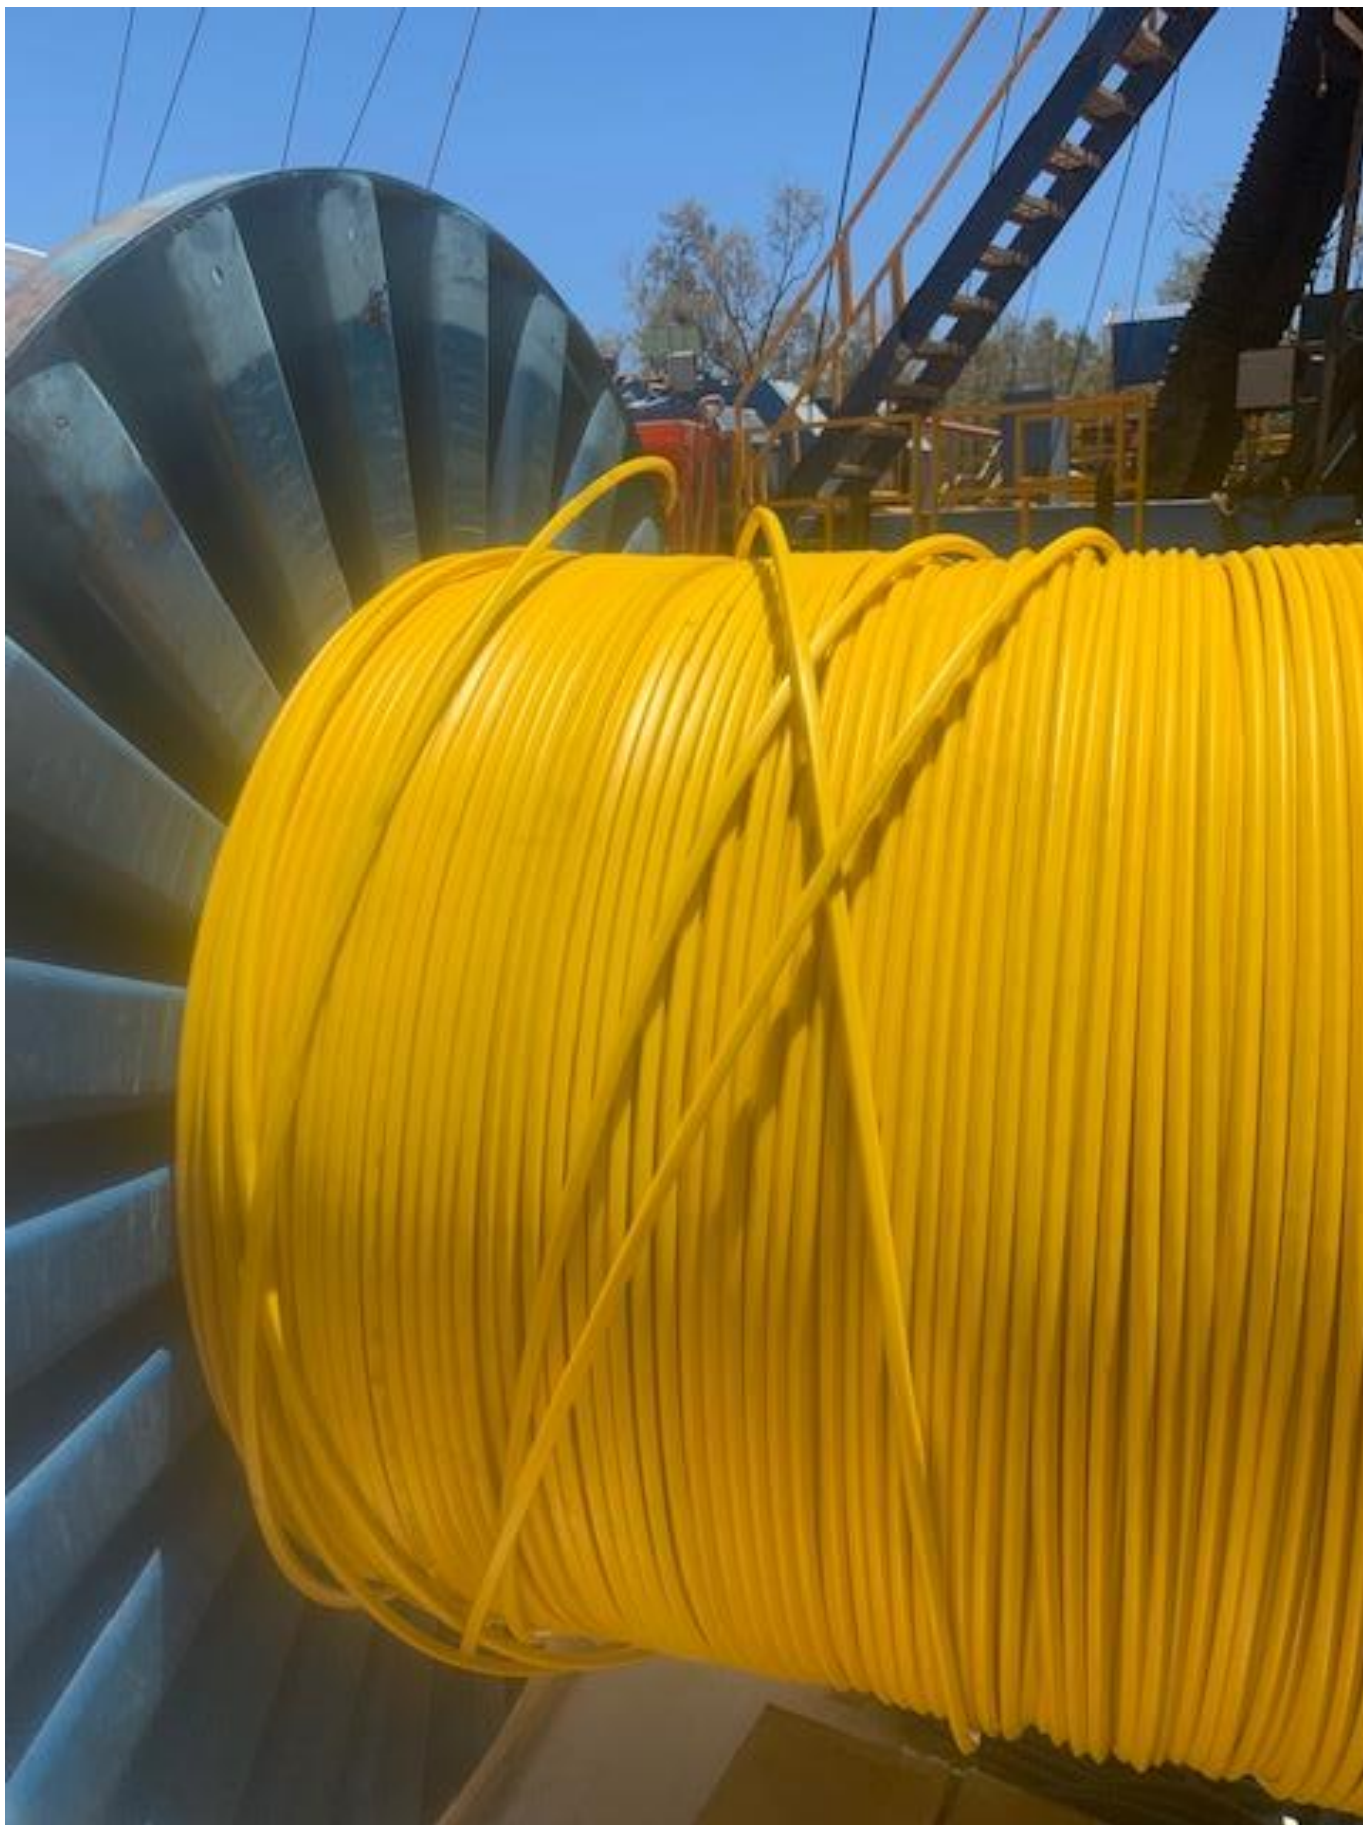
*Figure 1 - Cable drum from EOS19*

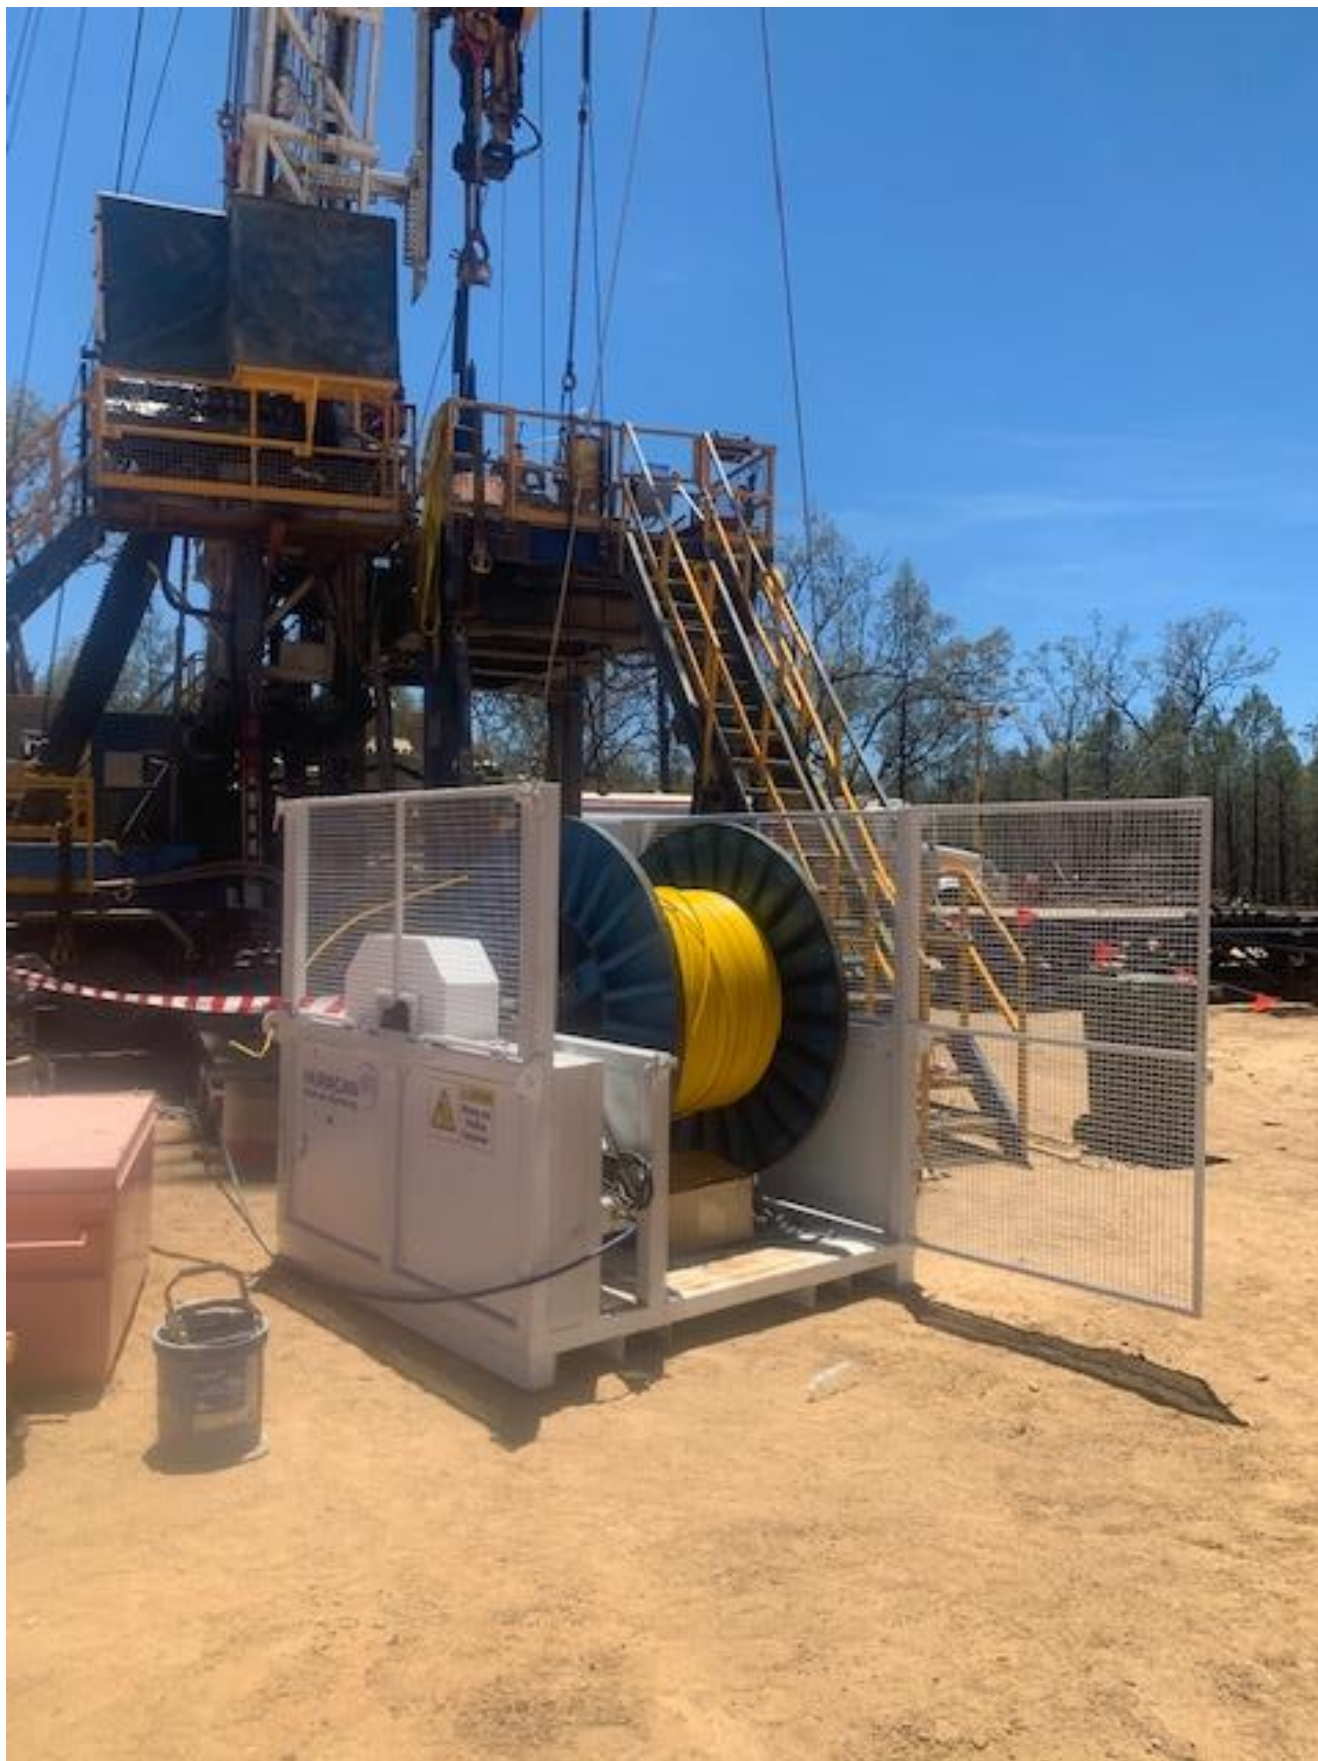
*Figure 2 - Location of spooling unit after cable parted*
