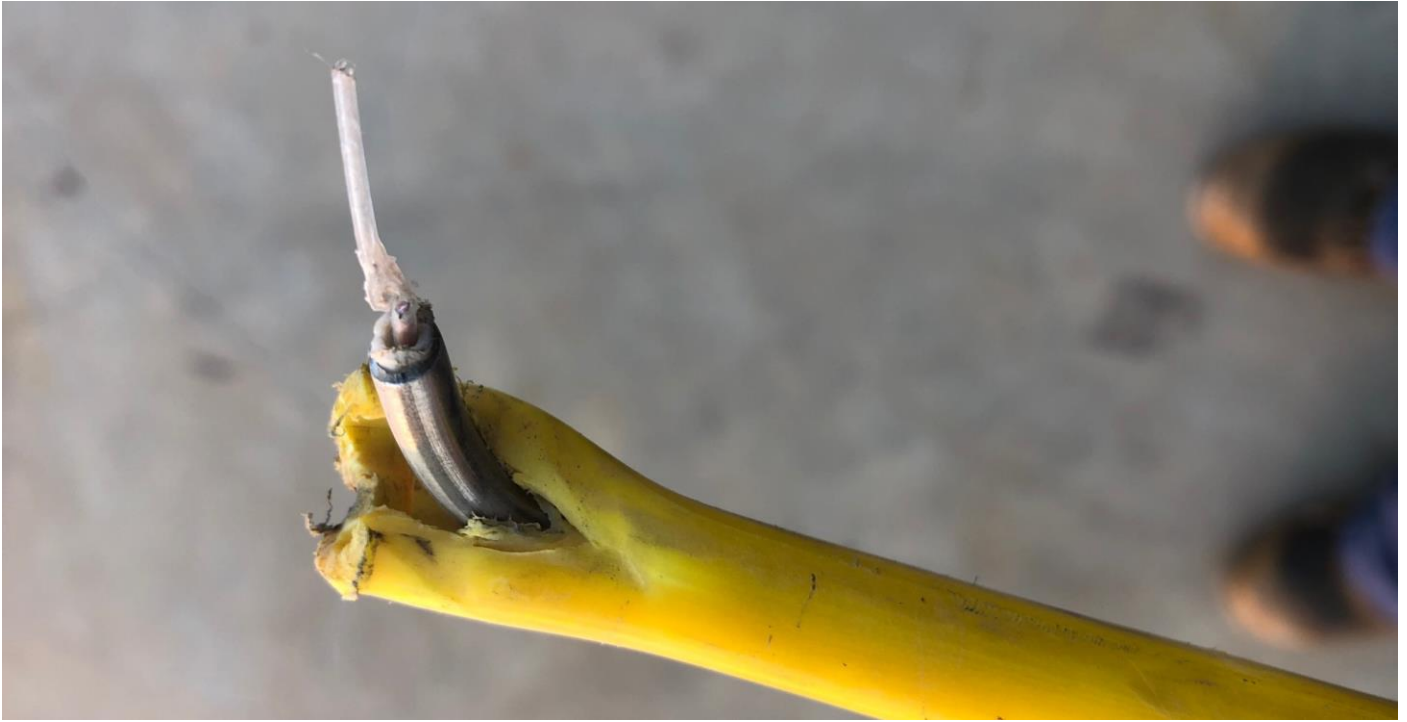
*Figure 1 - Damaged Cable End*

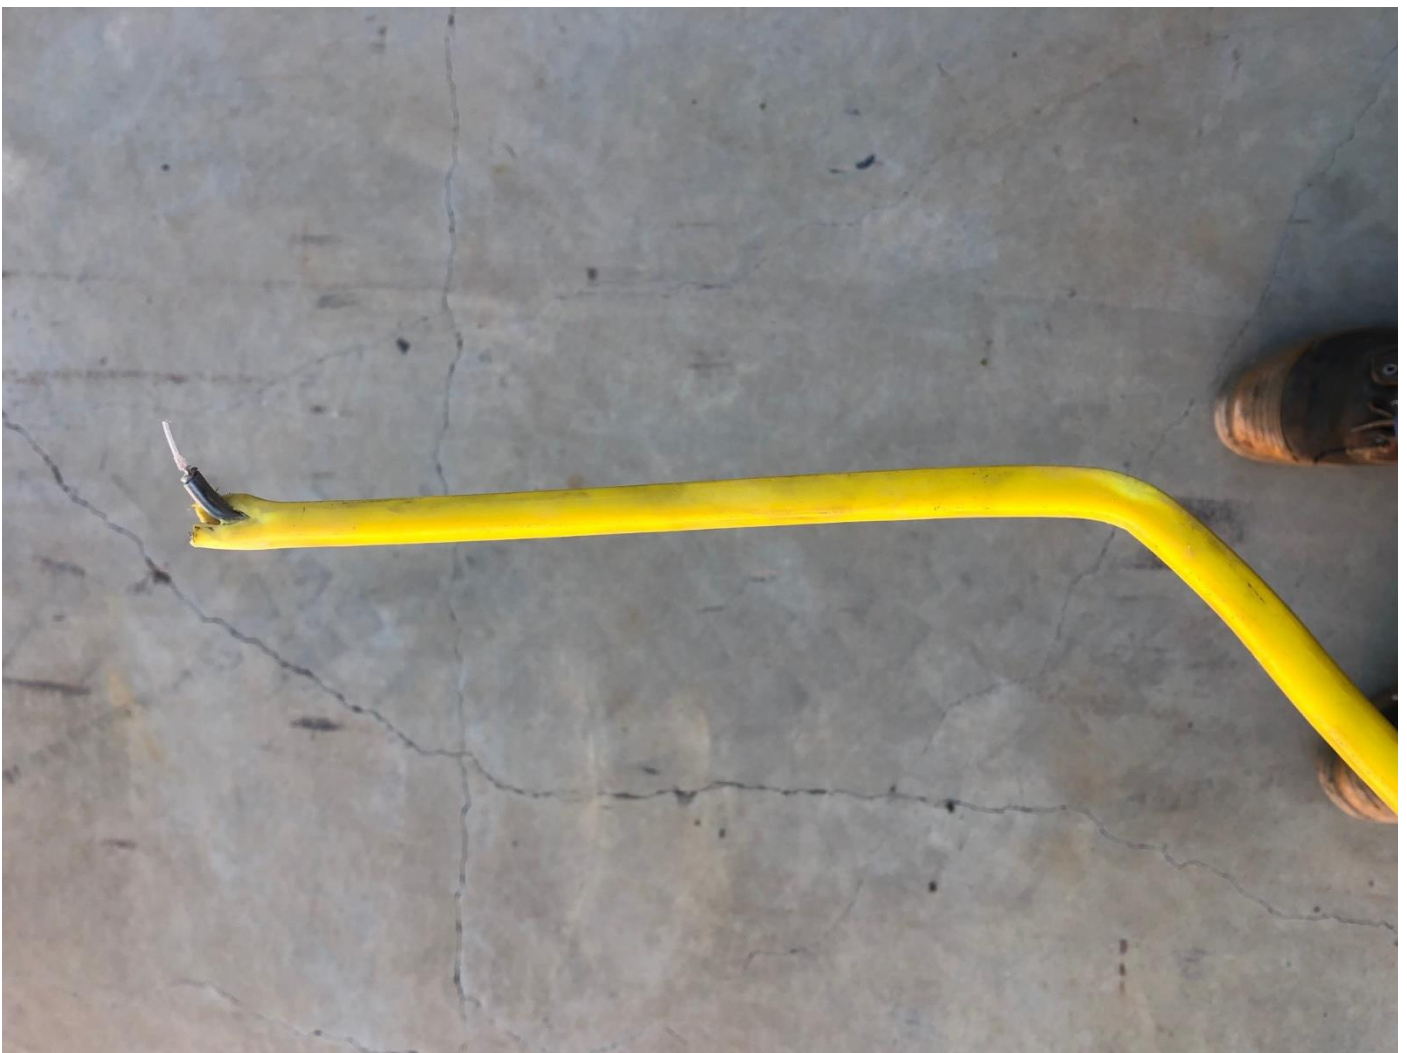
*Figure 2 - Damaged Cable Section*

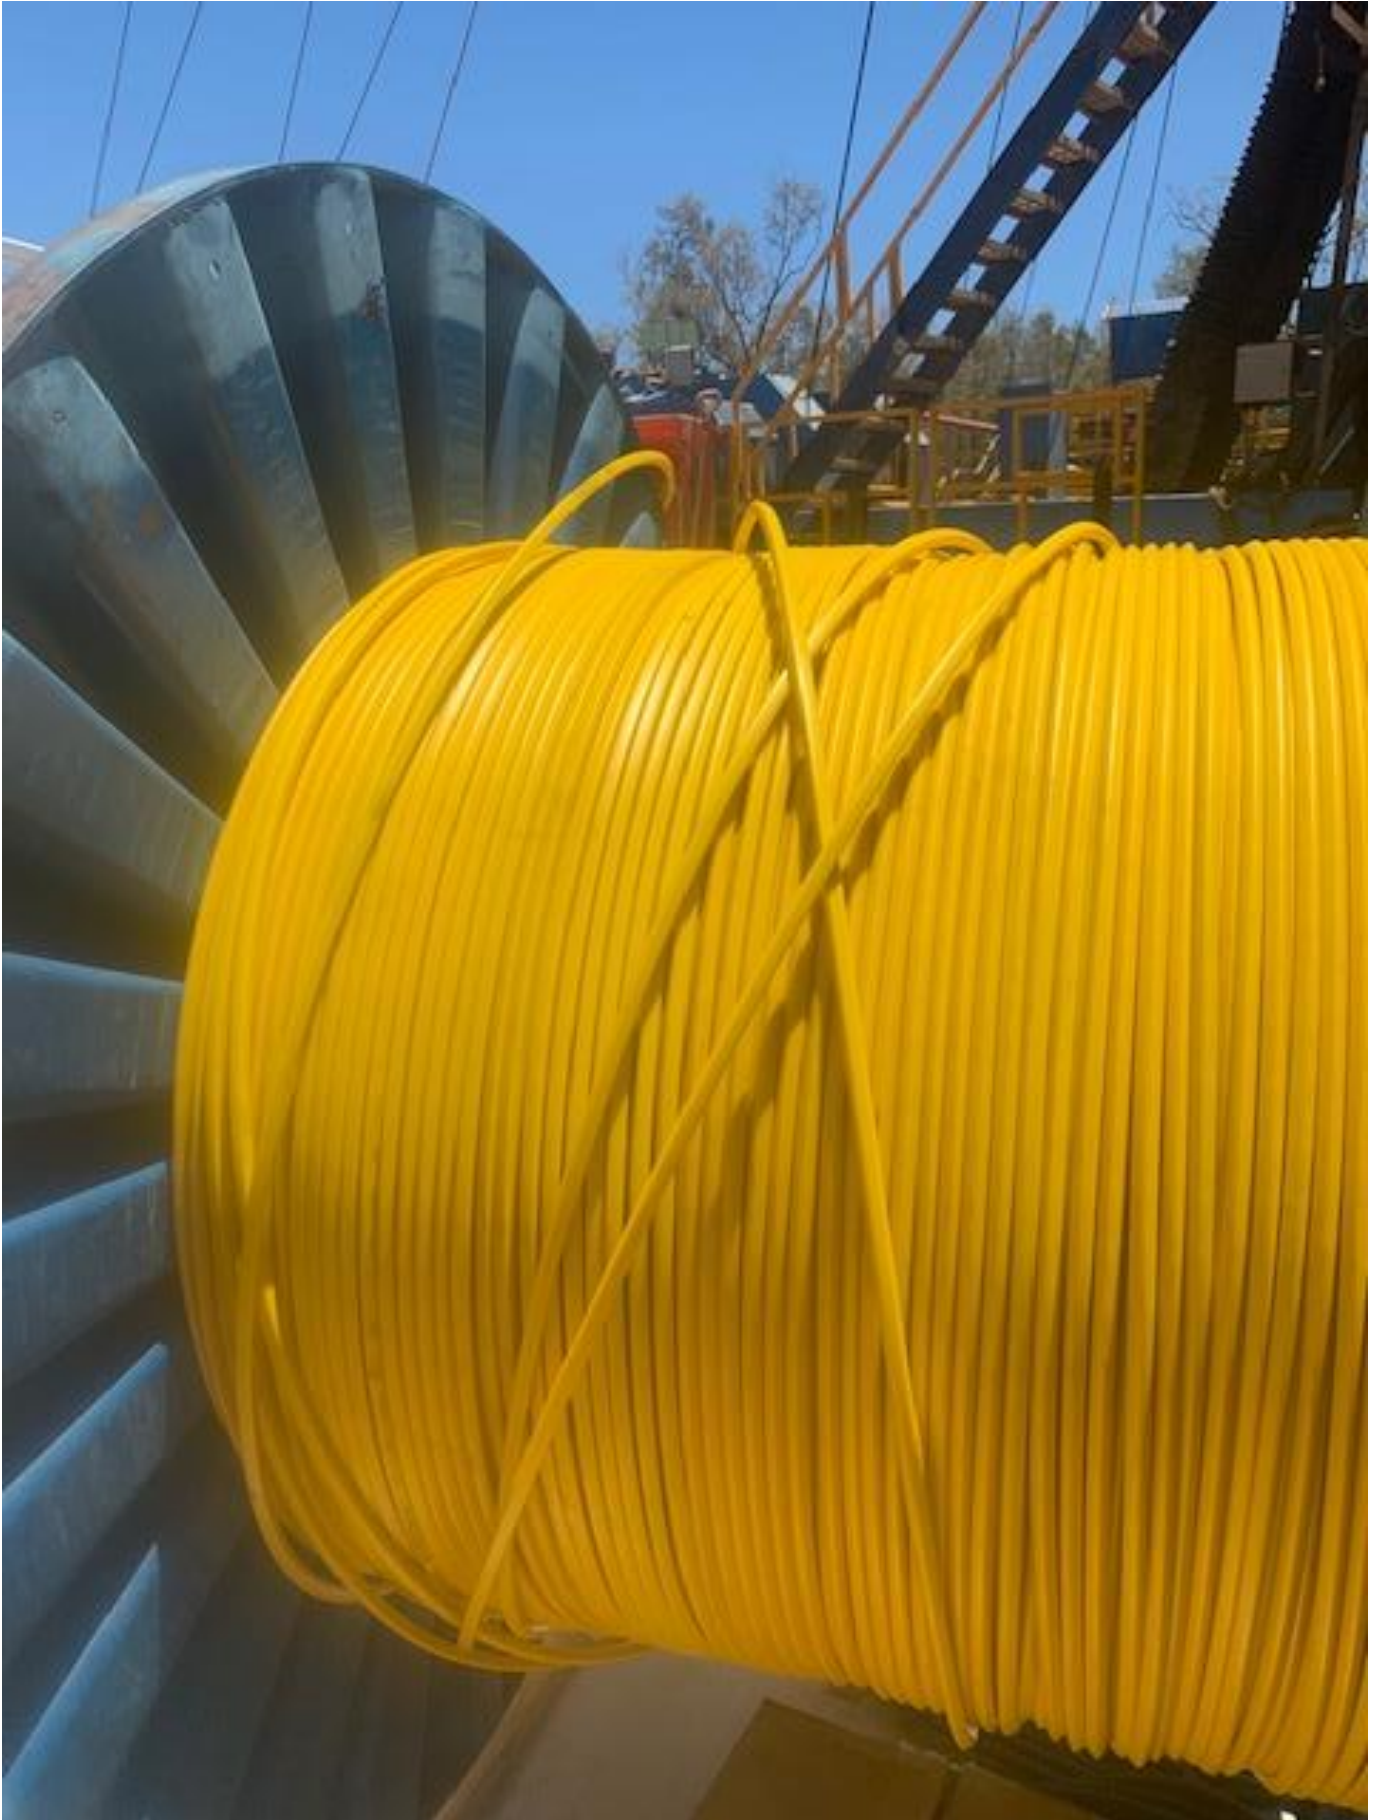
*Figure 3 - Cable drum from EOS19*

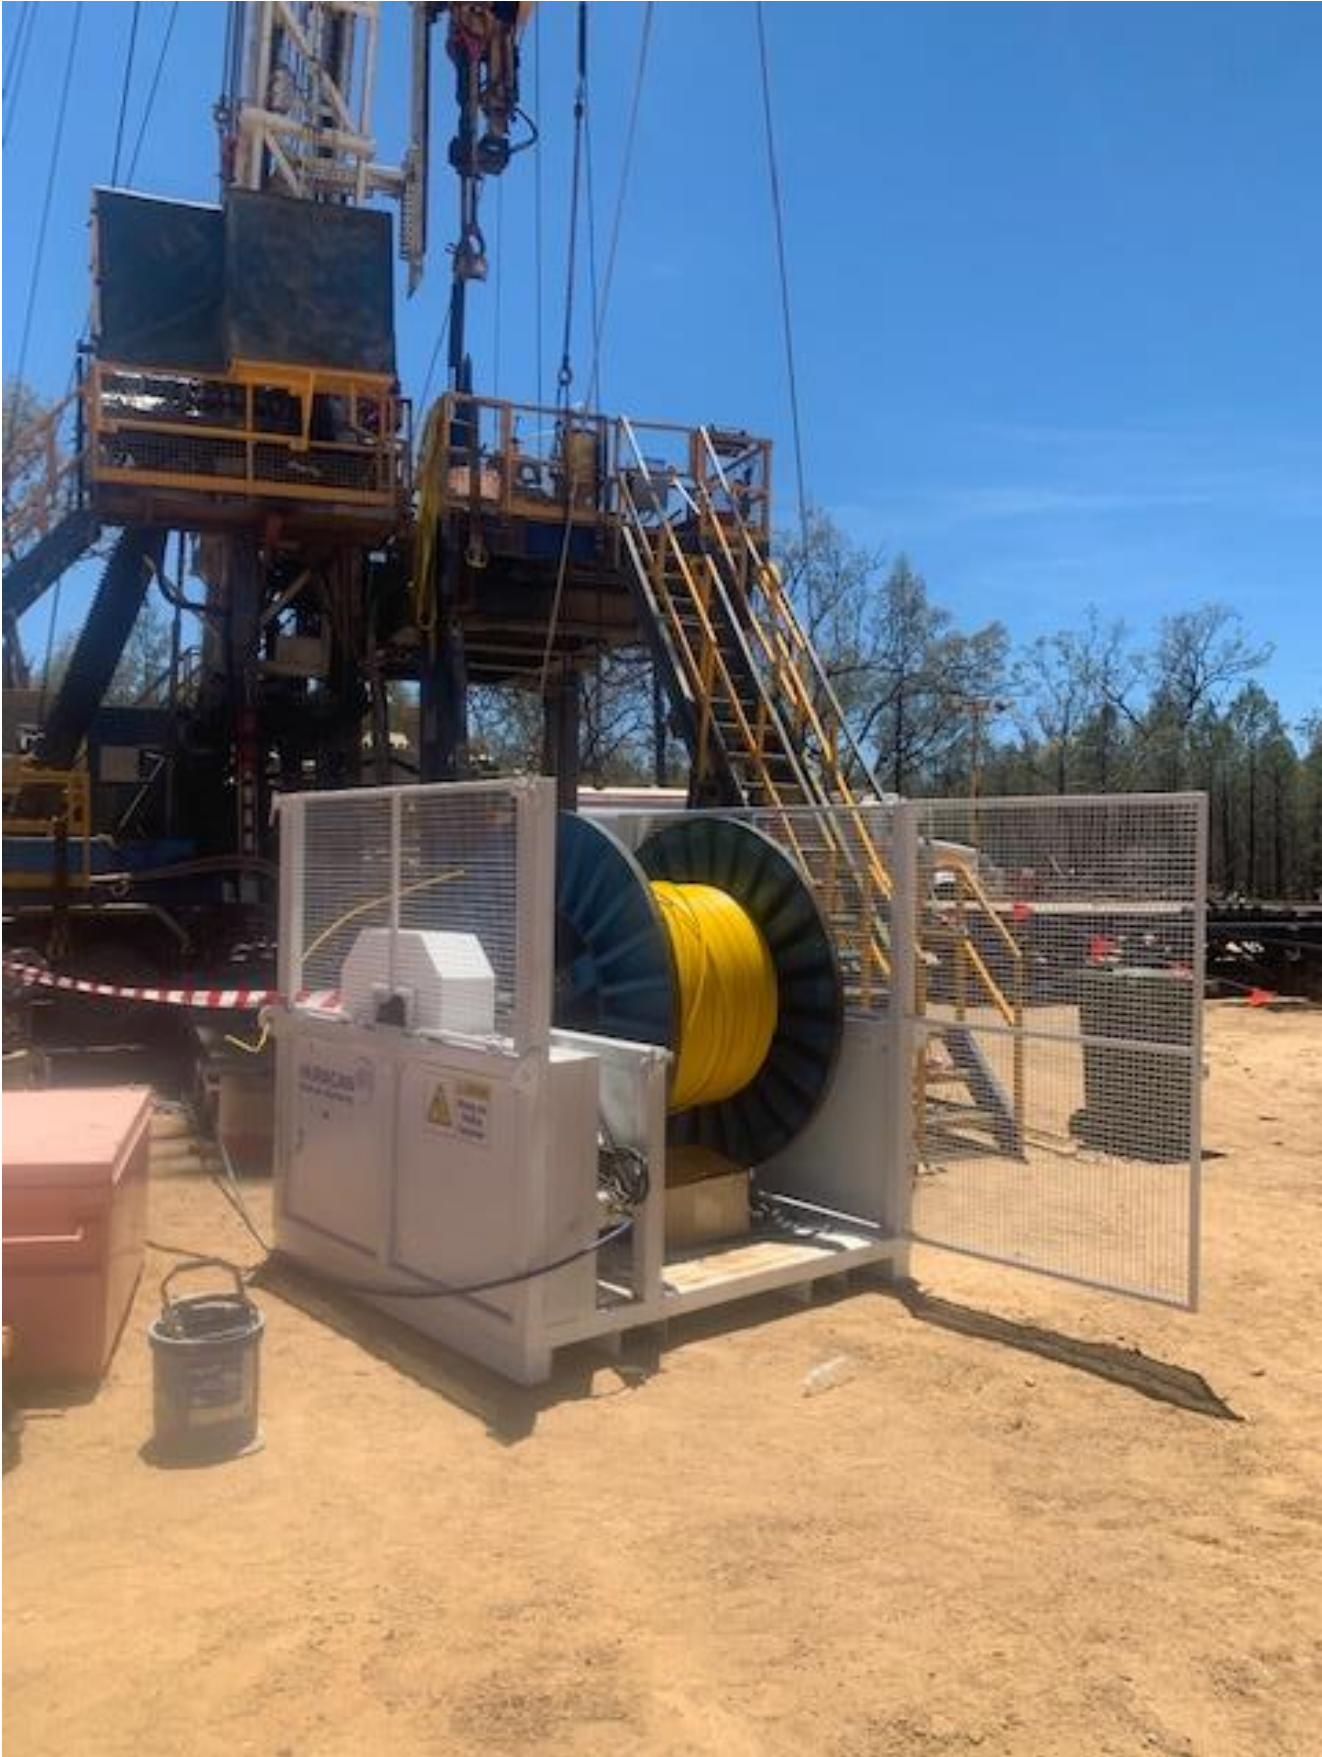
*Figure 4 - Location of spooling unit after cable parted*
