Western Queensland Crane Services Knuckle Boom Annual Inspection

Site Inspection

Vehicle Type	Iveco
Rego	XB 86IC
Klms	5861.4
Hrs	N/A
Crane make	Tadno
Crane Model	14109104285 - ZX860
Serial number	NA0589
Crane hours	N/A
Date fitted	10/10/2022

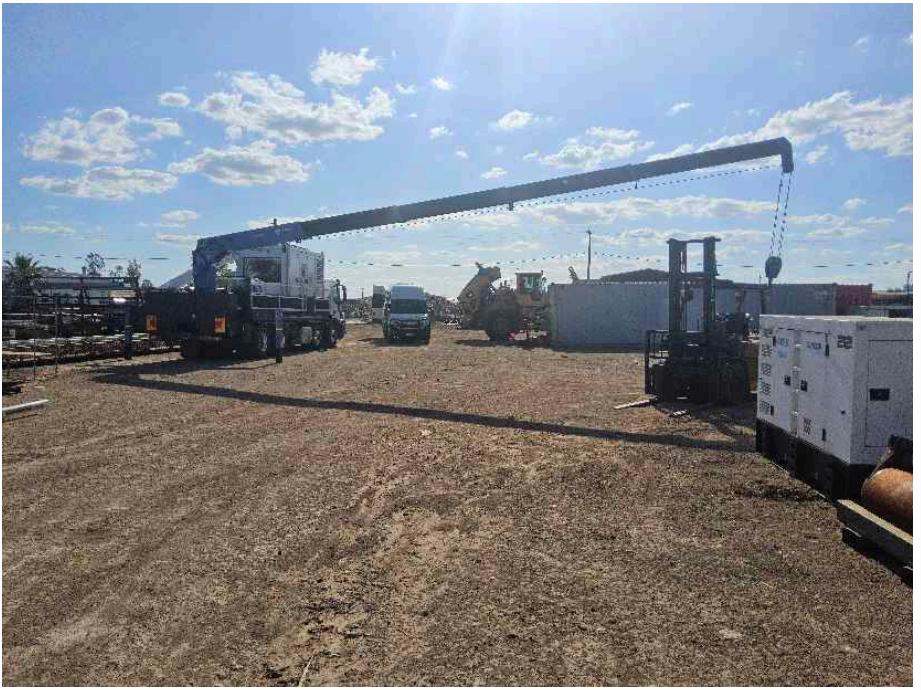
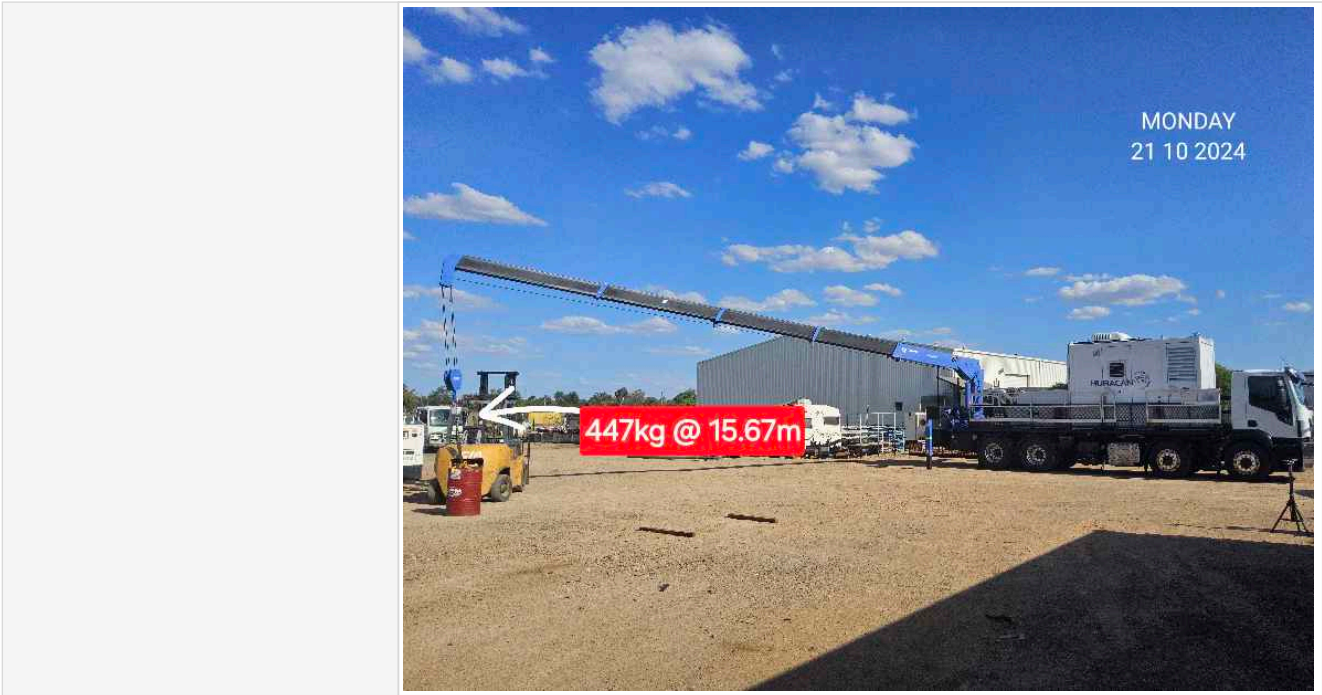
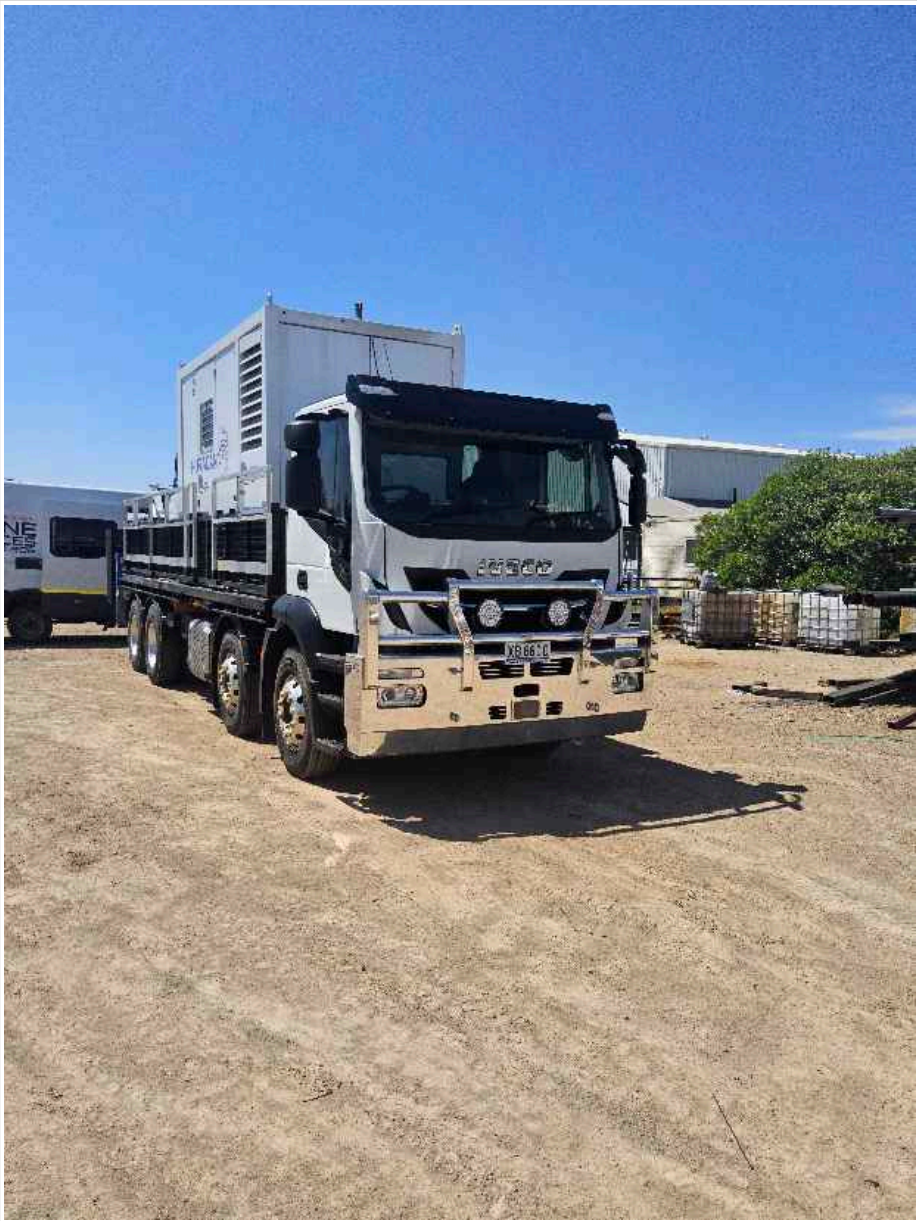
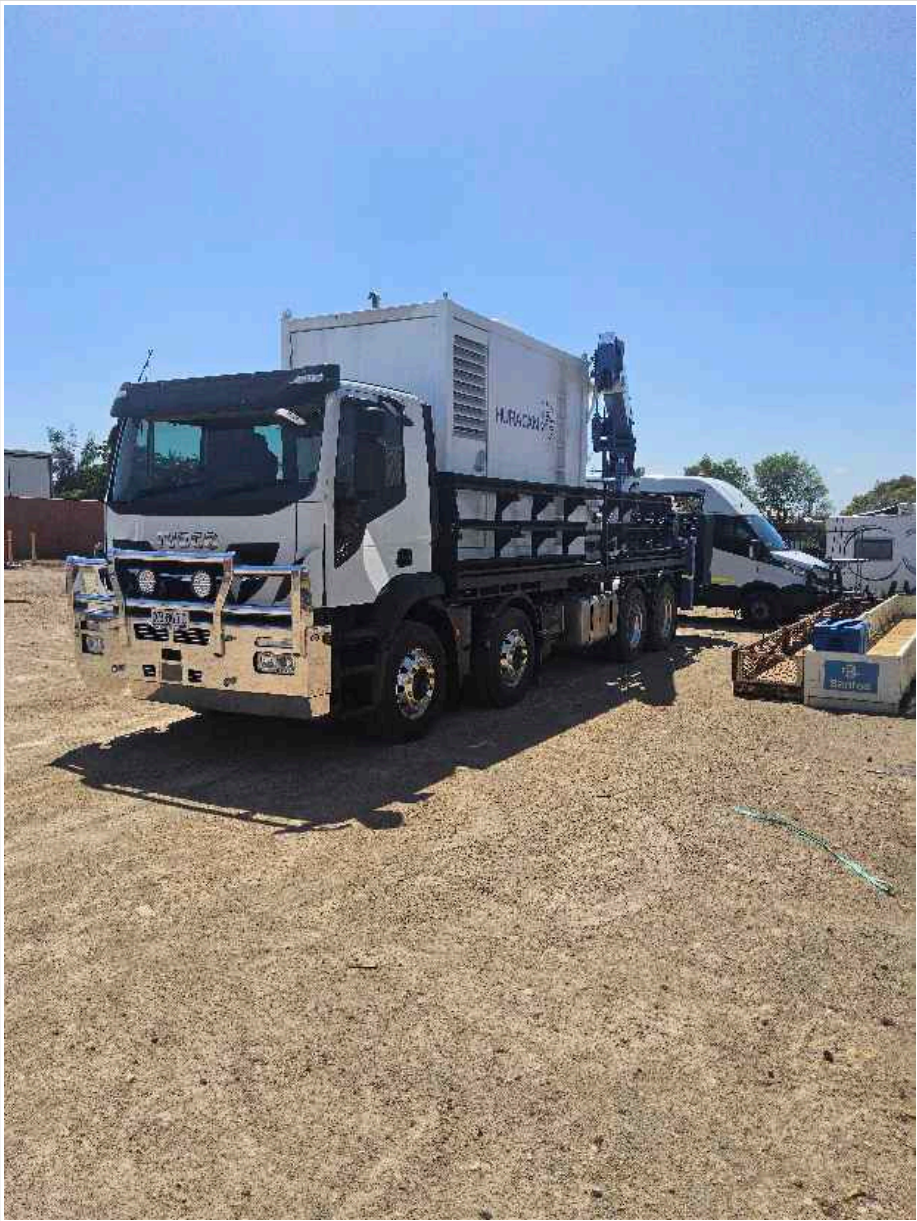
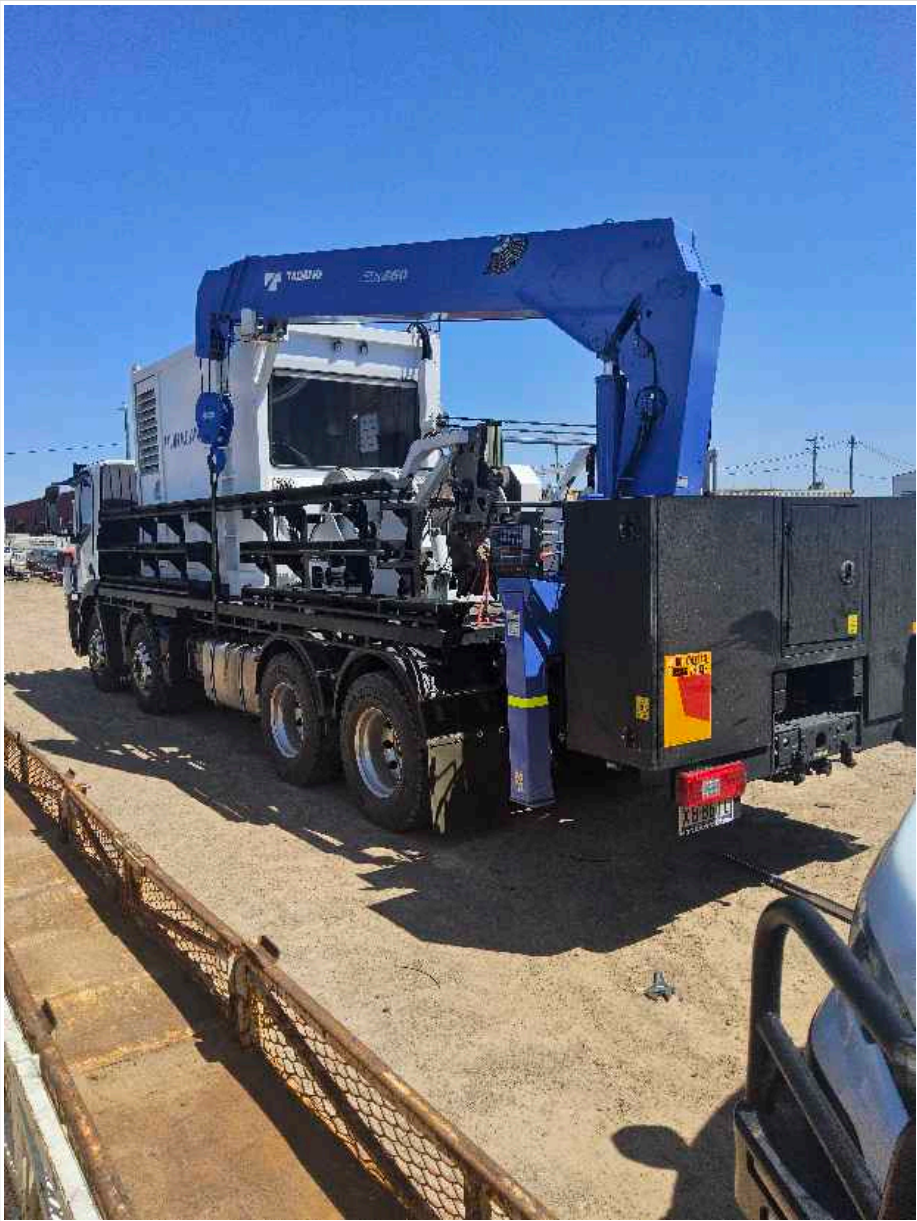
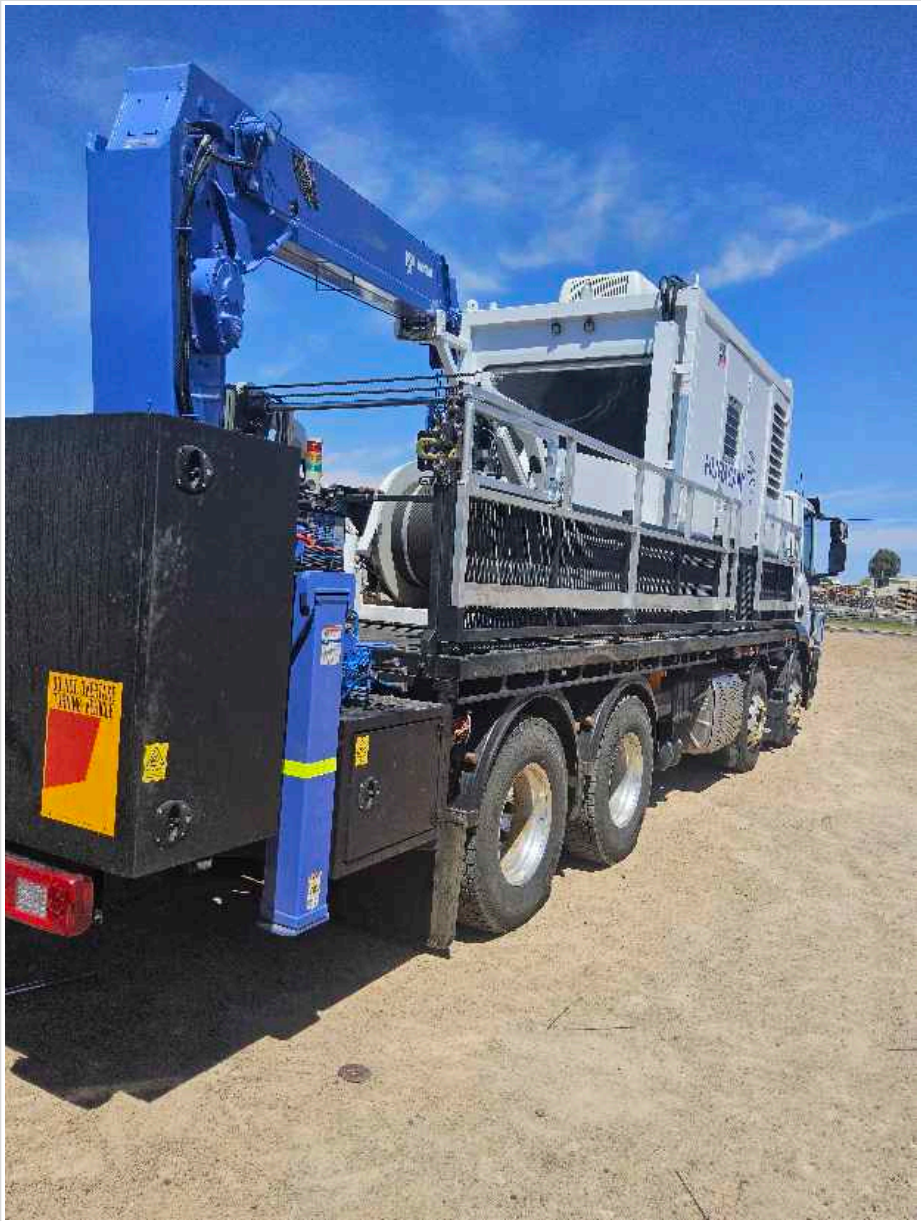
General crane pics

Did the crane require any repairs	Yes
Faults/ repaires	Nil
Faults pictures
