***HP 9000MFP/9040MFP/9050/9050MFP/M9040MFP/M9050MFP/CLJ9500***

***13.11.05 Input Device Paper Jam – Tray 4 print***

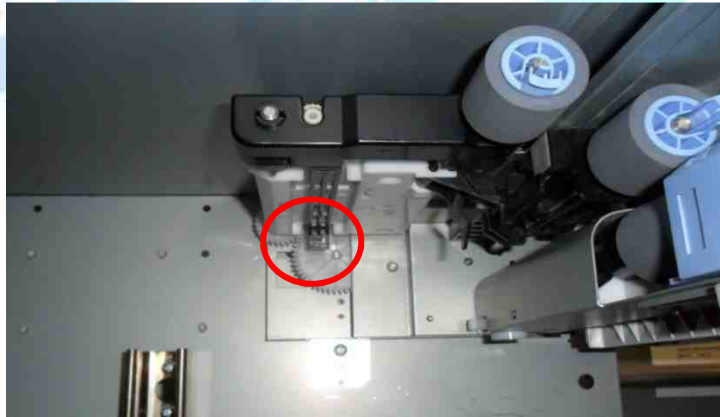
fig1

The tray 4 pick up assembly has a tab that is depressed when the cassette itself is completely closed to lower and engage the pick up roller. (figure 1)

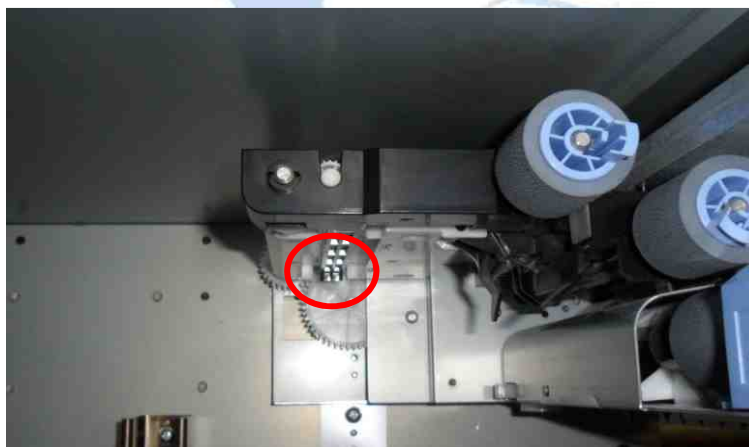
fig2

**Common Cause:** Broken Pick up assembly RG5-6208

This tab however is known to break (shown in figure 2), which then will not allow the roller to drop resulting in constant 13.11.05 paper jams.

The corrective action is to replace the paper pick up assembly RG5-6208
