Noise caused by printer constantly trying to lift paper when tray is lifted

60.2 Error

HP P4014/P4015/P4515/M601/M602/M603/M604/M605/M606

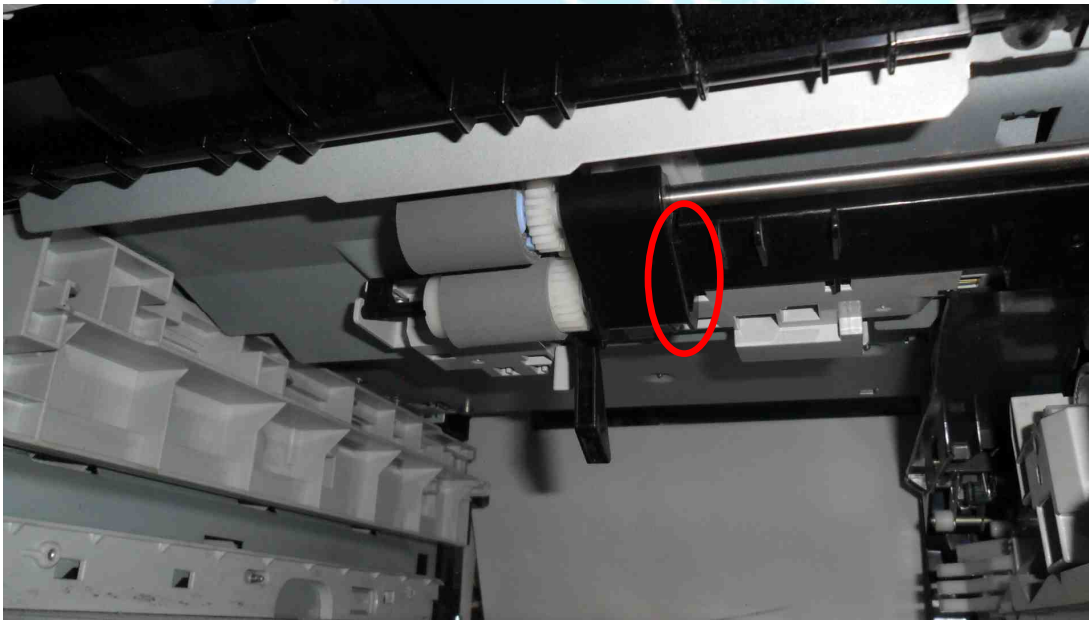
There is a black plastic housing to the right of the pick-up and feed roller that has a flag on its right side (Figure 1) which trips photo sensor (PS 907) on a sensor board. This housing has been known to pop out of position to where the flag does not reach PS 907 to tell the printer the tray is successfully lifted. You can see the retaining tab below the guide not allowing the housing to move freely.

With the printer on its back pull the retaining tab on the black housing forward until it pops back into position allowing the flag on its right side to now trip PS 907. See Figure 2.

Caution: damaging this housing may result in a non-repairable printer due to lack of availability - so proceed with caution.

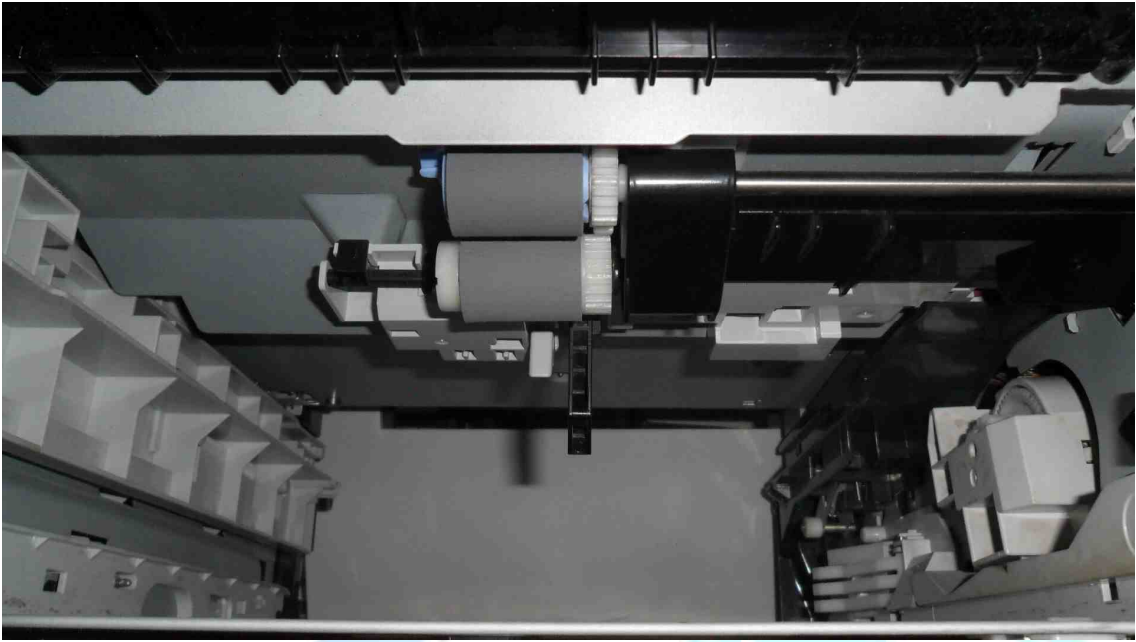
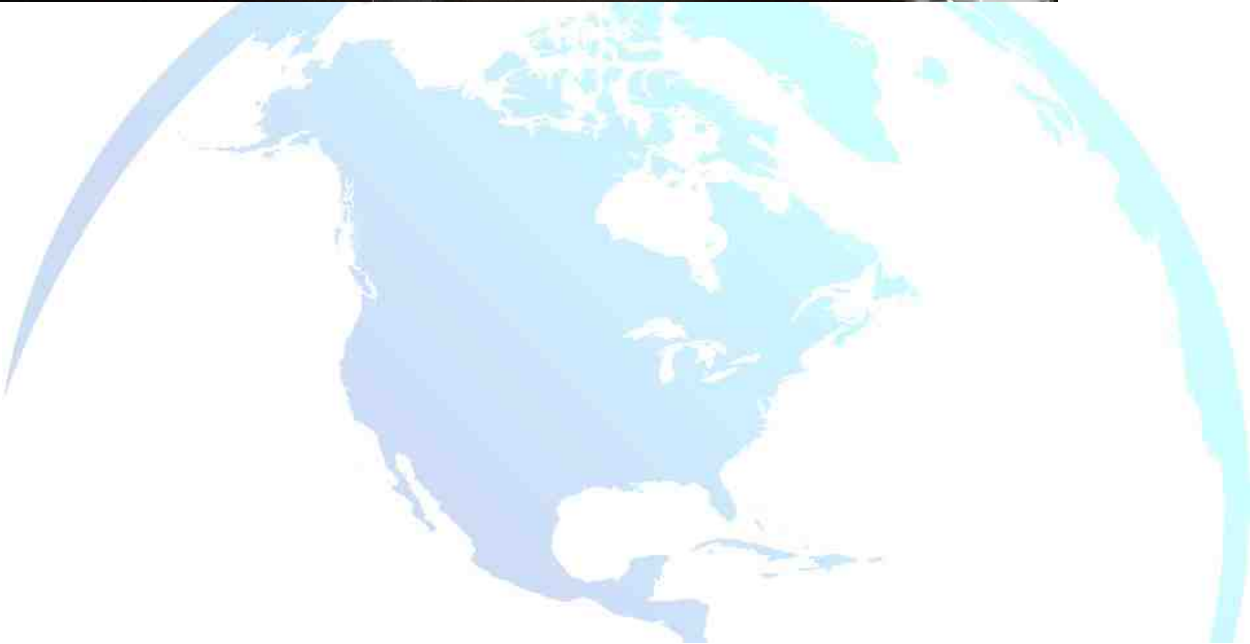
Figure 2 shows the correct positioning of the housing which moves freely.
