## **HP P3015 and M525 Series printers Error TRAY 2 OPEN**

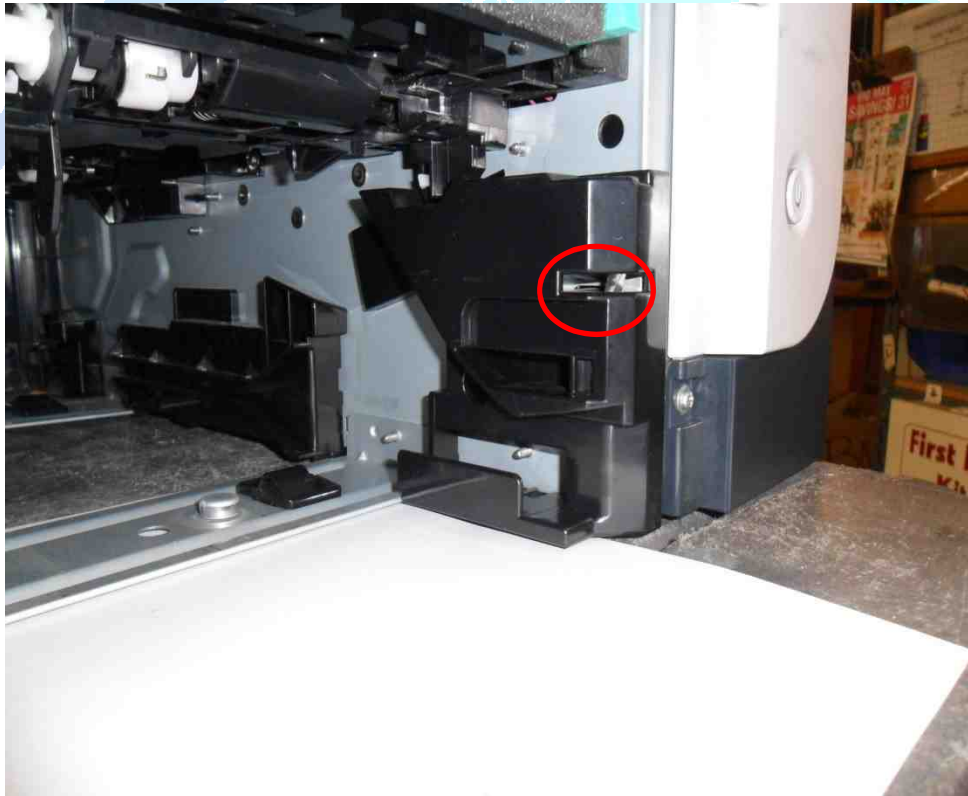
FIG1

In most occurrences we have found the only problem to be a weakened leaf spring – which is responsible for depressing a micro-switch to signal the DC Controller when the cassette is closed.

To verify this, with the printer on and the cassette removed, simply use a small object to press in on the metal leaf spring located within the right cassette guide (FIG 1) and note the control panel:

2) If the printer displays “TRAY 2 EMPTY” the leaf spring would need to be slightly bent to make a better contact with the micro switch itself.

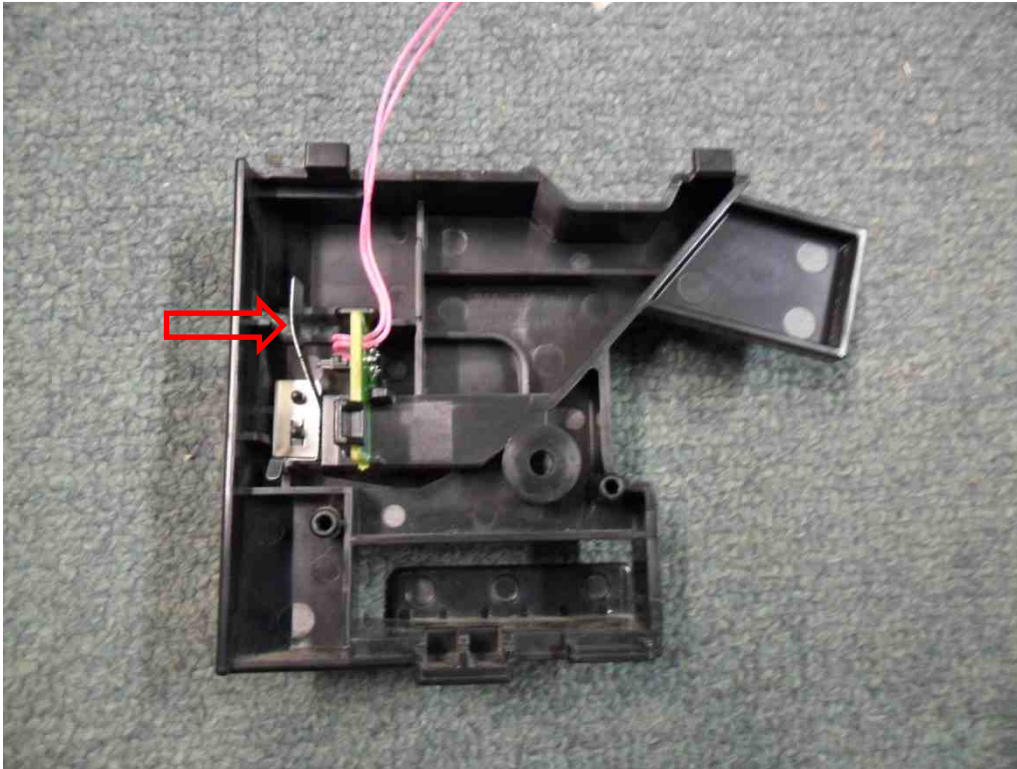
FIG2

1) If the control panel continues to read “TRAY 2 OPEN” the tray detection sensor would need to be replaced (FIG 2).

P3015 series # RM1-6487

M525 series # RM1-8620
