Toner ground spring dislocation

HP 4200, 4250, 4300, 4350, 4345MFP, M4345MFP

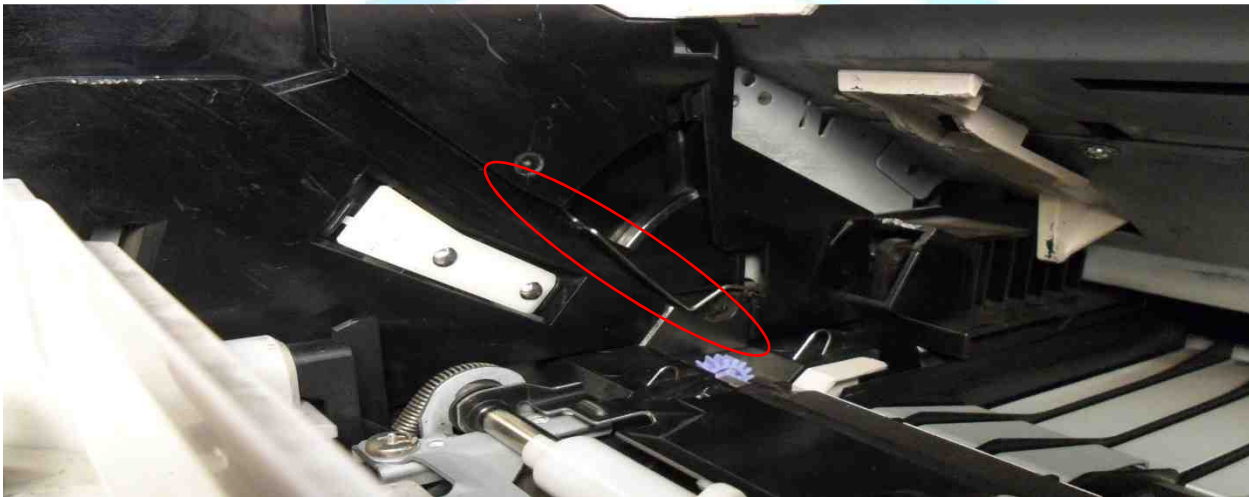
Correct position:

This spring shown below in correct position and incorrect positions has been known to become dislodged out of its retaining groove causing print quality problems, grinding sound from cartridge area or “INSTALL TONER CARTRIDGE” message.
