## HP CP3525, CM3530, M551, M575 – 59.F0 Error

### **Description:**

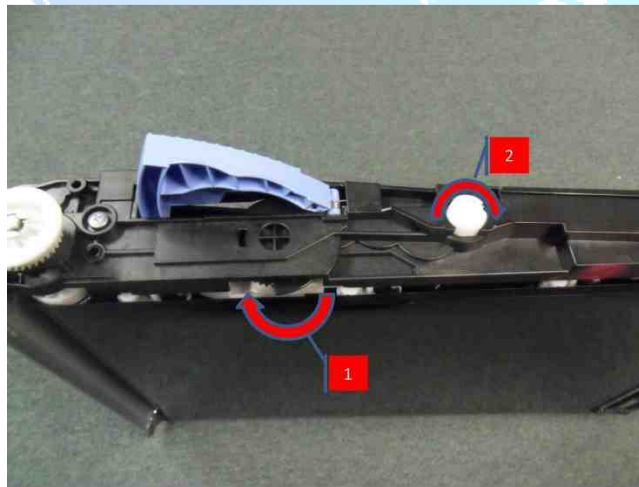
1. The first step is to reseal the ITB and power cycle the printer. NOTE: If the problem persists, an HP Certified Technician should be dispatched for further troubleshooting.
2. Inspect the ITB by taking the ITB completely out of the printer. Check to see if the flag rotates (callout 1) when the white knob is turned (callout 2). See the Figure below.

If the ITB flag is broken, damaged or does not rotate, replace the ITB (CC468-67907). Otherwise, continue to step 3 below:

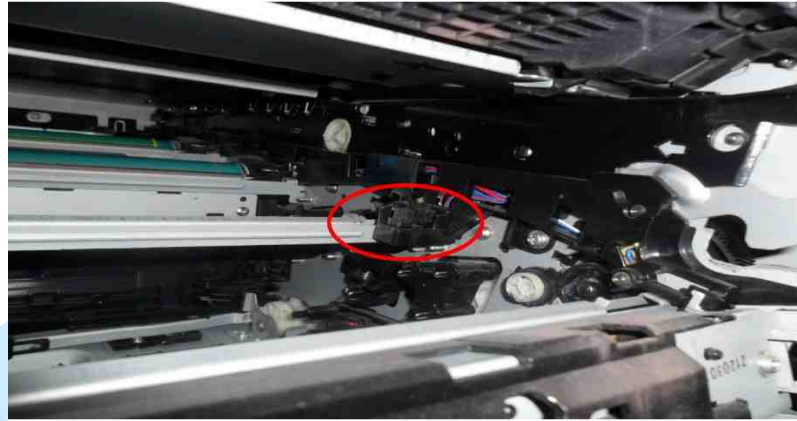
7. Locate SR17 through the right side of the printer. It is attached to the frame of the printer just about the end of the black cartridge (where it makes contact with frame).
8. Insert a piece of paper into the SR17 sensor bracket. The state of sensor I on the control panel should change to 1. Location of SR17 in image below

9. Observe the control panel for proper operation of the sensor. If the value for sensor I does not change, the sensor will need to be replaced (Photo interrupter SR17 WG85696000CN). If passing test, processed to step 10.
  10. Open the right door and defeat the interlock switch. With the ITB removed, perform the ITB contact/Alienation test.
  11. From the printer control panel access Trouble Shooting /Diagnostics Menu
  12. Locate and select Component Test
  13. Press the down arrow to highlight ITB Contact/Alienation, then press OK.  
During the test (about 20 seconds), observe the alienation drive hub located above the Cyan cartridge.
- If the alienation drive hub does not rotate, the fuser drive is most likely the problem. Replace the fuser drive assembly.
