## **Print quality problems due to toner contact**

### **P4015 series and M600 series**

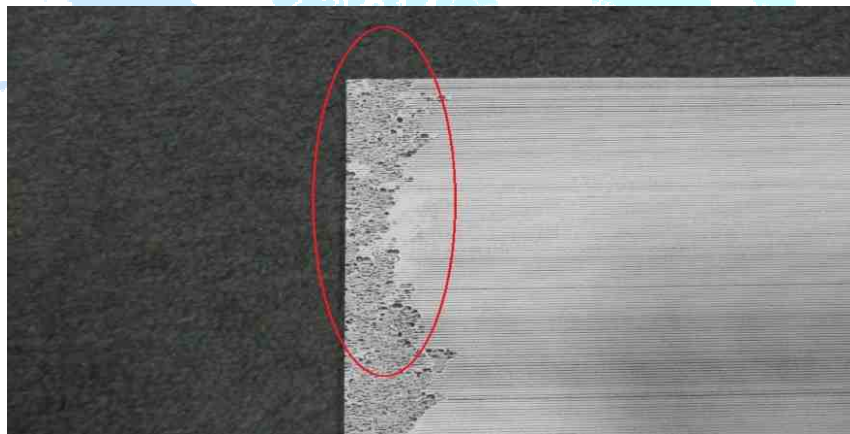
The most common defect is usually referred to as “circle” or “bubble print” with varying severities from a thin row down the side(s) of the page (shown below) or mostly full page, depending on how far out of position the contact is.

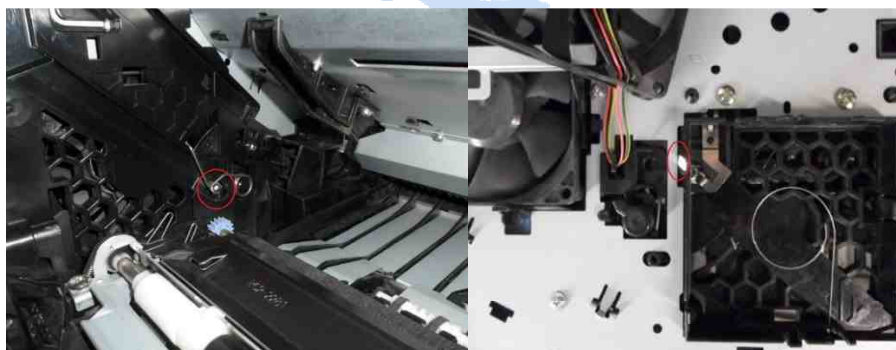
The main culprit for this is a drum ground contact either bent out of position or pressed in and caught on the printer frame – shown in correct position from inside toner cavity and outside left, with fan removed. Most often times can be manually adjusted back into place.
