HP P3015 and M525 Series printers Error TRAY 2 OPEN

There has been an increase in cases with the above listed printer series reporting a constant “TRAY 2 OPEN” message.

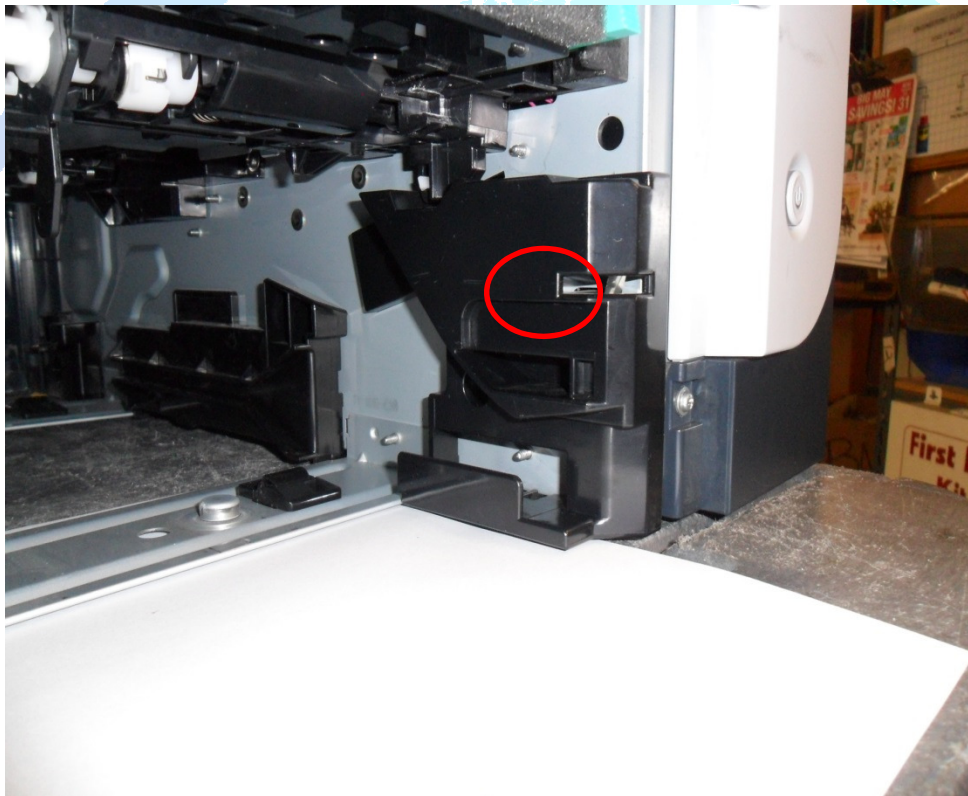
FIG1

In most occurrences we have found the only problem to be a weakened leaf spring – which is responsible for depressing a micro-switch to signal the DC Controller when the cassette is closed.

To verify this, with the printer on and the cassette removed, simply use a small object to press in on the metal leaf spring located within the right cassette guide (FIG 1) and note the control panel:

2) If the printer displays “TRAY 2 EMPTY” the leaf spring would need to be slightly bent to make a better contact with the micro switch itself.
