HP M607/M608/M609/E60055/E60065/E60075

13.B2.D2 or Tray overfill error message when printing from tray 2

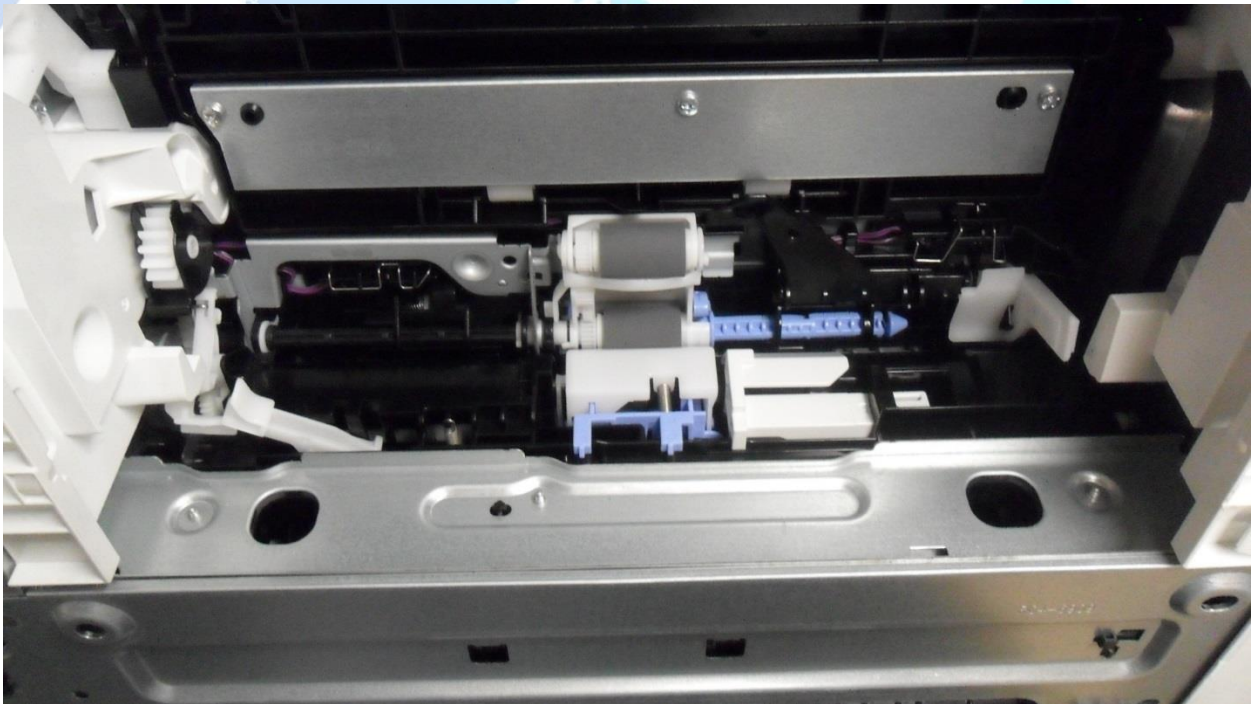
1. Check if the pickup rollers are installed correctly as shown:

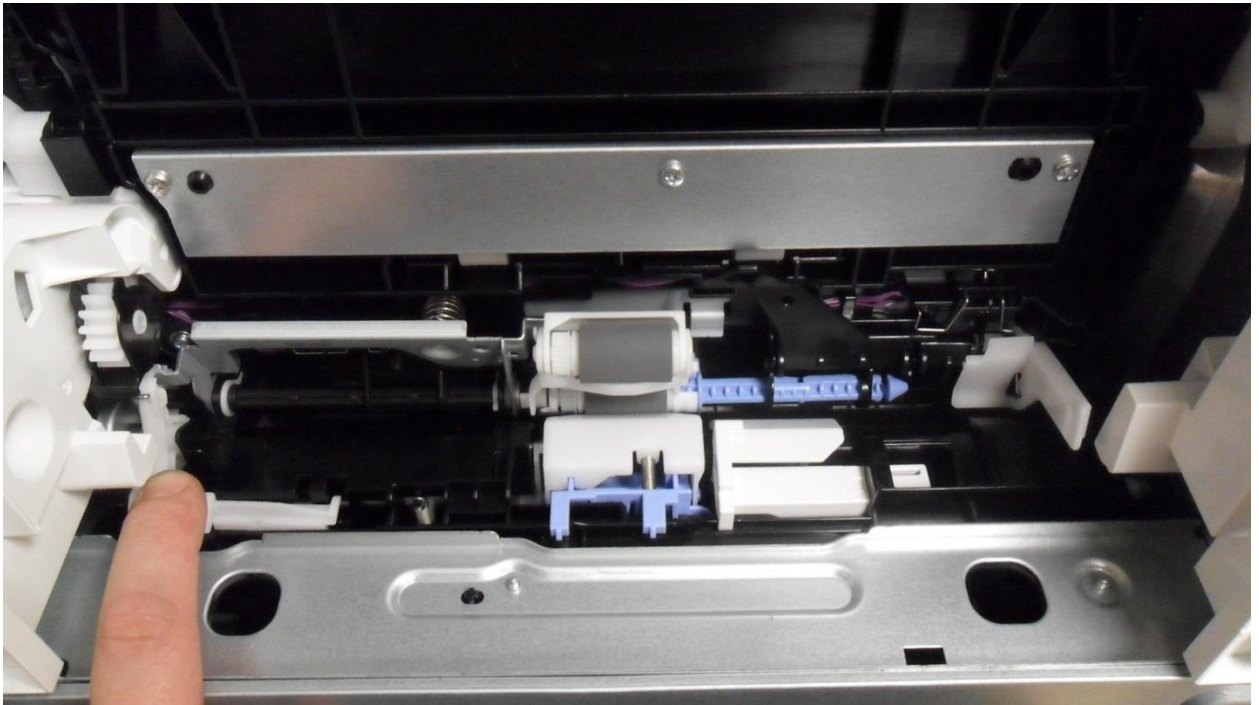
If white arm is pushed in, the roller bracket should drop down:

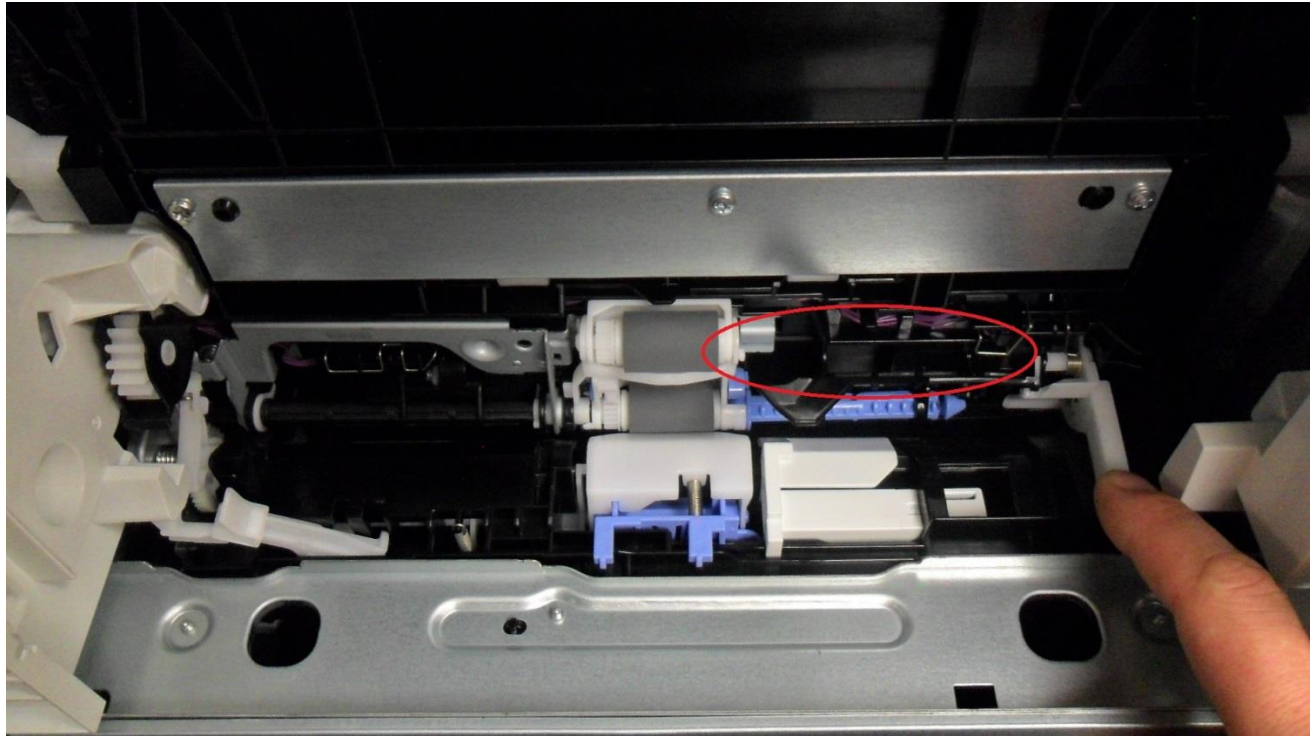
Paper sensor flag shown in correct position – Rear side of tray cavity, right side. If the white arm is pushed in, the flag should drop down for correct operation.

If the paper sensor flag is missing, damaged, or dislodged replace the Paper Pickup Assembly **RM2-6771**.
