HP CLJ M552/M553/M577 Print Quality / Poor Transfer

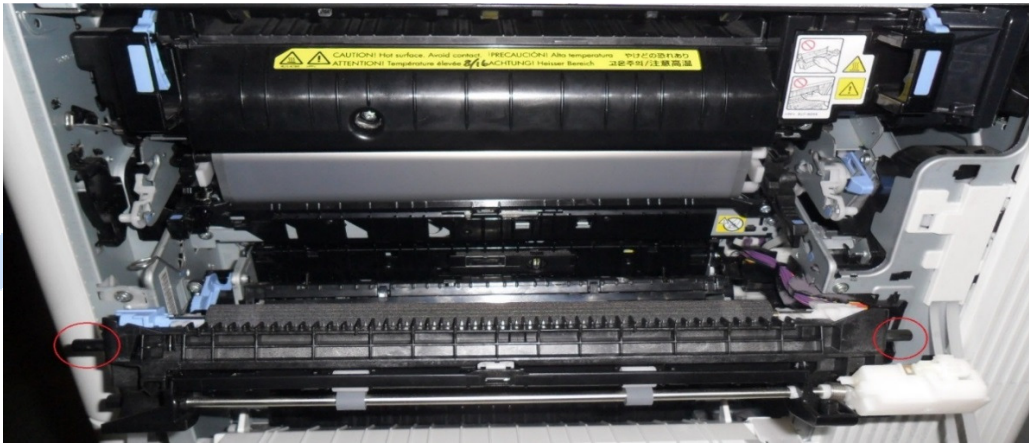
LPI has had a number of cases where a broken tab (or tabs) on the secondary transfer assembly which results in faded or washed out print on either right or left side of the page, or across the entire page in the case of both tabs broken. (Pic shown with both tabs correct/not broken)

There are two locking mechanisms in the printer that secure these two tabs and pull the secondary transfer assembly tight against the transfer belt as the right door is closed.

Secondary transfer assembly replacement #: RM2-0022 Duplex models, RM2-0090 Simplex models.

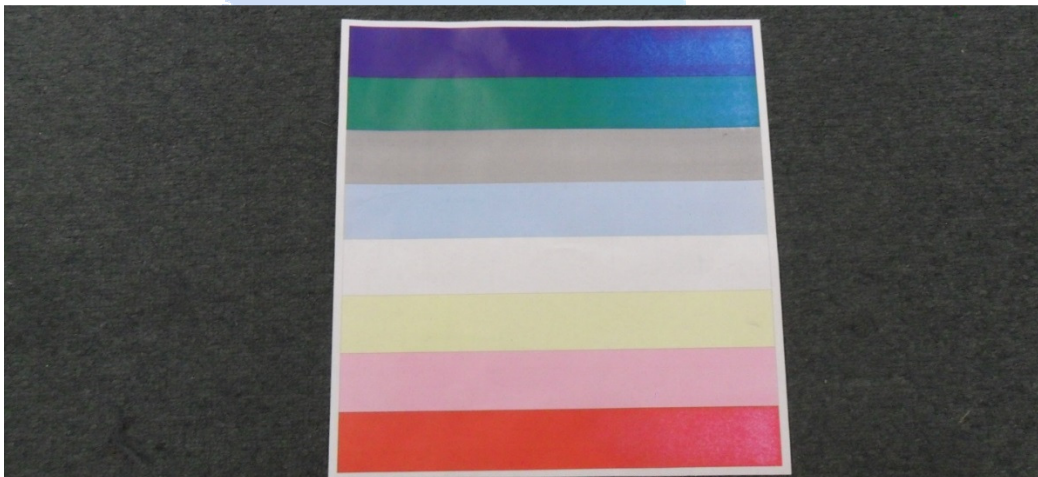
Example of “color band test” shown faded down right side from a printer that had the front tab broken:
