TECHNICAL INFORMATION

Product Name Nikon FM2/FE2/FA

Ref. No. FM2-840024

SHUTTER IMPROVEMENTS

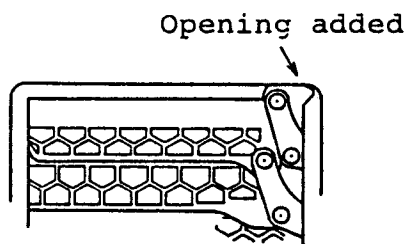
Figure 1

The upper wind-side corner of the inner aperture frame has been re-contoured to prevent the interference with the edge of closing curtain that travels with shaking between the aperture frames. See Figure 1.

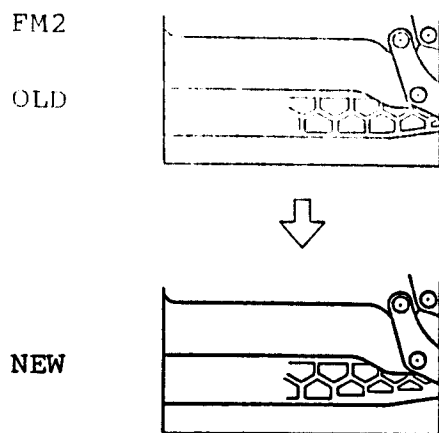
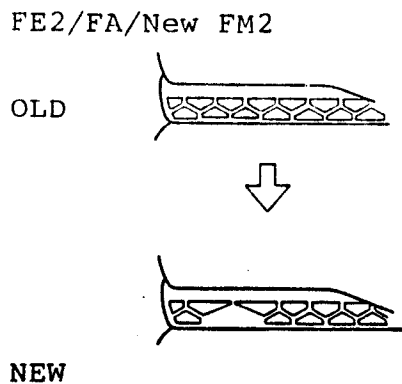
One part of the honeycomb structure has been changed to reinforce the blade of closing curtain. See Figures 2 and 3.

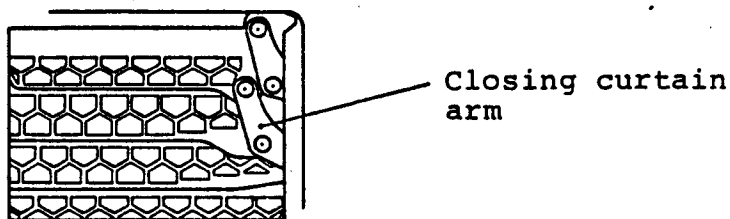
Figure 4

The material of closing curtain arm has been changed from titanium into carbon steel for reinforcement. See Figure 4.

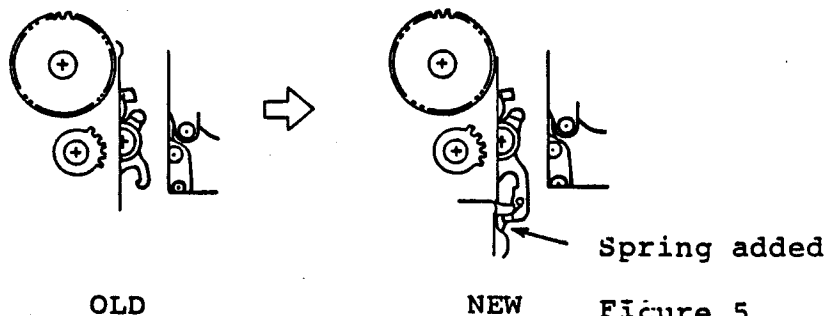
Figure 5

A spring has been added to the closing curtain brake to increase the efficiency of braking. But this has not been applied to the former FM2 camera. See Figure 5.

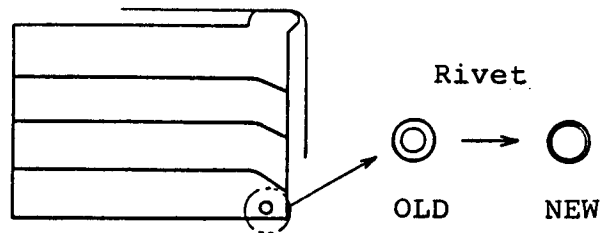
Figure 6

The rivets have been modified to prevent dislocation of shutter curtain blades. See Figure 6.

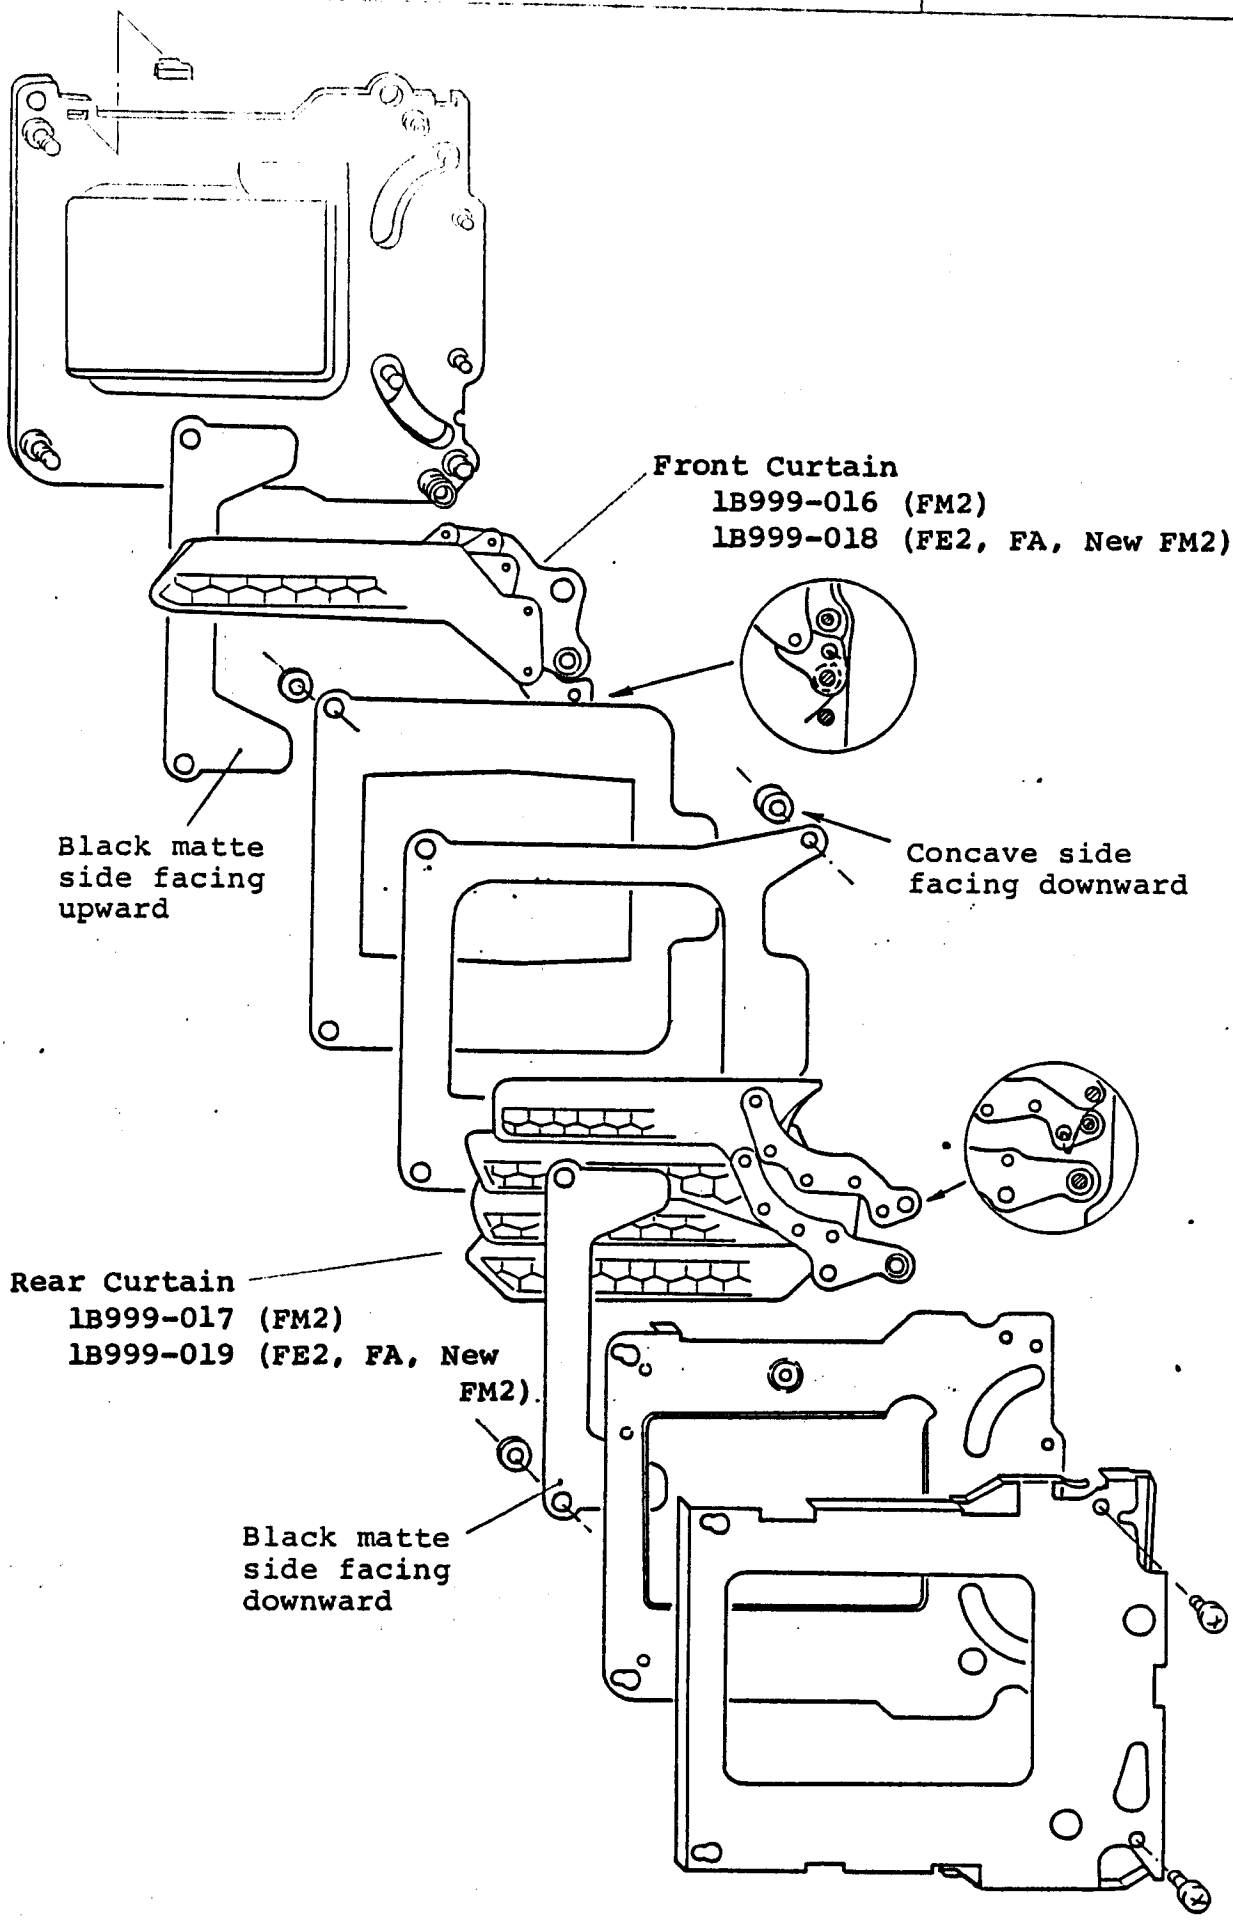
Front Curtain

Black matte
side facing
upward

Concave side
facing downward

Rear Curtain

Black matte
side facing
downward

1. Check if the spare curtain blade is precisely flat, before installing.
2. See the illustration attached to disassemble/reassemble the shutter unit. The parts illustrated are of improvements. If a different pre-improved part is found in the unit of previous FM2 camera, it should be replaced in addition to the spare curtain blades. A junk shutter unit available should be disassembled to obtain the parts in need.
3. After reassembling, install the shutter unit in the camera body temporarily to check the shutter speed delivery. Set M250 when checking the FE2 and FA cameras.
