Building Analysis Report

3057 Main Street
East Troy, WI 53120

Prepared for: Ben Keating and Bridgette Hopper

Prepared by: Dobiash and Associates, Inc.
7217 W North Ave.
Wauwatosa, WI 53213

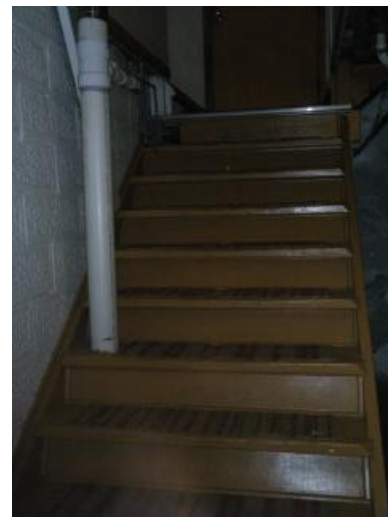
Stairs/Handrails: *Missing handrails.*

1. Stairs/Handrails: *Missing handrails.*

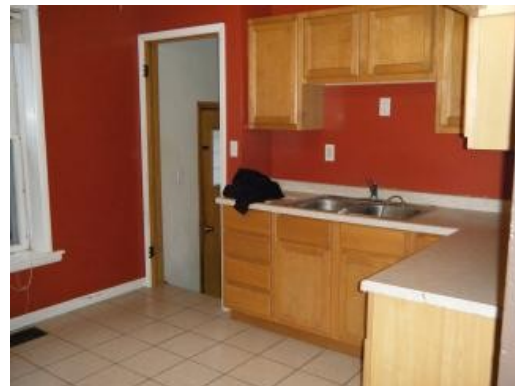
Ventilation:
Disposal:
Dishwasher:
Refrigerator:
Sink: *Stainless Steel Drain pipe*
is not vented properly

3. 1st Floor Kitchen Sink: *Stainless Steel Drain pipe is not vented properly*
4. 1st Floor Kitchen Electrical: *120 VAC GFCI Open ground at several outlets.*

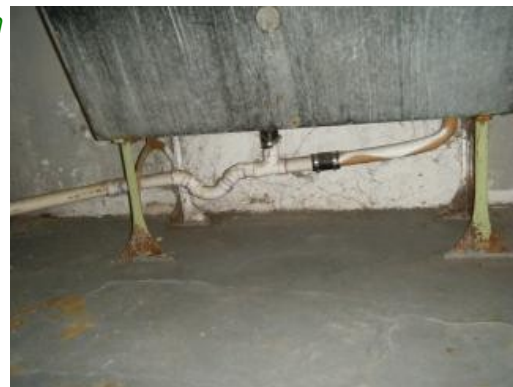
Basement Laundry Room/Area
Unacceptable/Poor

Laundry Tub: *Concrete Tub drain is not plumbed correctly. Tub drains filled with debris*

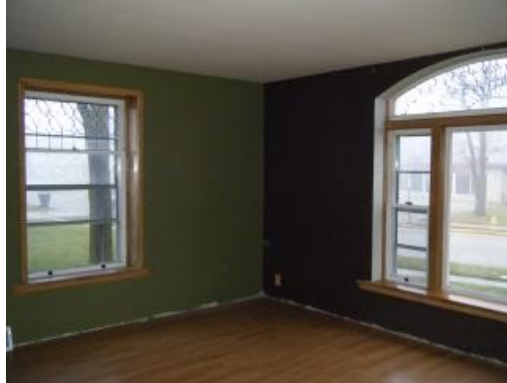
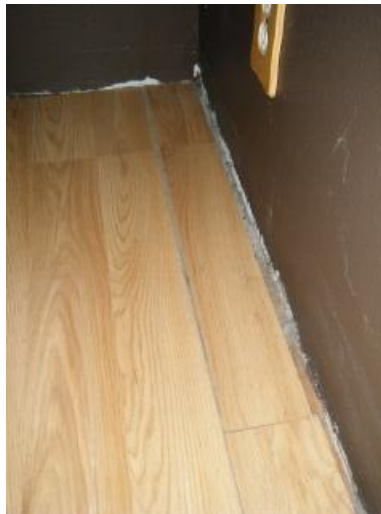
Floor: *Laminate* *Poor installation at flooring.*

Windows: *Wood double hung* *Missing storms at select locations.*

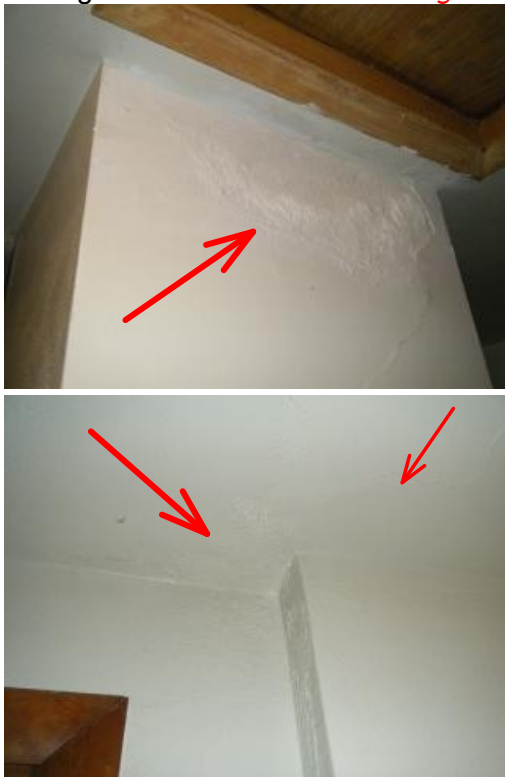
Ceiling: *Evidence of water damage at ceiling and wall near chimney.*

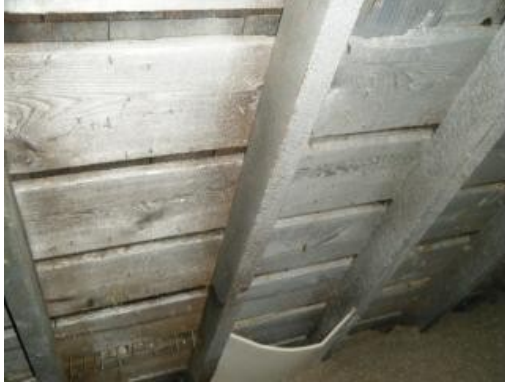
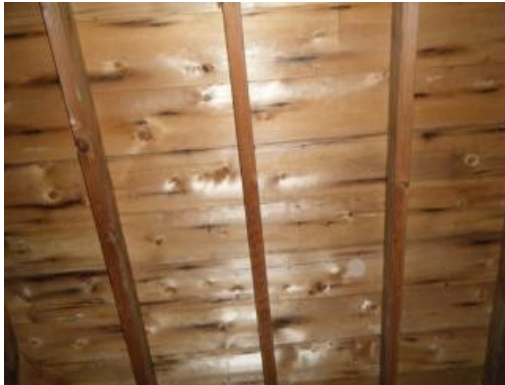
Roof Framing: *2x4 Rafter Evidence of a fire in the past. Portions of the rafters and sheathing are newer than others and portions have been painted. Some charred wood visible. Visible members do not appear to be structurally affected.*

Sheathing: *Dimensional wood Some sheathing has large gaps and will need re-sheathing when re-roofing.*

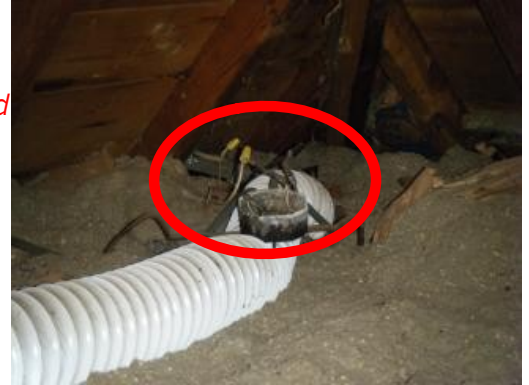
Wiring/Lighting: Open wiring in attic is a potential safety concern. Recommend having a qualified technician evaluate and make necessary repairs.

6. Attic Wiring/Lighting: *Open wiring in attic is a potential safety concern. Recommend having a qualified technician evaluate and make necessary repairs.*

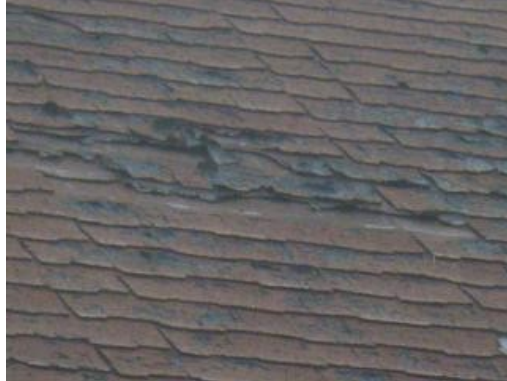
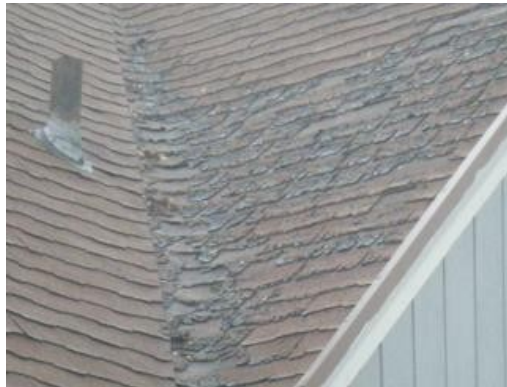
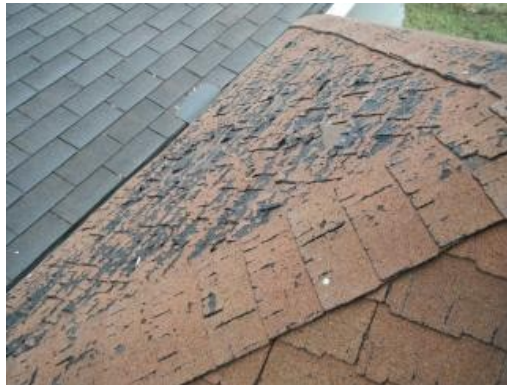
Material: *Asphalt shingle, Wood shake* *Several layers of shingles.*
Very poor condition.

7. Roof Surface Material: *Asphalt shingle, Wood shake Several layers of shingles. Very poor condition.*
8. Gutters: *Aluminum Need cleaning*
9. Downspouts: *Aluminum Need extension away from building*

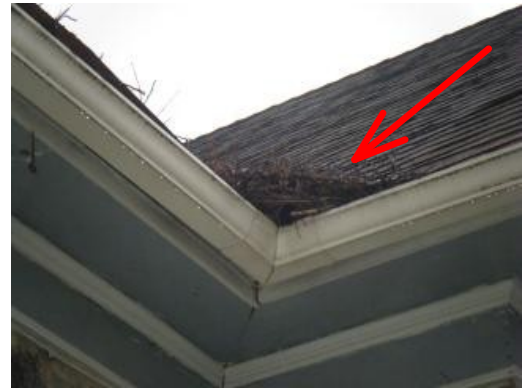
Gutters: *Aluminum Need cleaning*

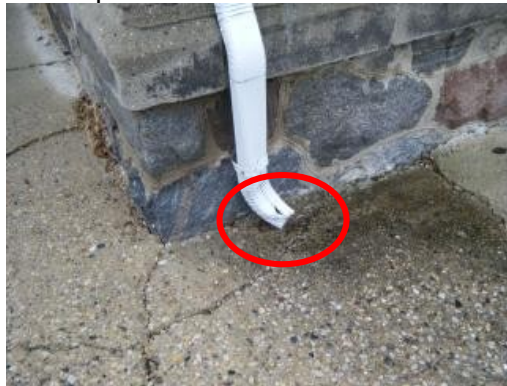
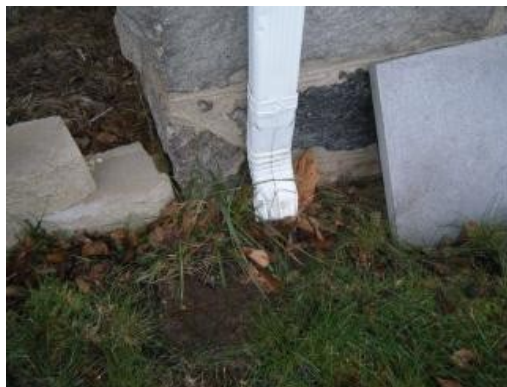
Downspouts: *Aluminum Need extension away from building*

Downspouts: Downspouts should be extended 5 to 10 feet from the building to facilitate proper foundation drainage and help limit basement seepage.

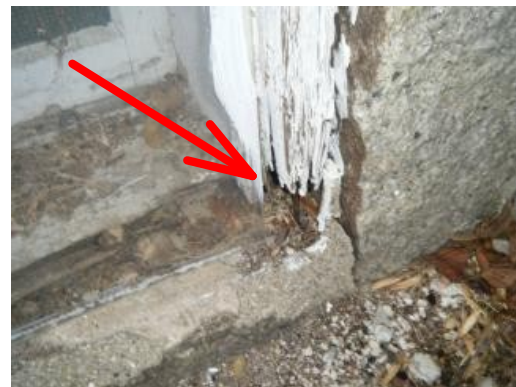
Trim: *Wood Some rotting/deterioration visible at various locations.*

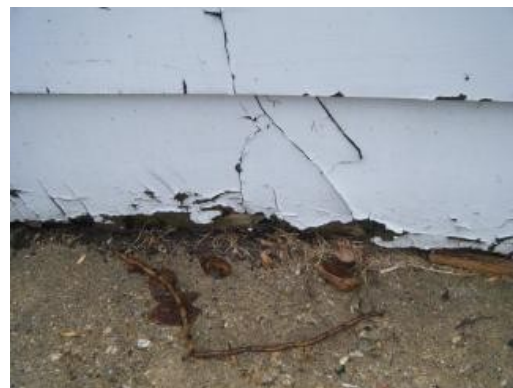
Exterior Surface: *Hardboard*
Serious deterioration.

10. Rear Garage Exterior Surface: *Hardboard Serious deterioration.*
11. Rear Garage Service Doors: *Wood Poor condition.*

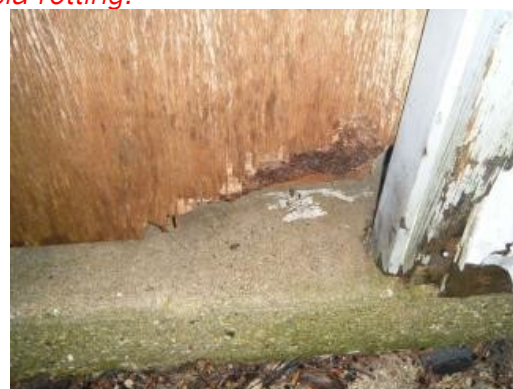
Roof: *Gutters falling down. Fascia rotting.*
Service Doors: *Wood Poor condition.*

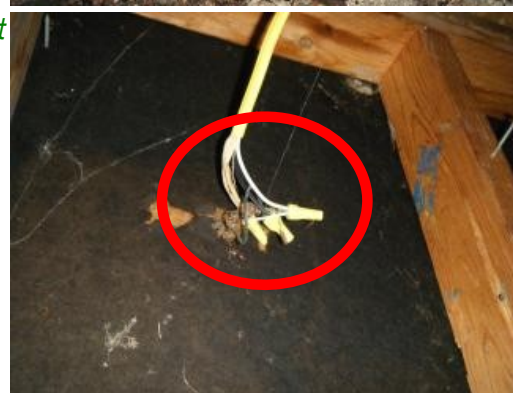
Electrical: *Wiring in garage is not compliant with current standards.*

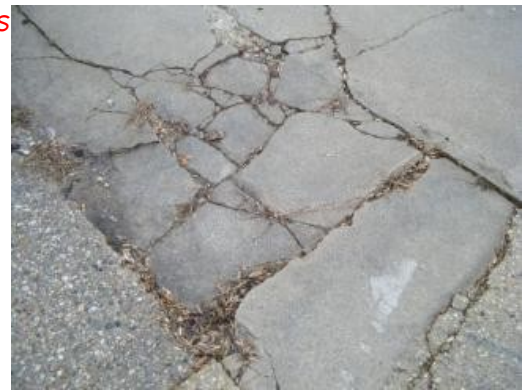
Driveway: **Concrete** Heavy cracks in surface. Potential tripping hazards.

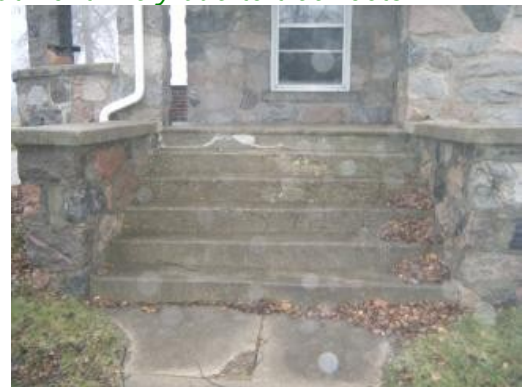
Walks: **Concrete** Some heaving at front likely due to tree roots.
Steps/Stoops: **Concrete**
Recommend a handrail at front porch steps.

Porch: Front porch stoop appears to be sunken slightly.
Grading: Maintain good drainage away from house to limit basement seepage. Needs improvement.

3. Steps/Stoops: *Concrete Recommend a handrail at front porch steps.*
