TRAVEO™ T2G CYT4DN errata sheet

Marking/Step: Rev. C

32-bit single-chip microcontroller

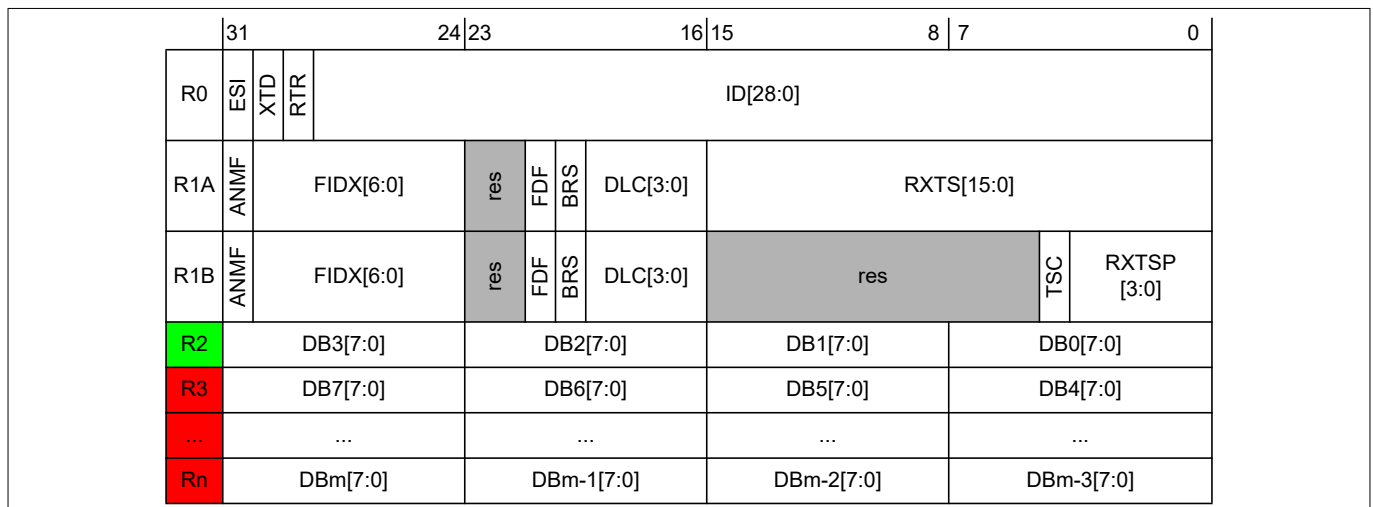
Figure 1 Rx Buffer and FIFO Element

Received data bytes (DB0..DBm) from the CAN Core are buffered in the cache of the Rx Handler before they are written to the Message RAM (in words of 4 byte). Data words inside the Message RAM are numbered from R2 to Rn ($n \leq 17$).

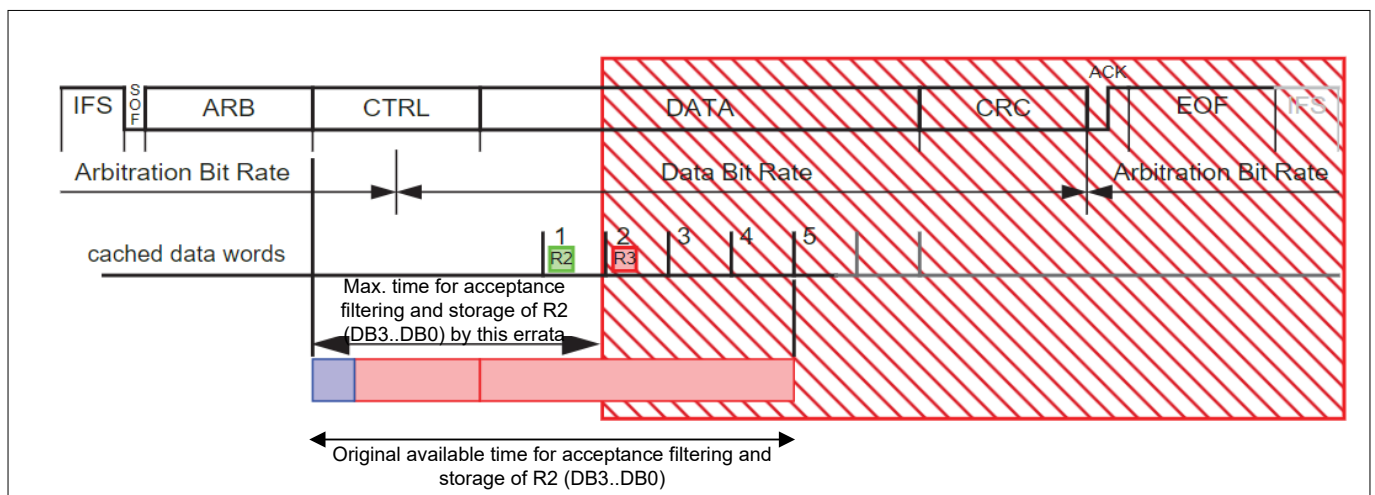
Figure 2 CAN frame with $DLC > 4$

Under the following conditions a received message will have corrupted data while the received message is signaled as valid to the host.

1. The data length code (DLC) of the received Message is greater than 4 ($DLC > 4$)
2. The storage of R_i of a received message into the Message RAM (after acceptance filtering is done) has not completed before $R_{(i+1)}$ is transferred from the CAN Core into the cache of the Rx Handler (where $2 \leq i \leq 5$)
3. While condition 1 and 2 apply, a concurrent read of data word R_i from the cache and write of data word $R_{(i+1)}$ into the cache of the Rx handler happens

Figure 2 shows how the available time for acceptance filtering and storage is reduced.

Due to condition 3 the issue occurs only sporadically. Use an end-to-end (E2E) protection (for example, checksum or CRC covering the data field) and add it to all messages in the CAN system, to detect data corruption in received frames.
