TRAVEO™ T2G CYT2CL errata sheet

Marking/Step: Rev. A

32-bit single-chip microcontroller

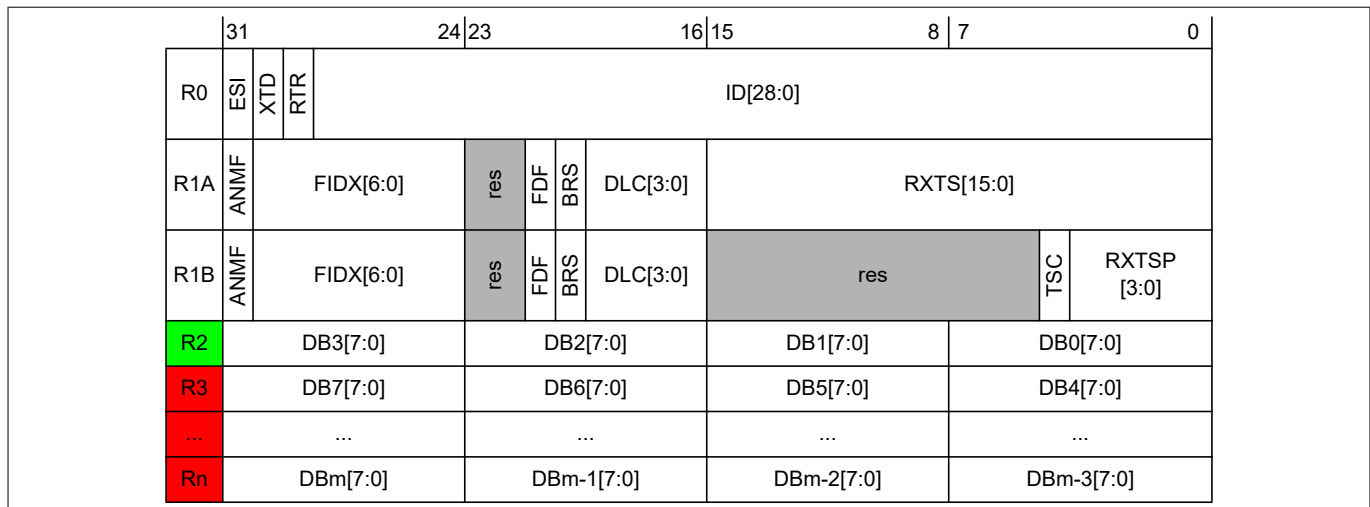
Figure 1 Rx Buffer and FIFO Element

Received data bytes (DB0..DBm) from the CAN Core are buffered in the cache of the Rx Handler before they are written to the Message RAM (in words of 4 byte). Data words inside the Message RAM are numbered from R2 to Rn ($n \leq 17$).

Under the following conditions a received message will have corrupted data while the received message is signaled as valid to the host.

1. The data length code (DLC) of the received Message is greater than 4 ($DLC > 4$)
2. The storage of R_i of a received message into the Message RAM (after acceptance filtering is done) has not completed before $R_{(i+1)}$ is transferred from the CAN Core into the cache of the Rx Handler (where $2 \leq i \leq 5$)
3. While condition 1 and 2 apply, a concurrent read of data word R_i from the cache and write of data word $R_{(i+1)}$ into the cache of the Rx handler happens

Due to condition 3 the issue occurs only sporadically. Use an end-to-end (E2E) protection (for example, checksum or CRC covering the data field) and add it to all messages in the CAN system, to detect data corruption in received frames.

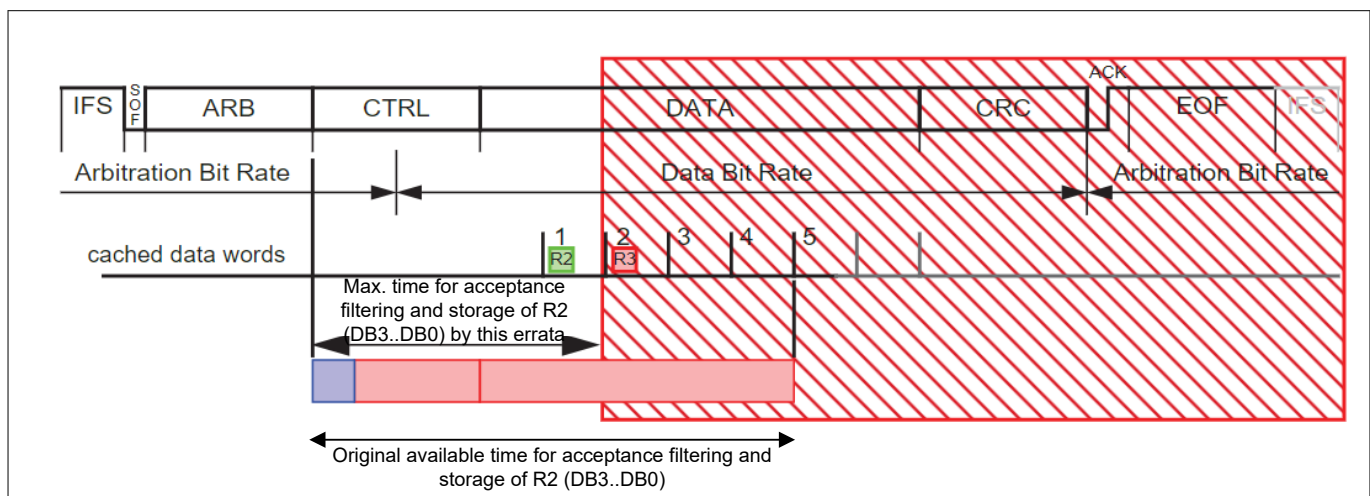
Figure 2 CAN frame with DLC > 4

The issue may occur in FD Frame Format as well as in Classic Frame Format.

Figure 2 shows how the available time for acceptance filtering and storage is reduced.
