Cleaning Roller Earth Spring
MSPRC4582FCZZ

Shearing off during actuation of cleaning roller
Possible C4-20 voltage errors as well as spring fragment falling into the PTC area.

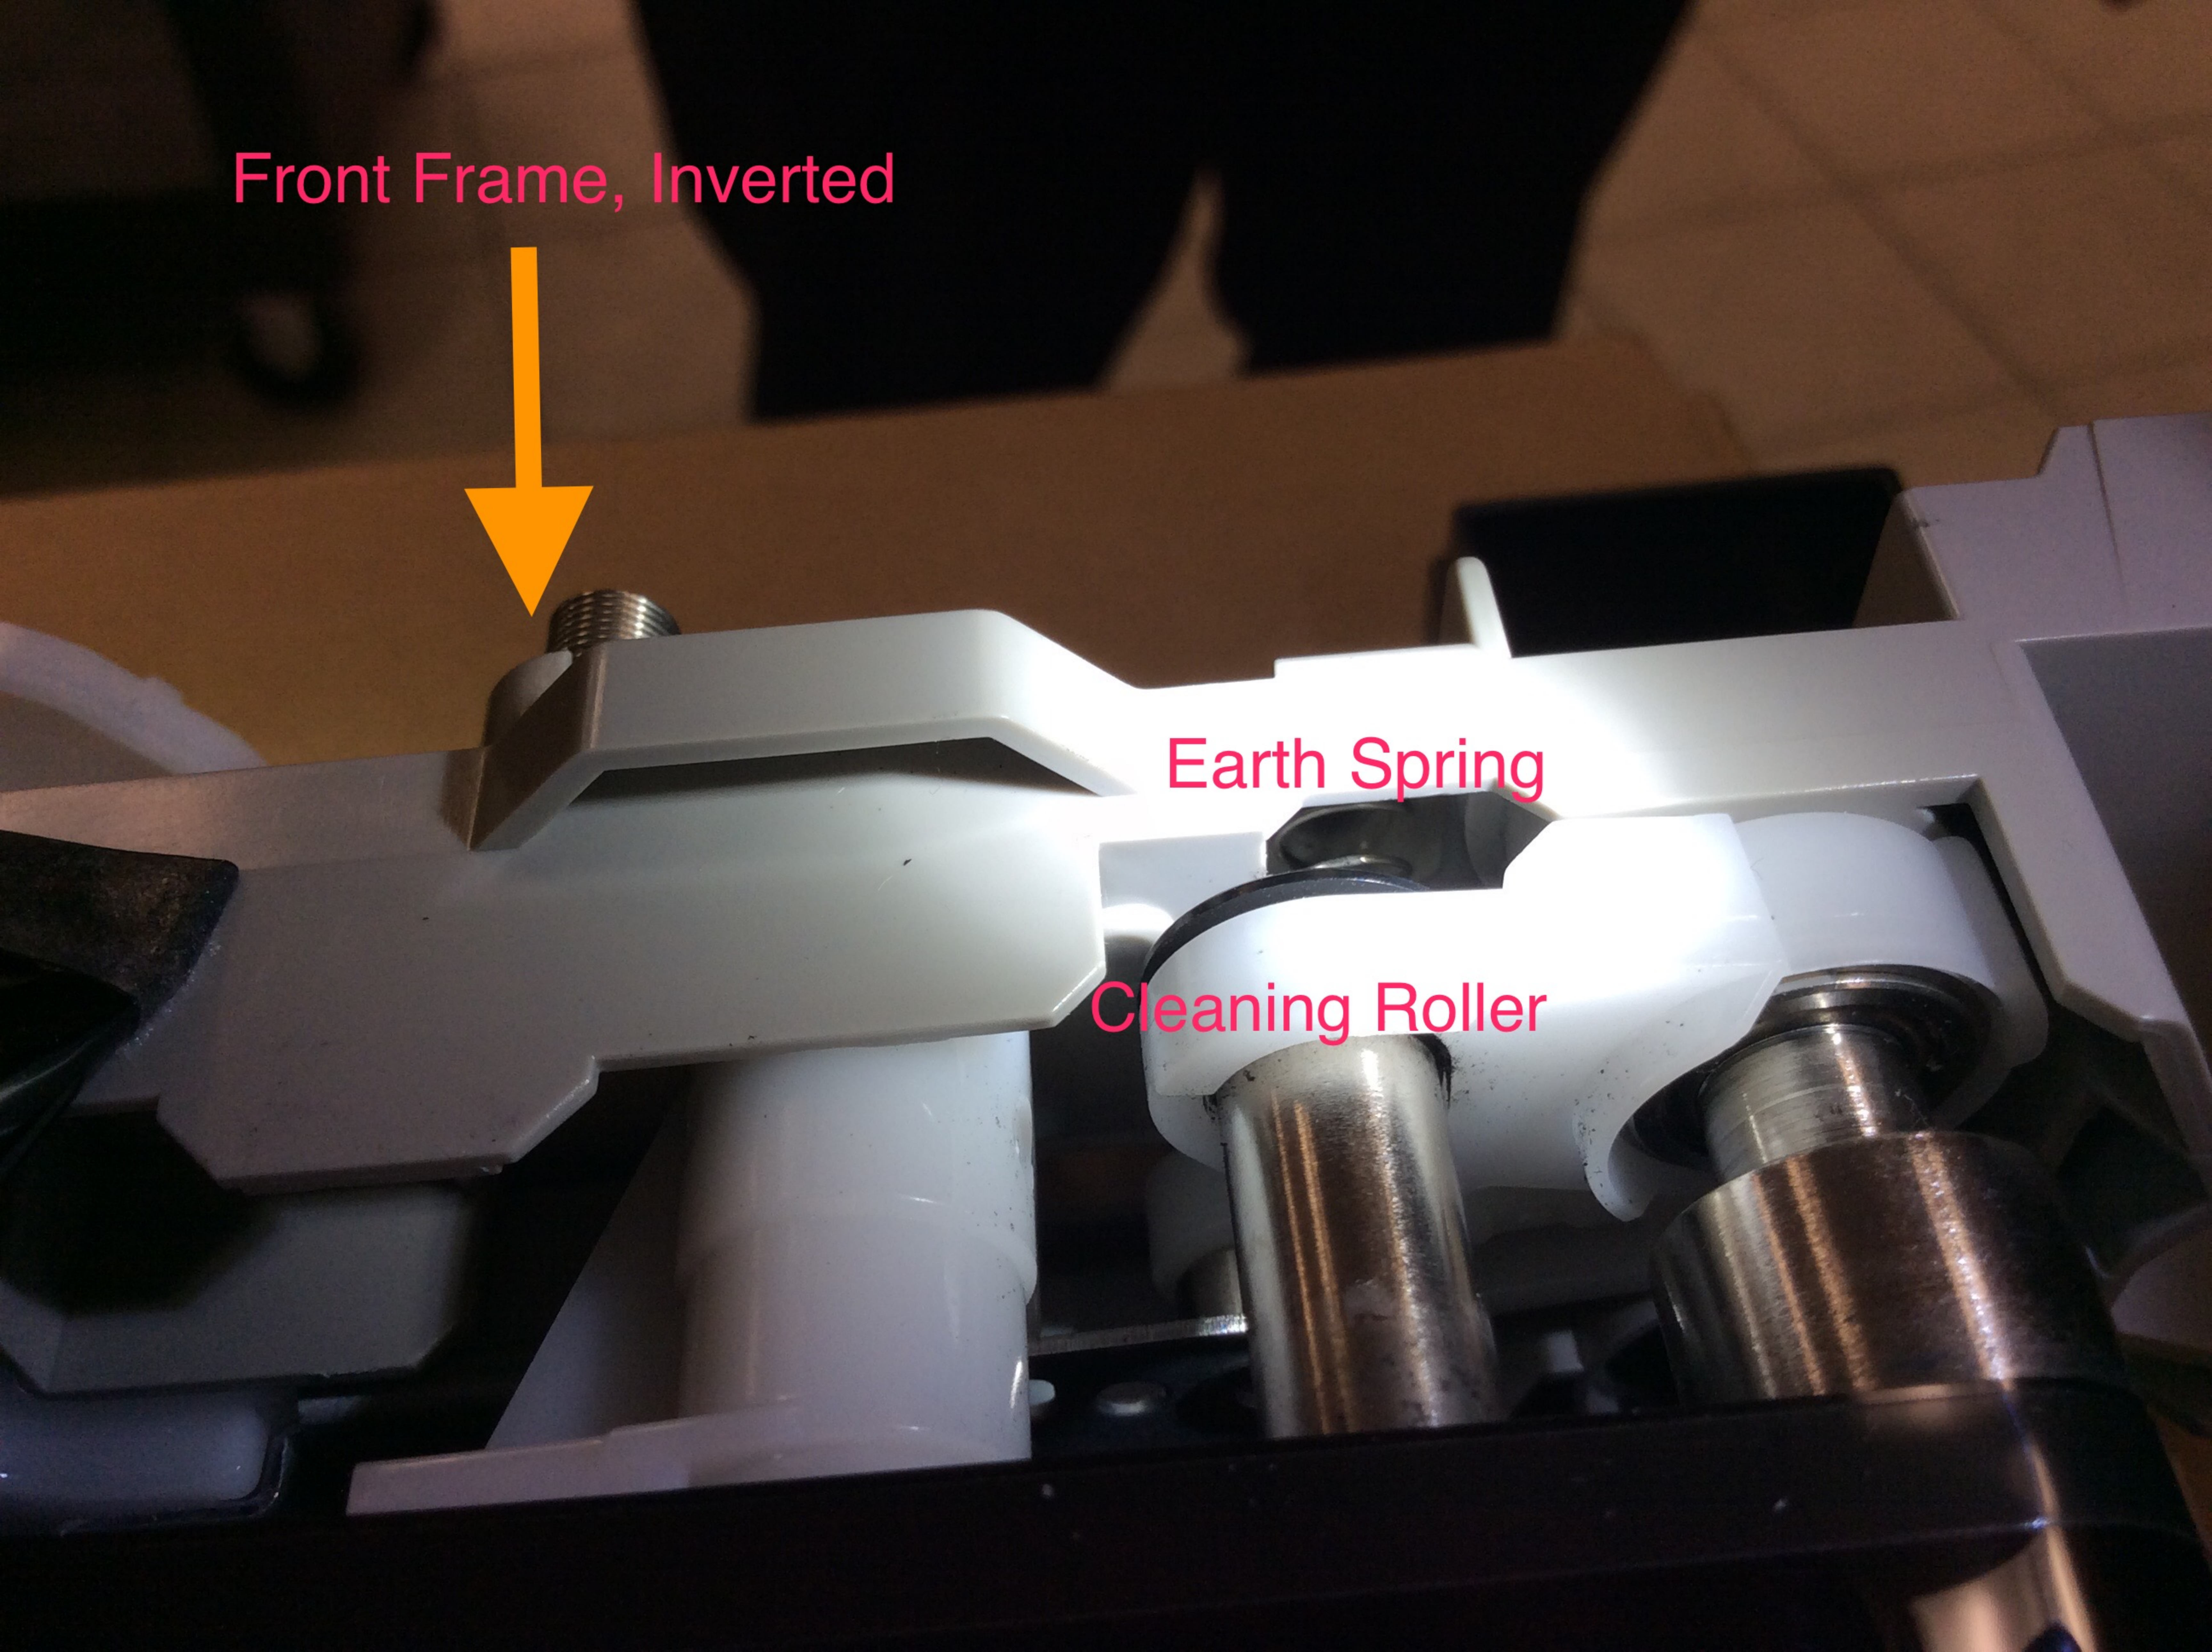
Front Frame, Inverted, Belt Removed

Cleaning Roller Earth Spring
with 2 loops missing

Cleaning Roller

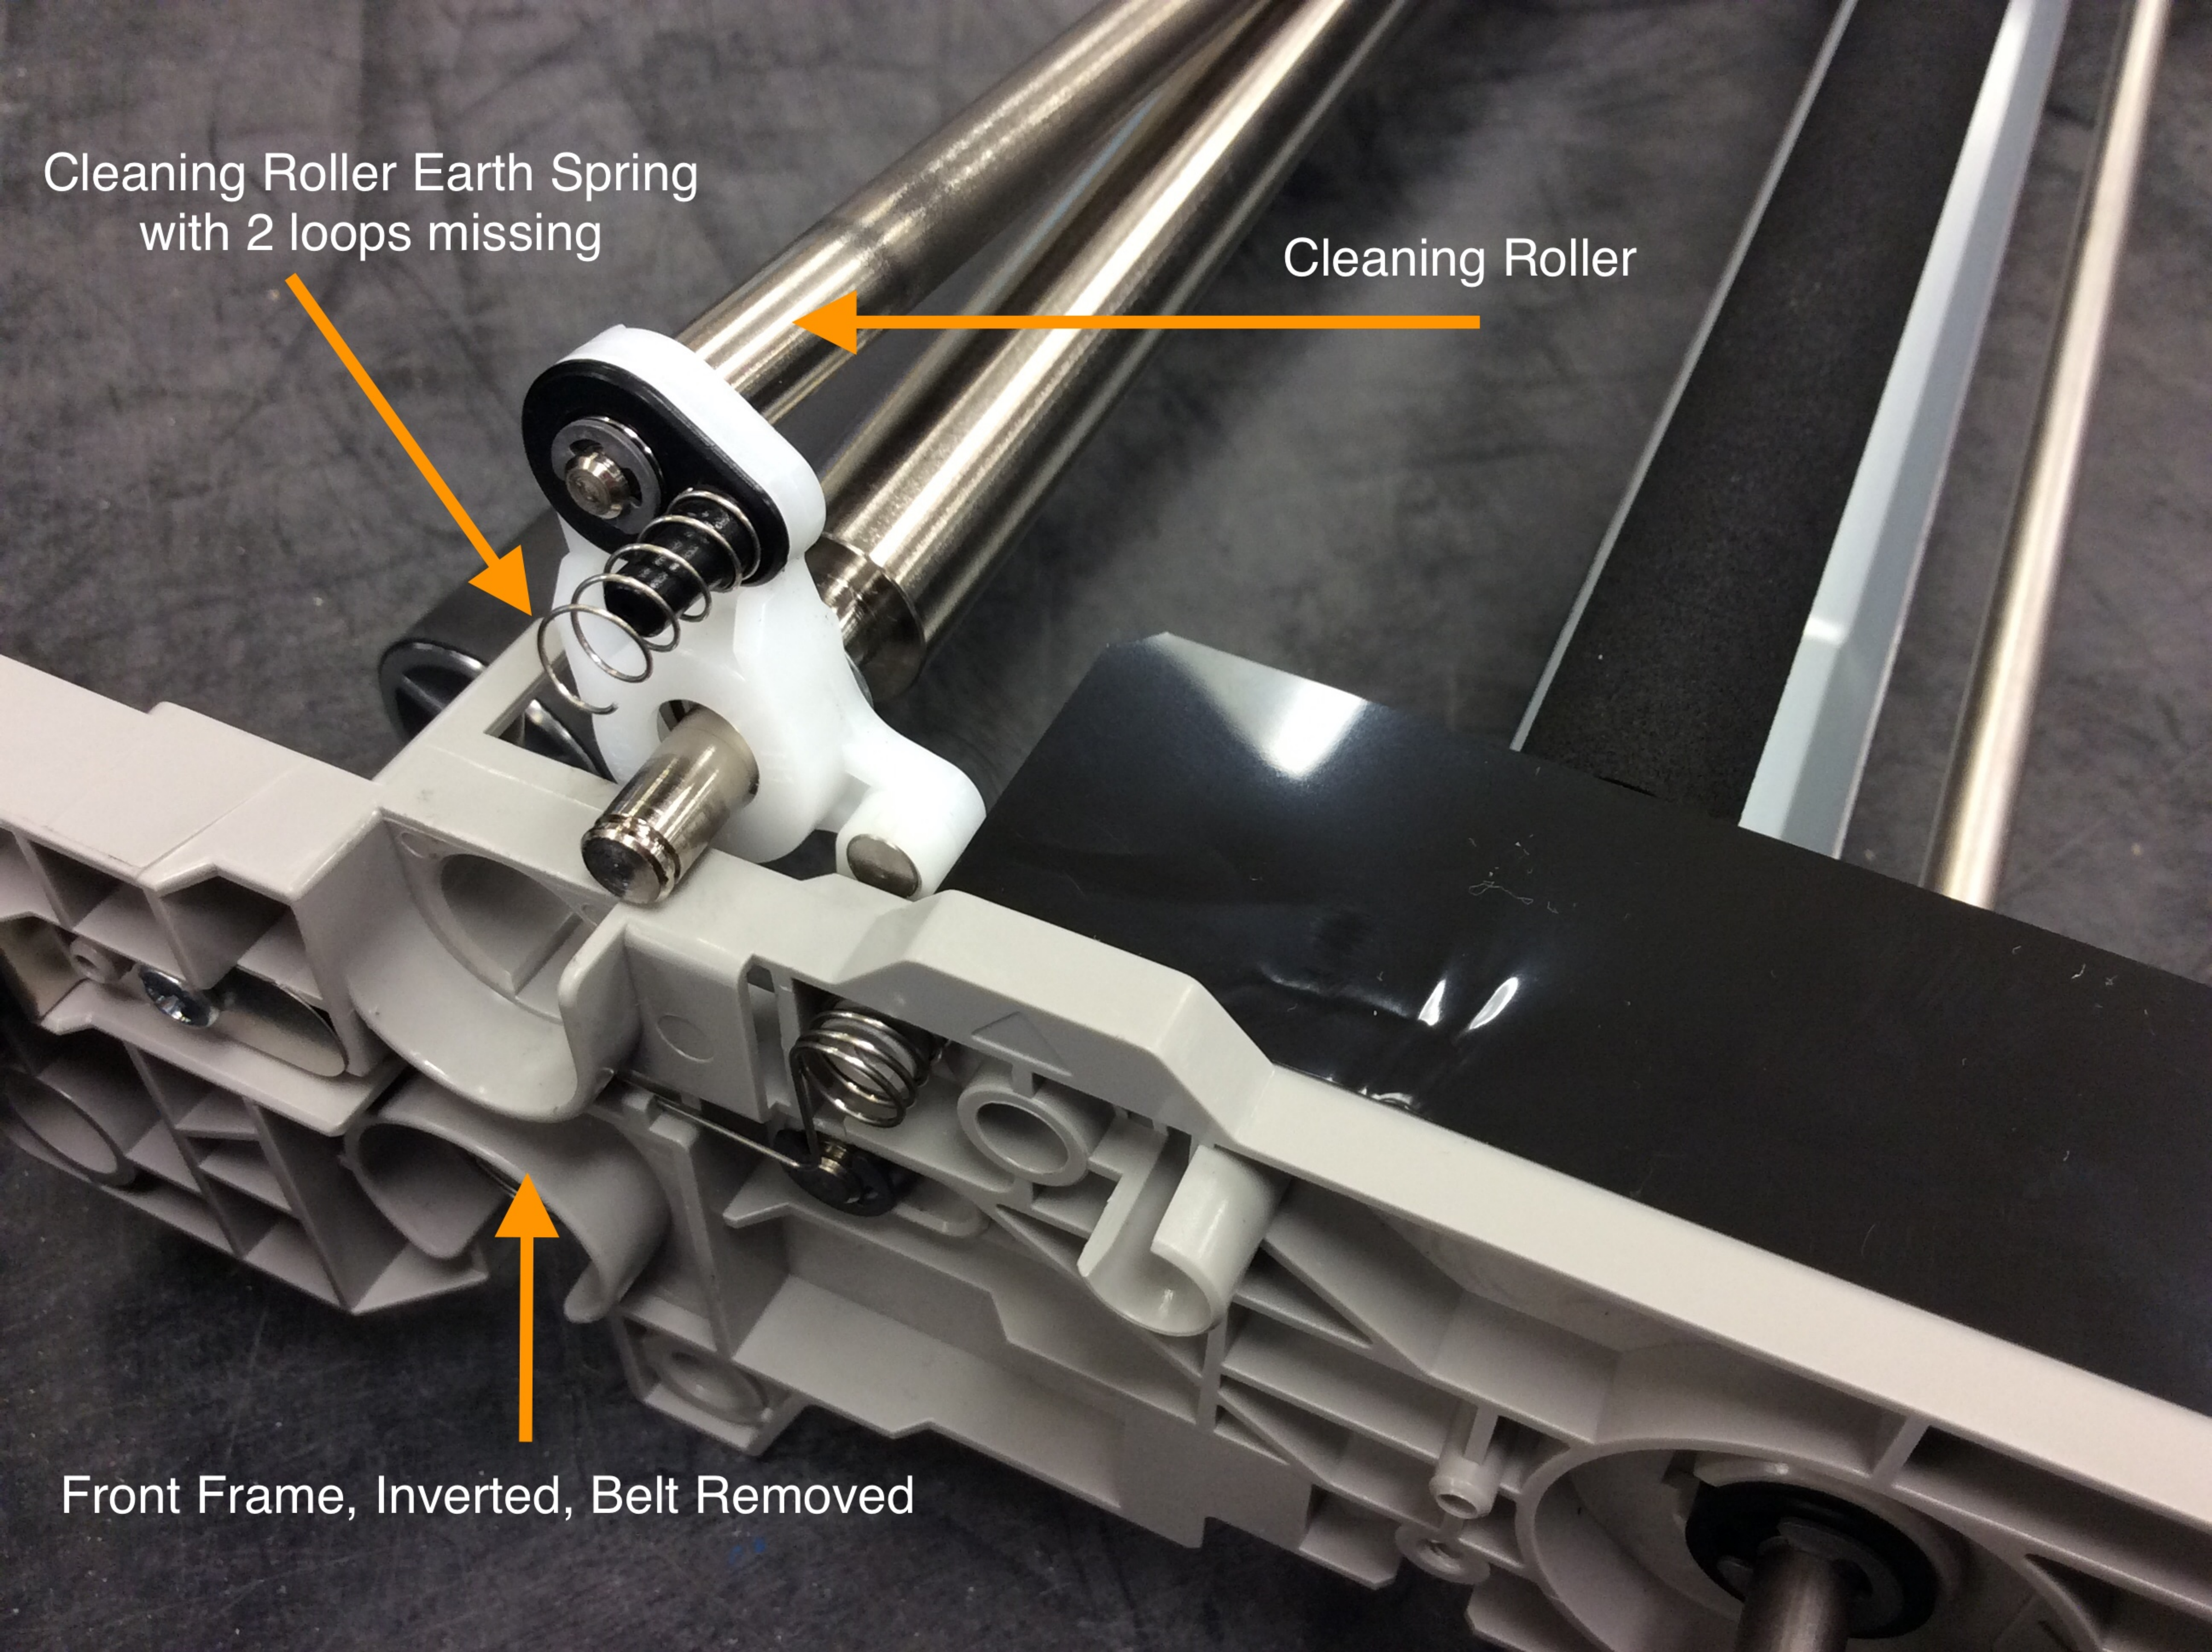
Front Frame, Inverted, Belt Removed

Cleaning Roller Earth Spring
