# VOLVO

## Service Bulletin

RE:  
New RPM sensor

740/940 ALL

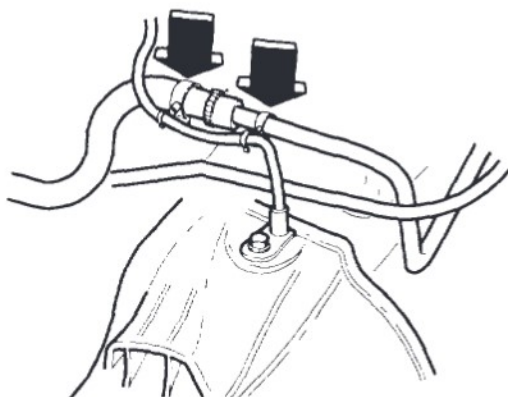
2800130A

An improved flywheel RPM sensor, P/N 3547847-8, was introduced into production during week 48, 1993. The new sender is marked with a white ring, 10 mm from the connector, and has improved cable attachment using clips. When replacing the flywheel RPM sensor on cars made before week 48 1993, attachment, cleaning and greasing of the connector should be carried out according to this service bulletin.

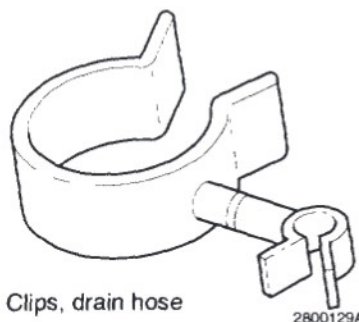
2800129A

Clips, drain hose

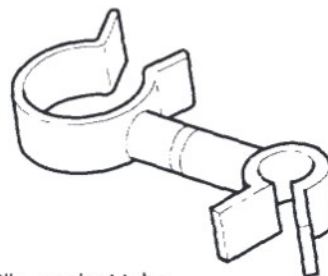
2800128A

Clip, coolant tube
