## STM32H72xx/73xx device errata

This document applies to the part numbers of STM32H72xx/73xx devices and the device variants as stated in this page.

It gives a summary and a description of the device errata, with respect to the device datasheet and reference manual RM0468.

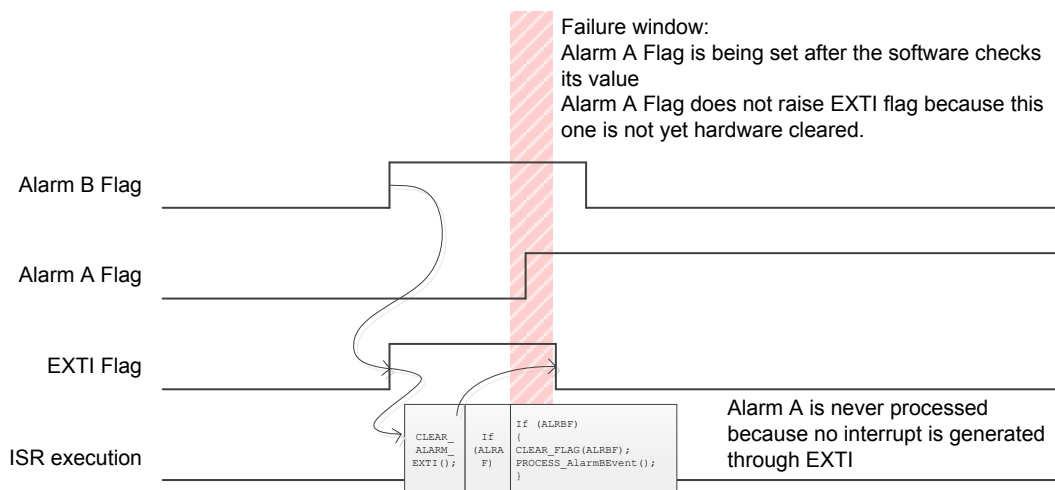
**Figure 1. Masked RTC interrupt**

The following code example and figure illustrate the failure mechanism: The Alarm A event is lost (fails to generate interrupt) as it occurs in the failure window, that is, after checking the Alarm A event flag but before the effective clear of the EXTI interrupt flag by hardware. The effective clear of the EXTI interrupt flag is delayed with respect to the software instruction to clear it.

In the interrupt service routine, apply three consecutive event flag checks - source one, source two, and source one again, as in the following code example:
