Results of redoing the alignment 2019

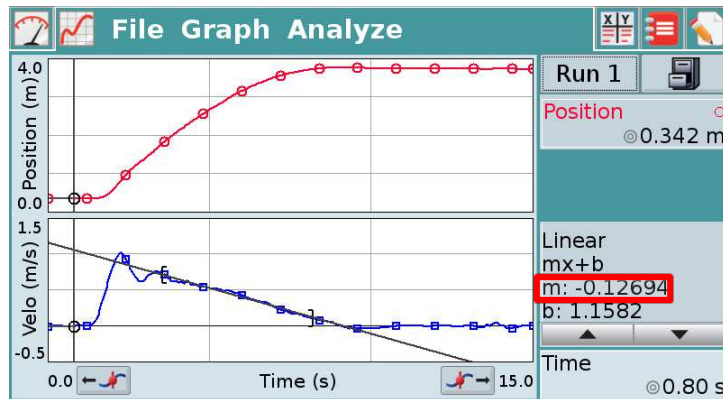
Aligned according to the initial build of the car, with minimal caster, camber, and just a little toe-in.

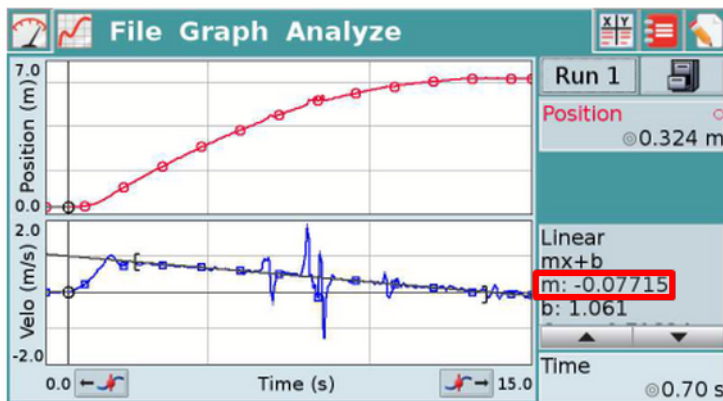
Aligned due to excessive tire wear and poor performance at the first practice.

The rolling friction was reduced almost by half, based on the acceleration (the slopes of the velocity graphs).

Maximum speed went up from around 7.5 to around 8.5.
