# CAMERON

HOME INSPECTION

1234 ANYWHERE STREET

NASHVILLE, TENNESSEE 37221

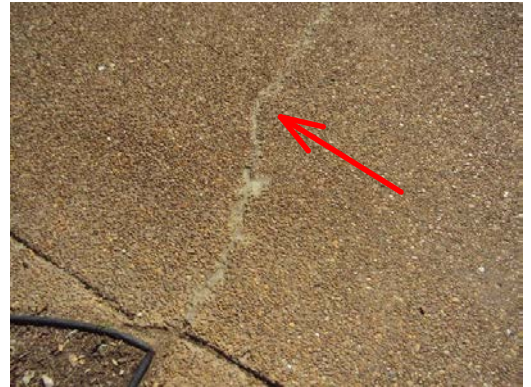
1. Acceptable **Driveway:** Pebble top - Cracks noted in the driveway. Cracks are within generally accepted parameters for settlement and shrinkage of the pour. Suggest that repairs to the cracks be maintained to hinder further deterioration.

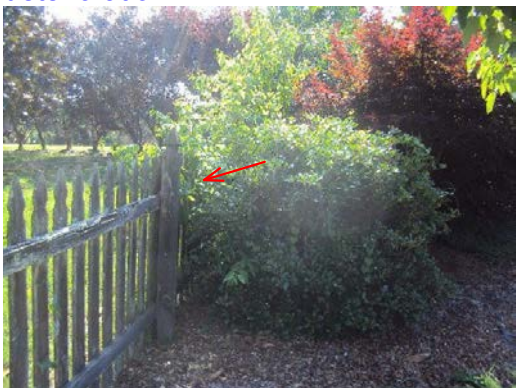
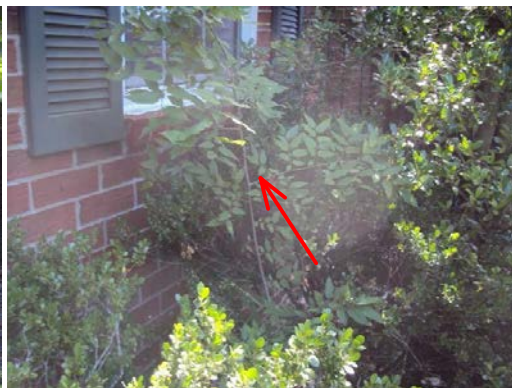
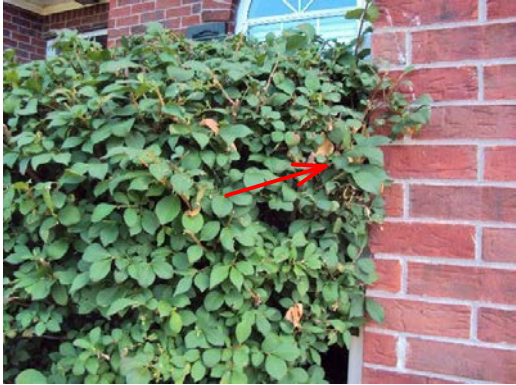
2. Acceptable **Walks:**  
3. Acceptable **Steps/Stoops:**  
4. Acceptable **Deck:**  
5. Acceptable **Grading:**  
6. Acceptable **Swale:**  
7. Acceptable **Vegetation:** Suggest that all vegetation be trimmed away from contact with the exterior finishes to allow for better evaporation of surface water from around the structure and hinder possible premature deterioration and/or damage to exterior surfaces, window screens and finishes. Suggest that vegetation be trimmed away from contact with fence to hinder possible premature deterioration.

**Fences:** Suggest that fence be pressure washed and sealed.

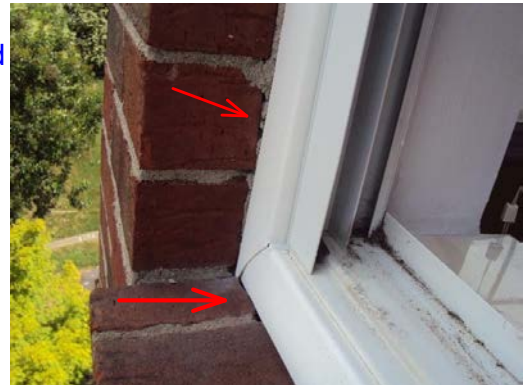
**Type:** Brick Veneer/Vinyl Siding - Suggest that all gaps between window frames/trim and brick veneer for second floor windows be sealed.

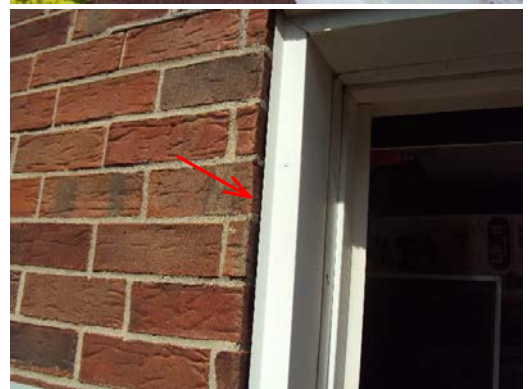
**Trim:** Sealant suggested around garage door where metal wrap on door frame meets the brick veneer.

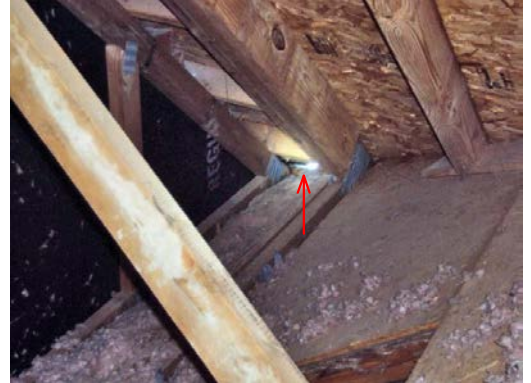
**Fascia:** Gaps noted from attic interior between the roof deck and fascia at the front gable over the front door. Suggest that this be sealed/screened to hinder possible nesting of pests in the attic.

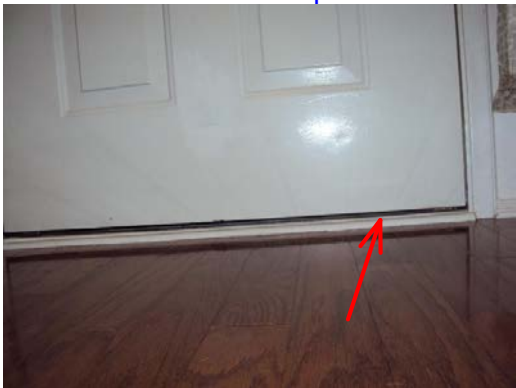
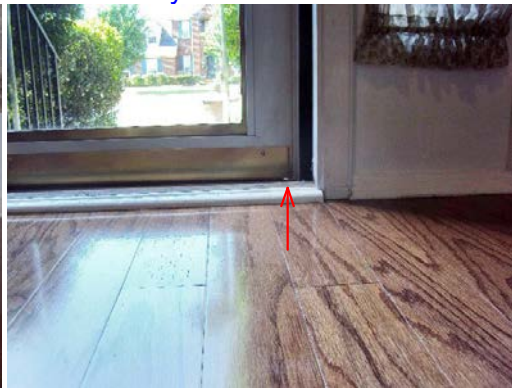
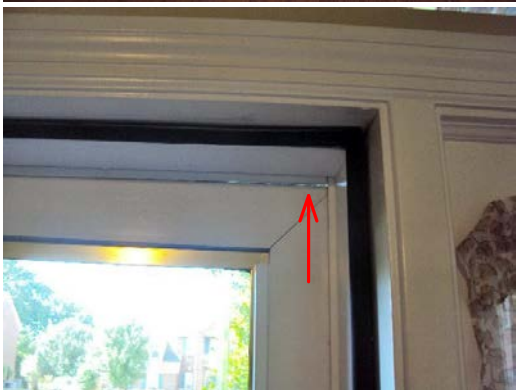
**Entry Doors:** No door sweep noted under front entry door. Gaps noted under and around front storm door. No door stop noted behind the front entry door.

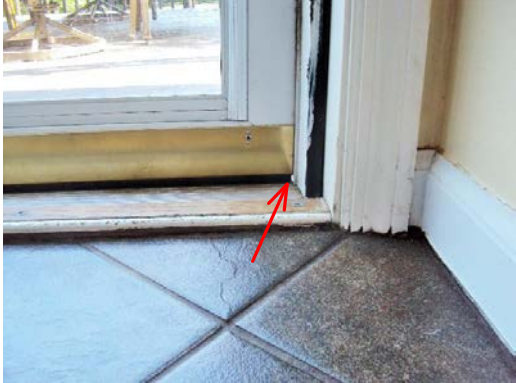
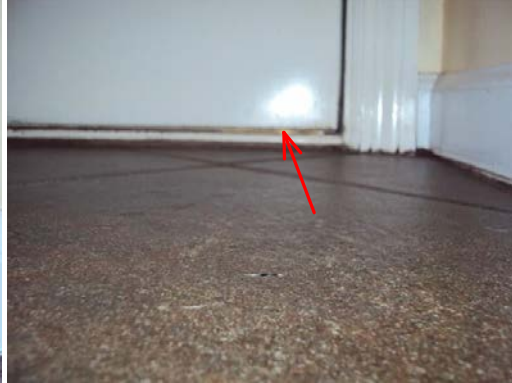
**Patio Door:** Gaps noted under the door sweeps for the rear entry door and rear storm door. No door stop noted behind rear entry door.

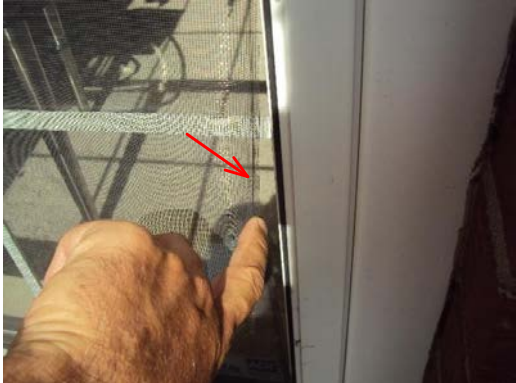
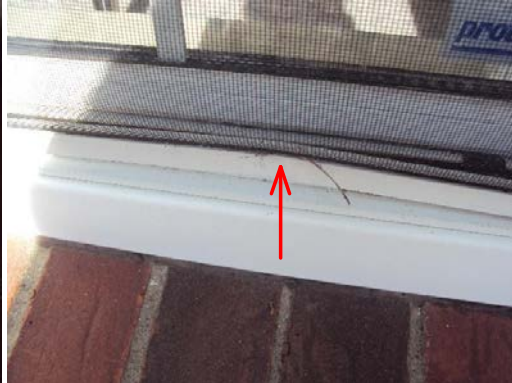
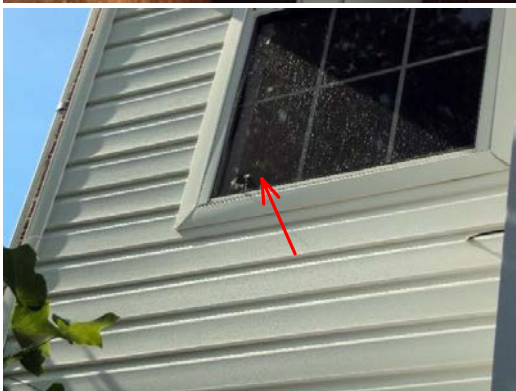
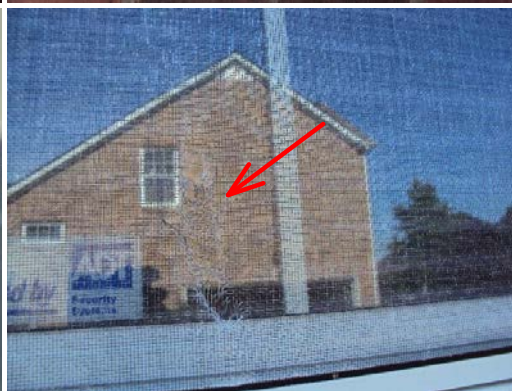
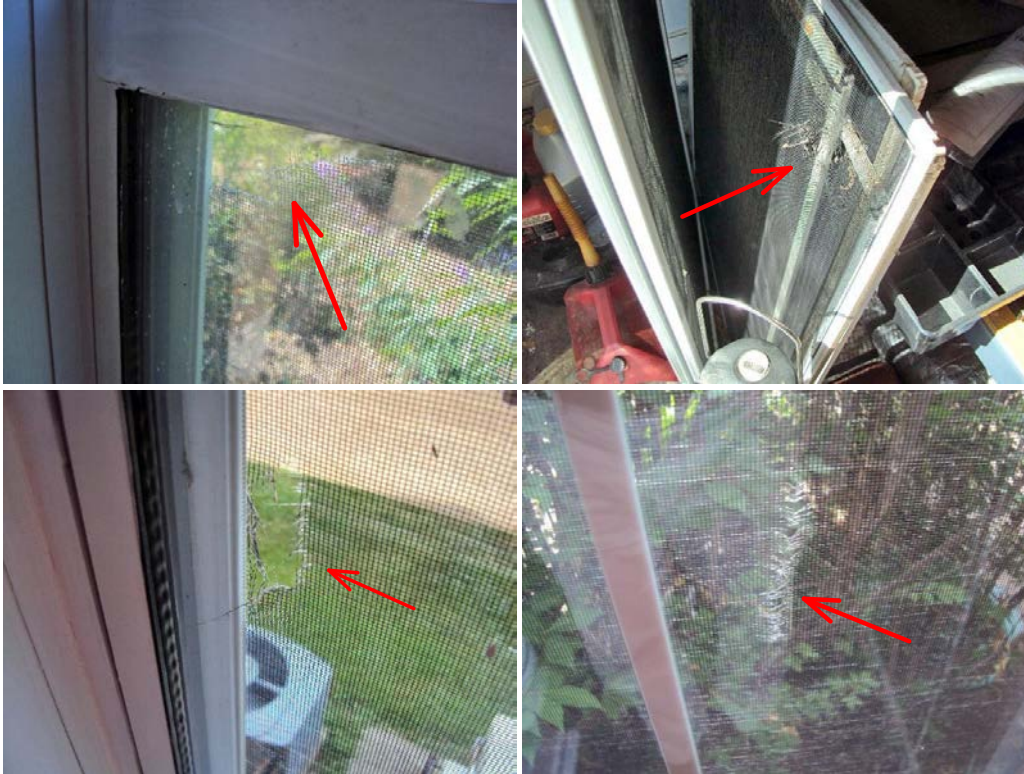
**Window Screens:** Window screens not installed in 6 windows. Damaged screens noted at several areas including those stored in their garage.

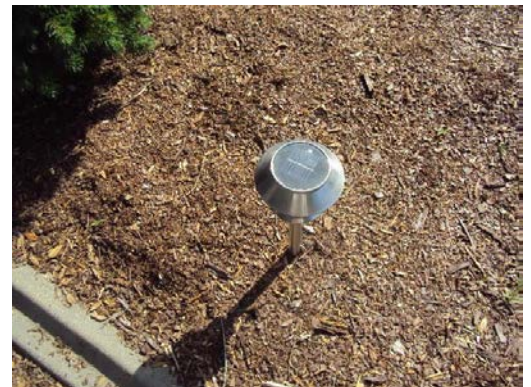
**Exterior Lighting:** Landscape lighting did not respond. These fixtures appear to be on operated by solar cells. Suggest that these fixtures be tested after sundown to verify that they are operational and without defect.

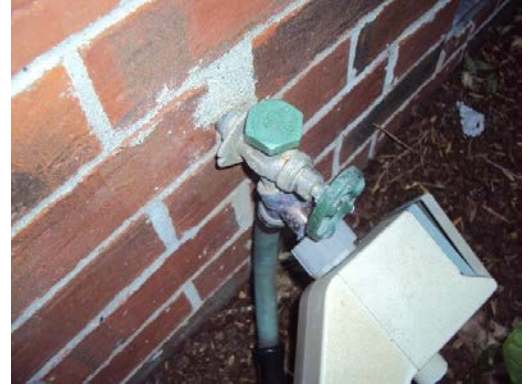
13. Acceptable **Hose Bibs:** Suggest that front hose bib be secured to the brick veneer and sealed around the base.

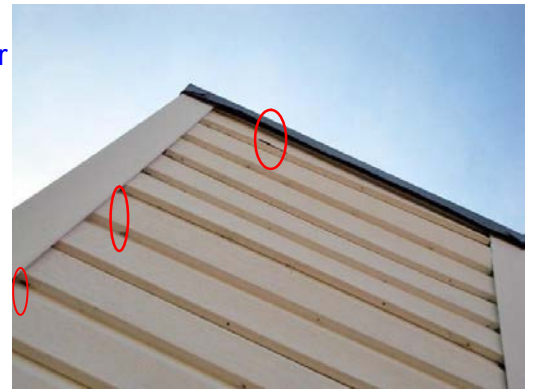
Rear Chimney  
12. Acceptable

**Chimney:** Suggest that small areas of damage to the siding on the chimney chase be repaired to hinder further deterioration and/or possible moisture intrusion.

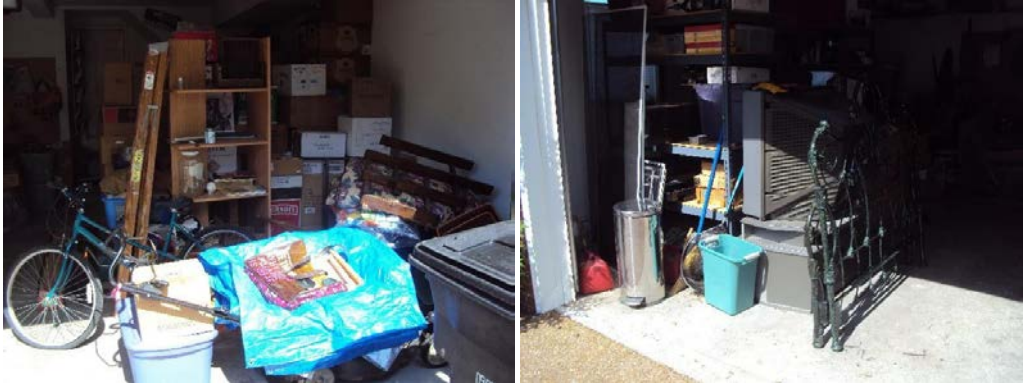
**Walls:** Some wall and ceiling surfaces were not visible due to stored items of the occupant.

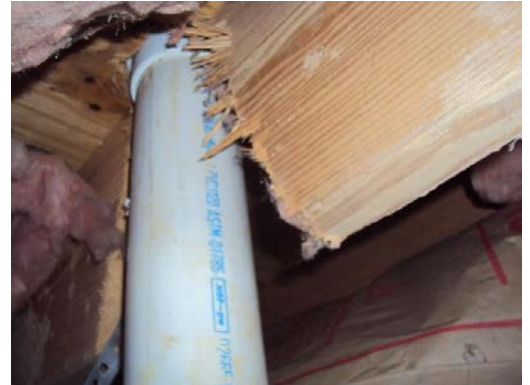
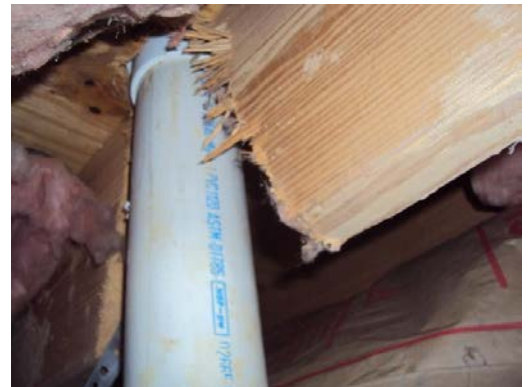
**Joists/Trusses:** Floor joist under the powder bathroom toilet was cut in two around the toilet drain line. Suggest that this be repaired to hinder possible sagging of the subfloor and cut joist ends. N evidence of sagging at the time of inspection.

1. **Joists/Trusses:** Floor joist under the powder bathroom toilet was cut in two around the toilet drain line. Suggest that this be repaired to hinder possible sagging of the subfloor and cut joist ends. N evidence of sagging at the time of inspection.

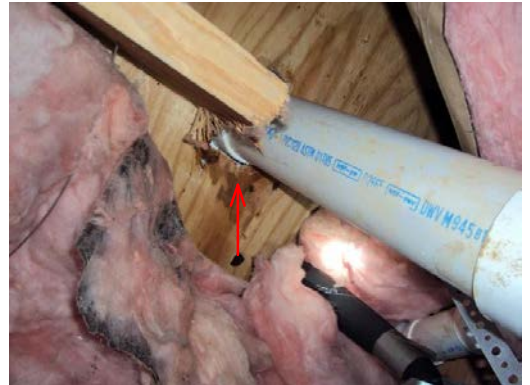
**Subfloor:** Some discoloration noted at the subfloor around the toilet flange for the powder bathroom toilet. No moisture was detected at the time of inspection. Suggest that this area be periodically monitored for increased discoloration and/or moisture. Most of the subfloor was not visible, due to insulation between the floor joists. Insulation was pulled back and the subfloor was examined around the drain and supply water lines.

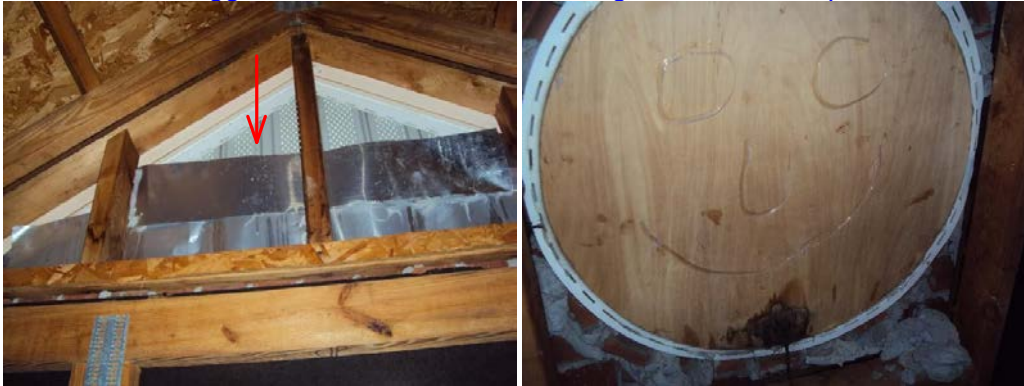
**Ventilation:** Suggest that all areas of covered gable vents be opened and screened.

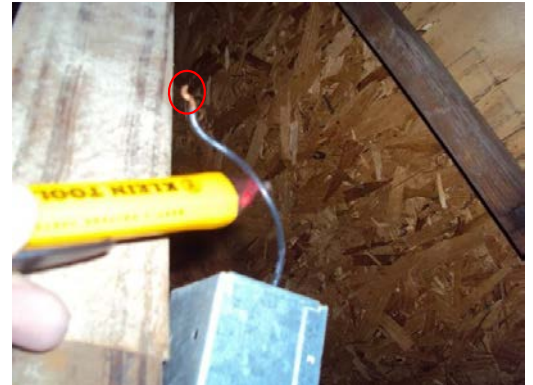
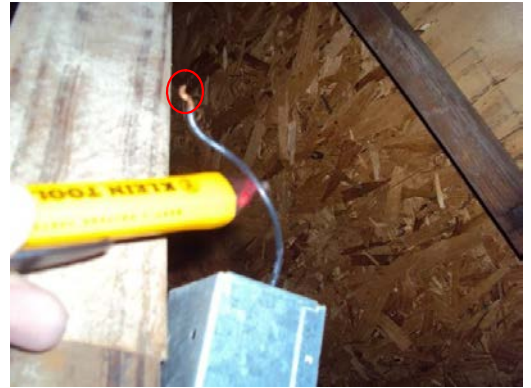
**Wiring/Lighting:** Uncapped live circuit end noted at junction box for what appears to be an attic fan that was removed. This uncapped circuit end needs to be disconnected and removed.

1. **Over Second Floor Attic Wiring/Lighting:** Uncapped live circuit end noted at junction box for what appears to be an attic fan that was removed. This uncapped circuit end needs to be disconnected and removed.

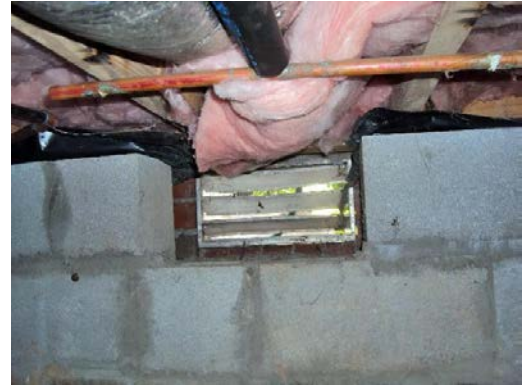
5. Acceptable **Ventilation:** Rear crawlspace vent need to be screened to hinder the possible intrusion of unwanted pests into the crawlspace.

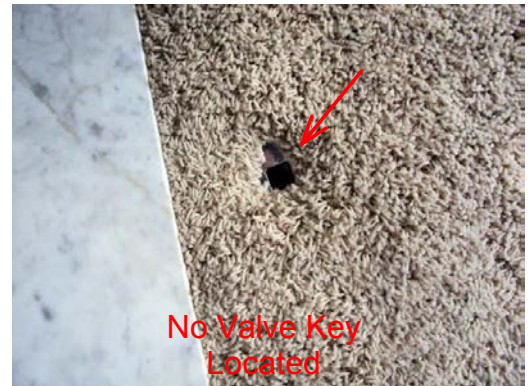
- 1. Acceptable **Fireplace Construction:** Prefab
- 2. **Type:** Gas log
- 3. Acceptable **Smoke Chamber:**
- 4. Acceptable **Flue:** Metal - Interior of the flue was not fully visible.
- 5. Acceptable **Damper:** Metal
- 6. Acceptable **Hearth:** No valve key was located. Inspector used personal valve key to text the unit.

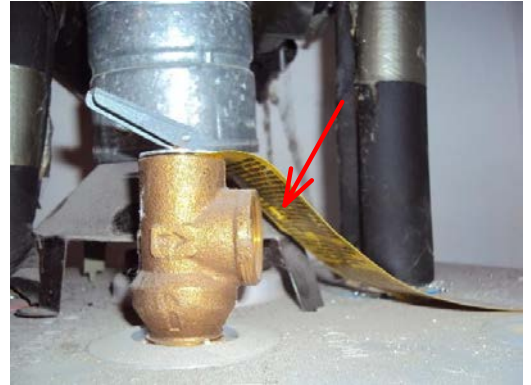
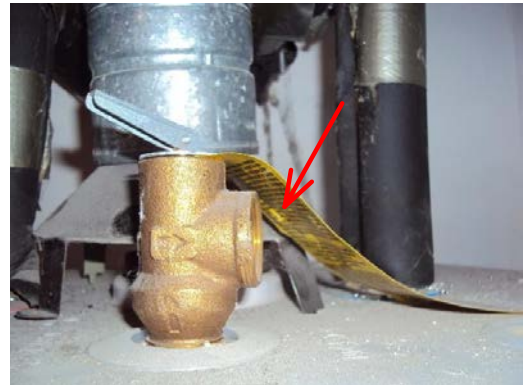
**TPRV and Drain Tube:** Copper - TPRV drain tube needs to be installed extending from the TPRV and discharging in a visible area no more than 6" from the floor.

2. **Garage Water Heater TPRV and Drain Tube:** Copper - TPRV drain tube needs to be installed extending from the TPRV and discharging in a visible area no more than 6" from the floor.

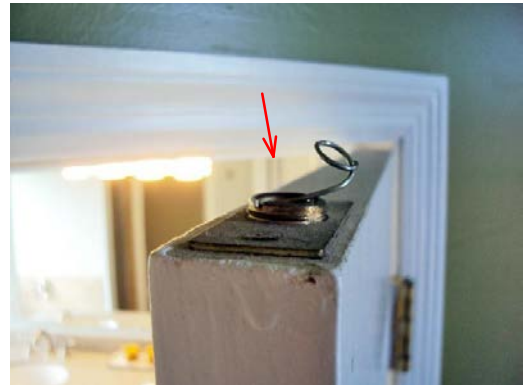
**Doors:** Damaged ball latch noted at top of right entry door. No door stops noted behind entry doors.

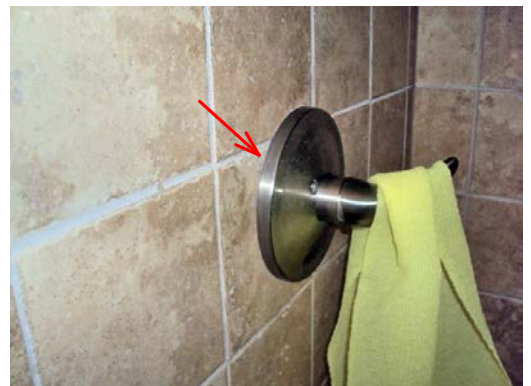
**Shower/Surround:** Sealant suggested around base of the tub/shower fixtures.

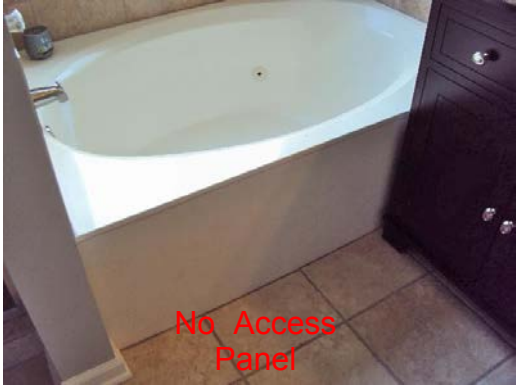
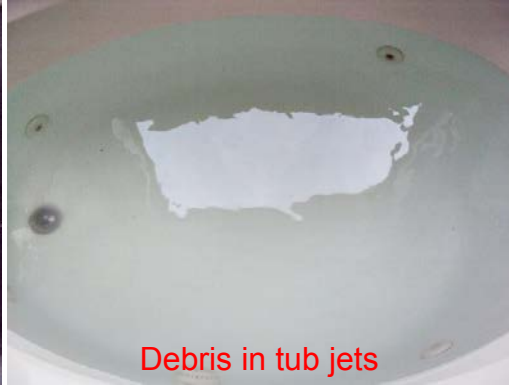
**Spa Tub/Surround:** No access panel noted for the area under the spa tub. Debris noted in the tub jets, when tub was filled and jets engaged. Suggest that the tub and jets be flushed and cleaned prior to use.

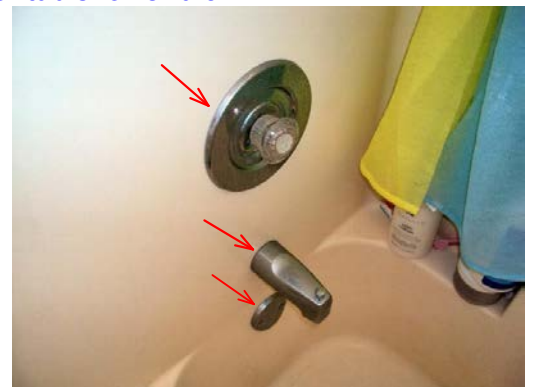
**Shower/Surround:** Sealant suggested around the base of the shower/tub fixtures.

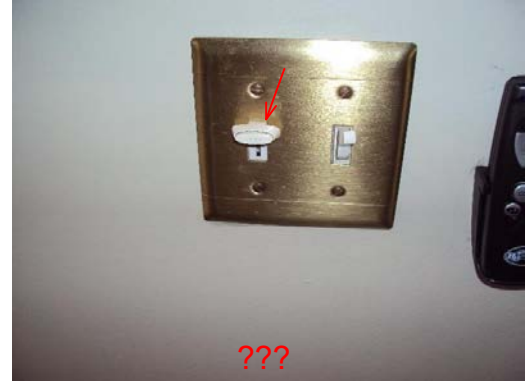
**Electrical:** Switch controlled outlets noted at the top 1/2 of the outlets to the right and left of the fireplace. Purpose for dimmer at entry from foyer was not determined/verified.

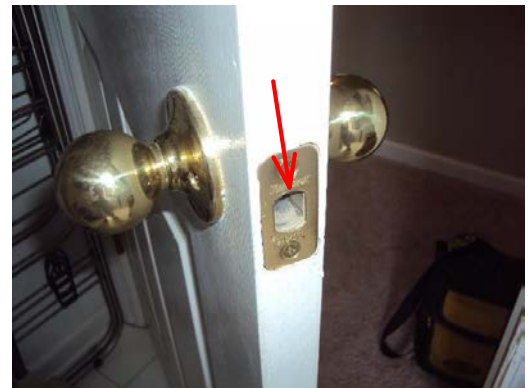
**Doors:** Door latch not complete.

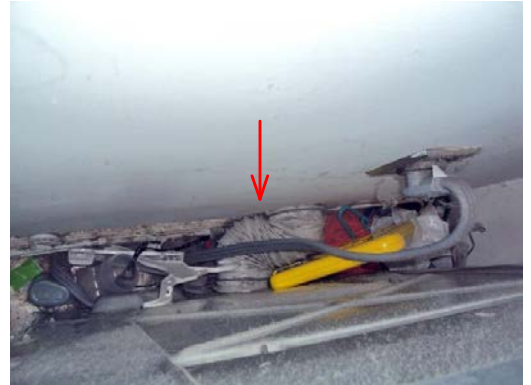
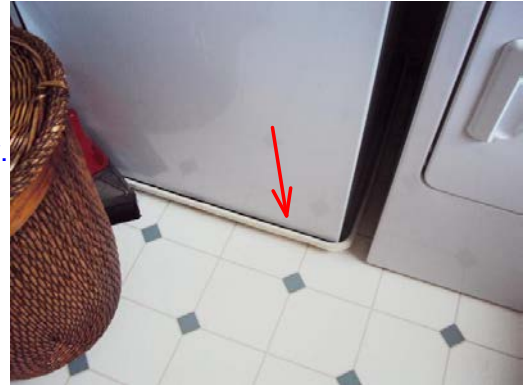
13. Acceptable **Dryer Vent:** Suggest that plastic vent hose for dryer be replaced with a metal one. These plastic vent hoses have been shown to be a fire hazard.
14. Acceptable **Washer Drain:**
15. Acceptable **Floor Drain:** Floor drain from overflow pan under washing machine was not visible. Suggest that drain be verified when the washing machine has been removed. The discharge for this drain appeared to be present at the front wall of the home under the powder bath window.
