## **1060 Gulf Blvd., Clearwater, FL. 33767**

### Inspection Report

Dive inspection was performed and completed on August 4, 2021.

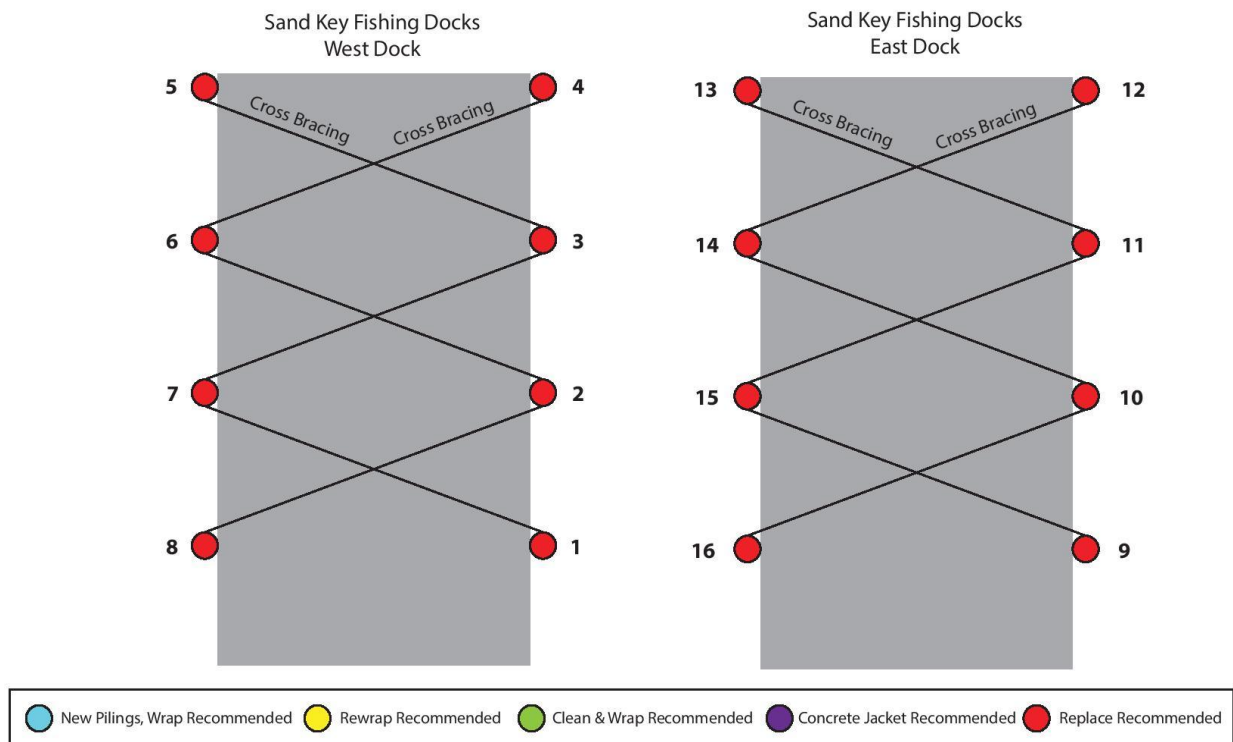
Upon completion of our dive inspection, we found that all of the pilings have evidence of worm infestation and damage to the piling. Videos correlate to the number on each piling in the following diagrams.

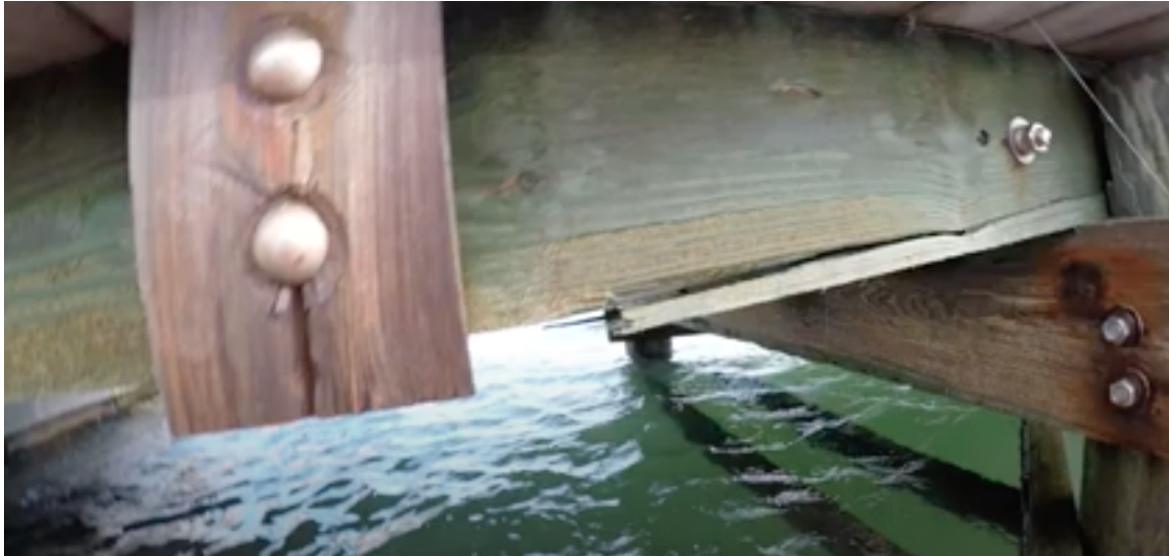
**Image 1.**

There are two pile caps on each parallel set of pilings. One is holding the stringers and floaters to support the dock. The other is helping support the cross braces. Most of the support framing boards and stanchions are cracked.

Some of the pilings are cracked through and missing mass at the top. Galvanized hardware that is bolted through the pilings are causing the hole to rot the piling and will prevent the pilings from being able to support new hardware in the future. Support framing boards are cracking/split and rotting due to rusting galvanized hardware and direct exposure to salt water.

The dock is in operable but not good condition. All framing, hardware, and pilings have damage and are rotting. Both docks are recommended for complete replacement.

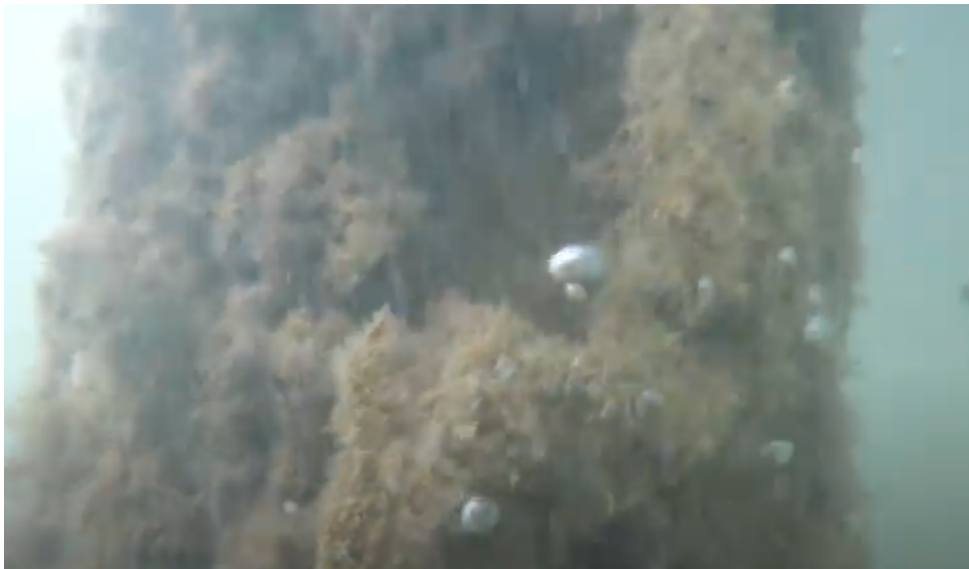
**Image 2.**

There is extensive worm damage on most of the pilings.

Once replaced, pilings should be properly wrapped with a multi-layer system that is sunk into the mudline to prevent worm infestation and future damage.

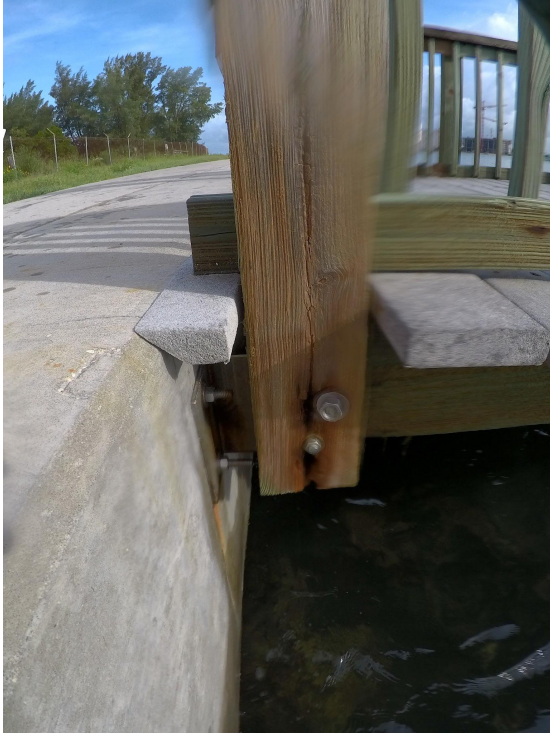
All hardware on the docks are stainless steel.
