STM32F446xC/xE device errata

This document applies to the part numbers of STM32F446xC/xE devices and the device variants as stated in this page. It gives a summary and a description of the device errata, with respect to the device datasheet and reference manual RM00390. Deviation of the real device behavior from the intended device behavior is considered to be a device limitation. Deviation of the description in the reference manual or the datasheet from the intended device behavior is considered to be a documentation erratum. The term “*errata*” applies both to limitations and documentation errata.

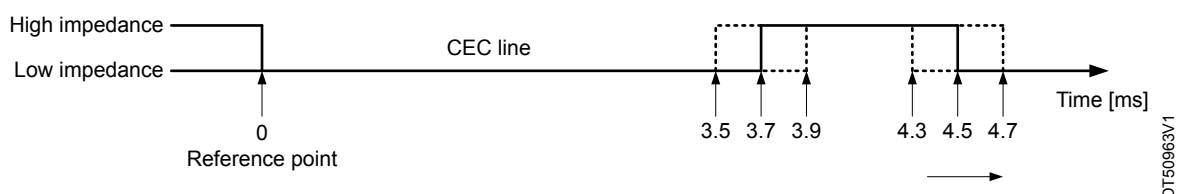
Figure 2. CEC start bit format with tolerances

The start bit timing standard tolerances are shown in Figure 2. The start bit is initiated by the device by driving the CEC line low (reference point). After 3.7 ms, the device releases the CEC line and starts checking its level. The following conditions must be met for the start bit to be valid:

If one of these conditions is not met, the transmission is aborted and never automatically retried. No error flag is set and the TXSOM (Tx Start Of Message) bit is not cleared.

The only way to detect this error is for the application software to start a timeout when setting the TXSOM bit, restart it upon ARBLST or any RX event (as the transmission can be delayed by interleaved reception), and stop it upon TXBR (proof that the start bit was transmitted successfully) or TXEND event, or upon any TX error (which clears TXSOM). If the timeout expires (because none of those events occurred), the application software must restart the CEC peripheral and retransmit the message.
