1756 ControlLogix Controllers, Revision 17

Catalog Numbers 1756-L61, 1756-L62, 1756-L63, 1756-L64, 1756-L65, 1756-L61S, 1756-L62S, 1756-L63S, 1756-LSP

Publication 1756-RN017B-EN-E - July 2009

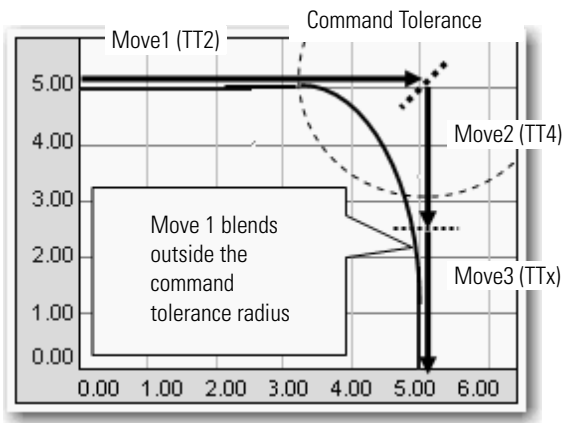
Cat. No.	Revision No.	Anomaly	Description
1756-L61, 1756-L62, 1756-L63, 1756-L64,	17.02	MCT not configured with a 1-to-1 Ratio can cause loss of position or axis jump	<p>You may experience a loss of position or an axis jump after coordinate transform is activated via a MCT instruction. The problem occurs if: any axes' motion are programmed and the Coordination Units Conversion Ratios of the Source and/or Target Coordinate Systems and the axes contained therein are not configured with a 1-to-1 conversion ratio and Coordinate Transforms are activated, that is, an MCT instruction has been programmed.</p> <p>The problem only occurred if the system had not been configured properly.</p> <p>Lgx00078679</p>
1756-L61S, 1756-L62S, 1756-L63S	17.06		
1756-L61, 1756-L62, 1756-L63, 1756-L64,	17.02	Combination of Termination Types may cause you to miss the target position	<p>You may have missed hitting the end point of a move with Termination Type 4 or 5 (TT4/5) when it was preceded by another move with Termination Type 2 or 3 (TT2/3). See figure below as one possible combination:</p>
