# 1768 CompactLogix Controllers, Revision 17

Catalog Numbers 1768-L43, 1768-L45

Publication 1768-RN017C-EN-E - July 2009

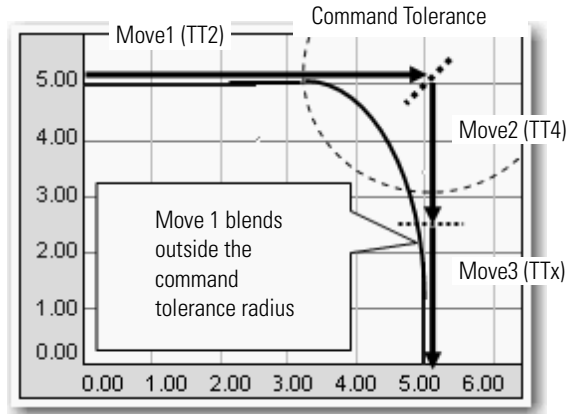
Revision No.	Anomaly	Description
17.02	An Incremental MCCM Move with Merge Enabled May Cause Error#46: Circular R1 R2 Mismatch Error.	<p>Your controller occasionally sees a Circular R1 R2 Mismatch error on a merge of a MCCM instruction with:</p> <ul style="list-style-type: none"> <li>Circle Type = Center and Move Type = Incremental</li> </ul> <p>or</p> <ul style="list-style-type: none"> <li>a Circle Type = Center Incremental and any Move Type</li> </ul> <p>Whether the occurred error was a function of the parameters of the circle and the merge point of the circle.</p> <p>Lgx00079059</p>
	Combination of Termination Types may cause you to miss the target position.	<p>You may have missed hitting the end point of a move with Termination Type 4 or 5 (TT4/5) when it was preceded by another move with Termination Type 2 or 3 (TT2/3). See figure below as one possible combination:</p>
