1768 CompactLogix Controllers, Revision 20

CompactLogix Catalog Numbers 1768-L43, 1768-L45

Compact GuardLogix Catalog Numbers 1768-L43S, 1768-L45S

Publication 1768-RN020B-EN-P - May 2012

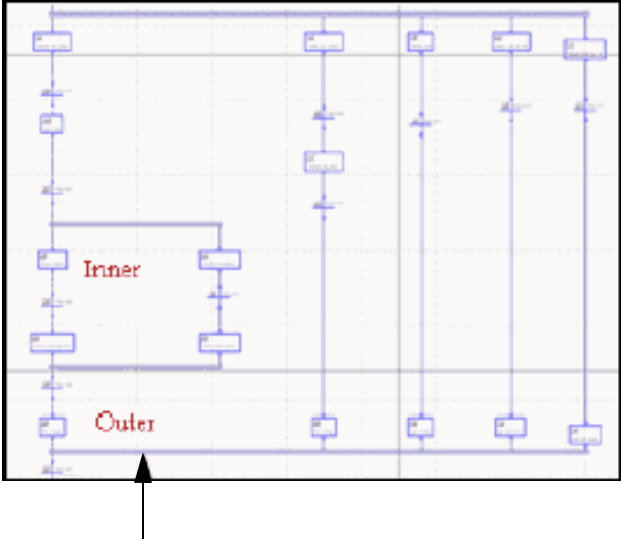
Cat. No.	Description
1768-L43, 1768-L45, 1768-L43S, 1768-L45S	<p>CORRECTED: An anomaly can occur when you nest simultaneous branches in a Sequential Function Chart (SFC) routine as shown below.</p>

<p style="text-align: center;">Bottom-most Steps</p> <p>During normal operations, the logic does not step out of a simultaneous branch until all of the incoming legs have reached their bottom-most step. In the example shown, the logic does not step out of the Outer simultaneous branch until the leftmost leg has stepped out of the Inner simultaneous branch. The first time through the SFC routine, the application works as expected. On subsequent scans, however, the chart steps out of the Outer simultaneous branch even though the left leg has not reached the Inner simultaneous branch yet.</p> <p>This behavior occurs because the information in the bottom step, that is, the step next to the word Outer, remains from the previous scan. This stale information incorrectly causes the transition to move on as if the left leg is at the bottom step when it actually is not.</p> <p>To work around this anomaly, confirm all of the incoming legs have reached their bottom steps in the transition. You can check the .x bits to make sure the bottom-most step of each converging leg is active before allowing the chart to advance. This check can be added to the transition logic already present.</p> <p>For example, the steps in the following expression are the bottom steps (see graphic above) of the incoming legs. Each step has a timer. The transition does not move on until all of the step timers have reached their preset value.</p> <p>The expression can be modified to be sure those steps are truly active. This is the original expression:</p> <pre>// Unit is ready to Transition Step1_ready.dn and Step2_ready.dn and Step3_ready.dn and Step4_ready.dn and Step5_ready.dn</pre> <p>This is the modified expression to work around this anomaly.</p> <pre>// Unit is ready to Transition Step1_ready.x and Step2_ready.x and Step3_ready.x and Step4_ready.x and Step5_ready.x and Step1_ready.dn and Step2_ready.dn and Step3_ready.dn and Step4_ready.dn and Step5_ready.dn</pre> <p>IMPORTANT: The x bit is cleared when the chart transitions out of a step.</p> <p>Adding this check to the condition forces the engine to wait until all of those steps are genuinely active before advancing out of the simultaneous branch.</p> <p style="text-align: right;">Lgx00118188, Lgx00116506</p> <p>CORRECTED: Applications that have a large quantity of HMI tags on scan in the controller can experience a non-recoverable major fault when doing online edits.</p> <p style="text-align: right;">Lgx00118192, Lgx00115817</p>

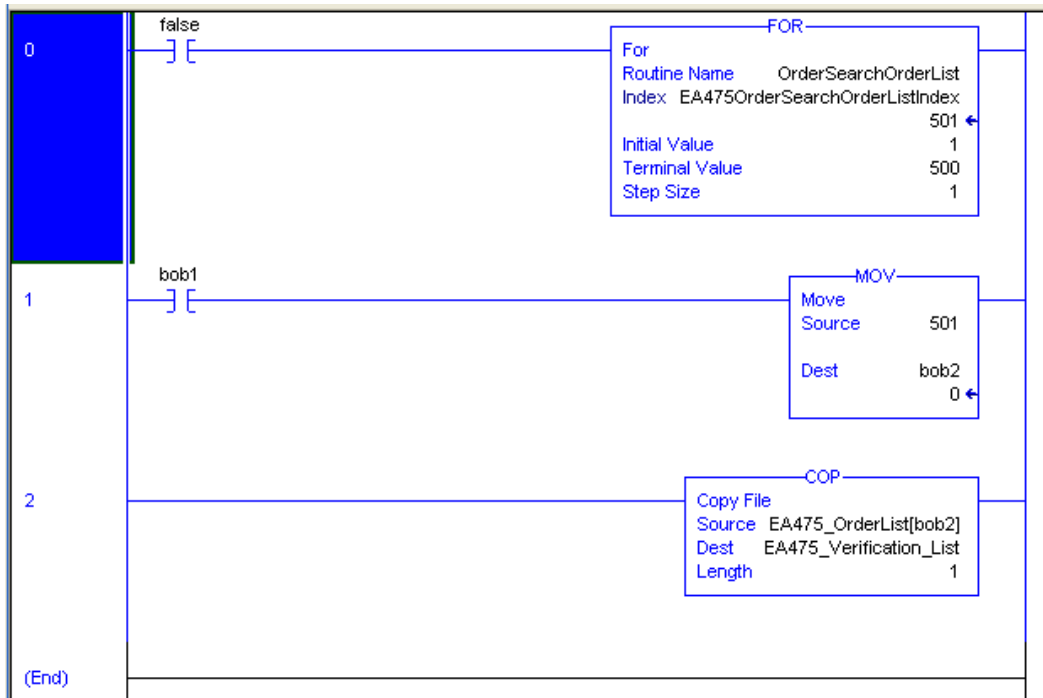
Cat. No.	Description																														
1768-L43, 1768-L45, 1768-L43S, 1768-L45S	<p>CORRECTED: If a FOR instruction is scanned true and an instruction has an index out of range that references a UDT or multi-dimensional array, the controller will fault. Clearing the fault and returning to run mode will cause a nonrecoverable major fault.</p> <div>
