Incident ID: [TS-00339998](#)

J47451. Shipping sorter (CB4000) Broken collector brush

Product: [Intellisort CB 4000](#)

Category: [Conductor Rail](#)

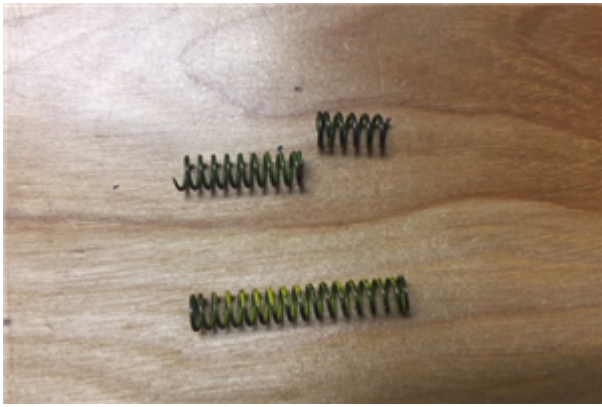
Figure 2

Broken spring from Brush assembly. Good and broken spring.

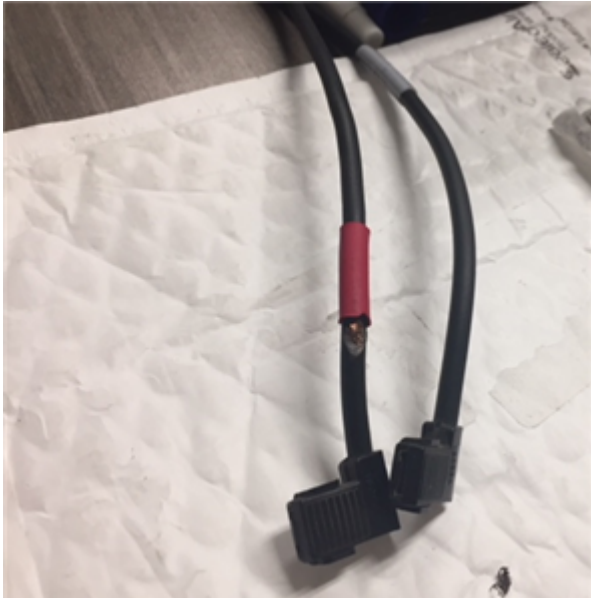
Figure 3

Damage brush harness cable removed from sorter incident.

It was found the at least some of the brushes installed today were done so in the incorrect height, causing them to break. Site is inspecting all 8 replaced brushes now.

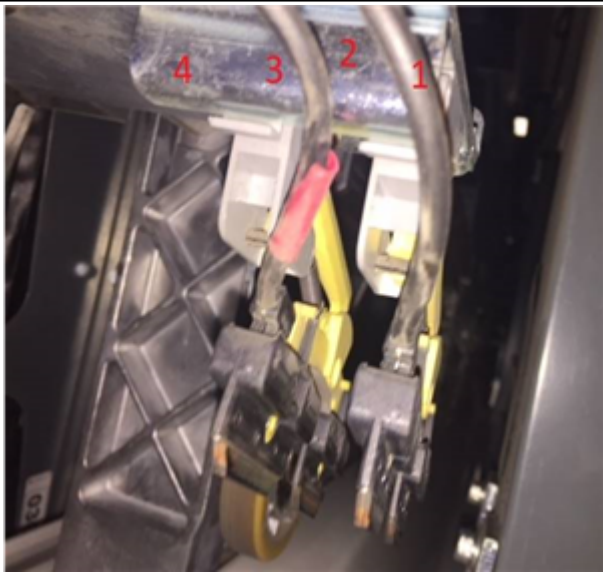
Figure 4

Slot #1 and #3 are the correct location for brush installation. Slot #1 is 0V and slot #3 is 75V

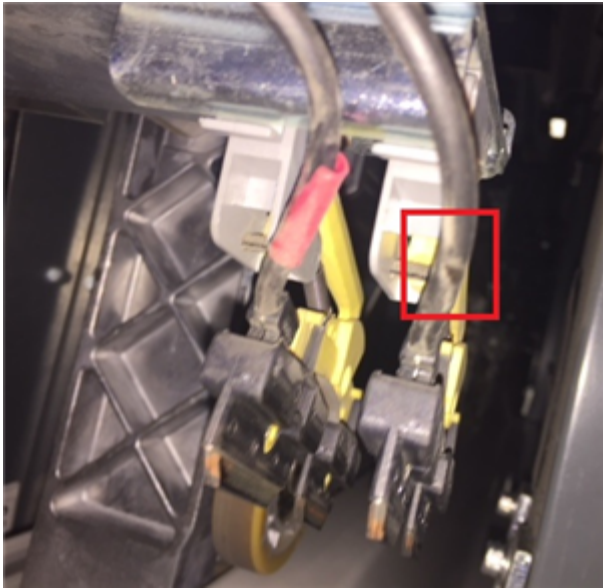
Figure 5

Brush Harness for carrier #304 shows sign of rubbing. Adjust harness cable

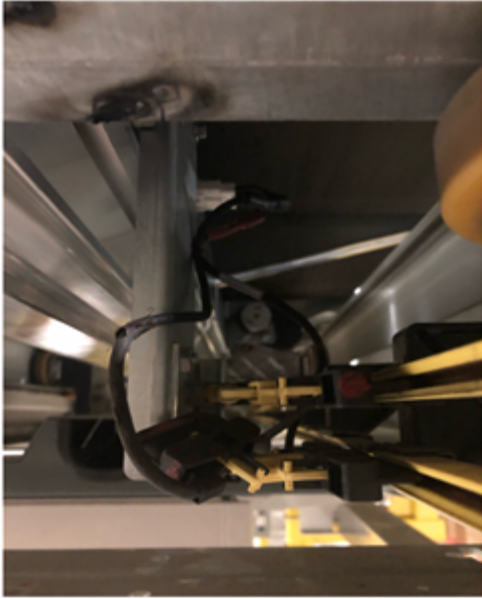
Figure 11

Taking a closer look at 568 looks like cable management issue of wire harness on the bracket

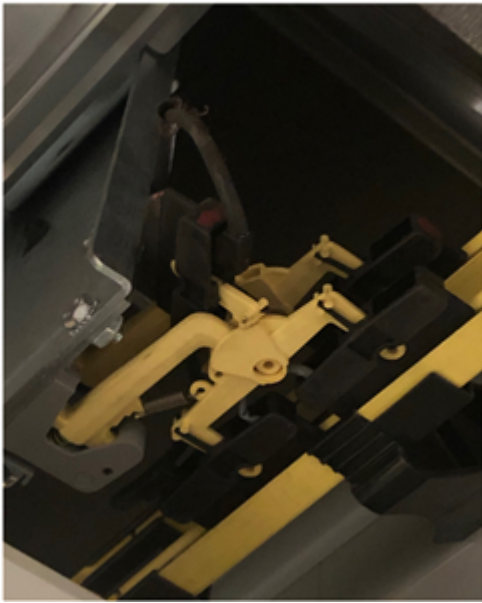
Figure 12

brush sent by Jamie

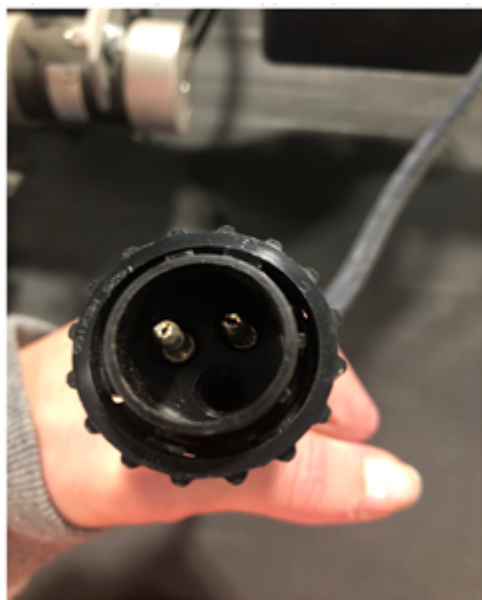
Figure 13

Pin #2 pushed in on carrier 582

Site is continue to run resistance check/ continuity between 500-700 and 450-750. they will also replace the carrier 582 and then test the sorter.

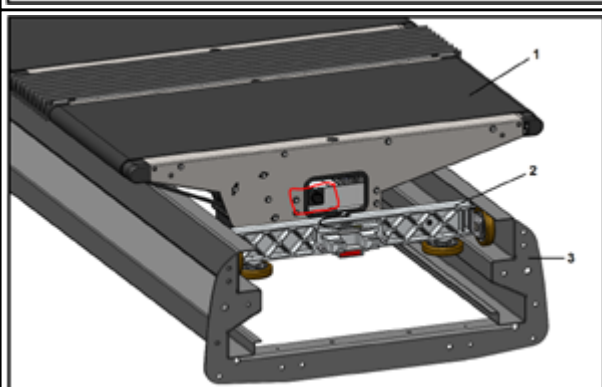
Figure 16

A bad connection was found and corrected. The reported carrier was 656 but this was not 100% positive to the correct cart number. The section that was reading 498 ohms, is now reading 0.8 ohms.

Site found a bad carrier connection (Carrier 656). The high resistance measurement (498 Ohms) taken between carriers 628-700 might have been a result of the bad connection.

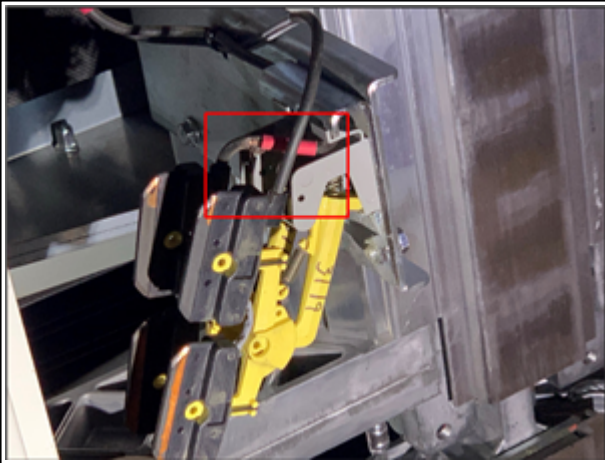
Figure 26

While troubleshooting site found broken wires in carrier 304. They're in the process of fixing the wiring issue.

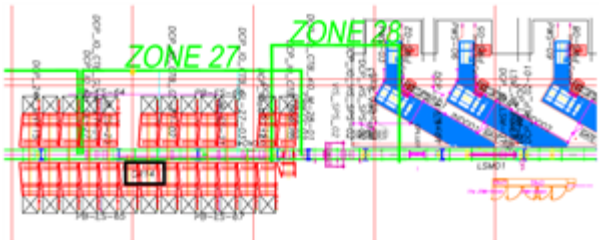
Figure 33

location of CR14 where Jiffy was found:
(see Figure 33)

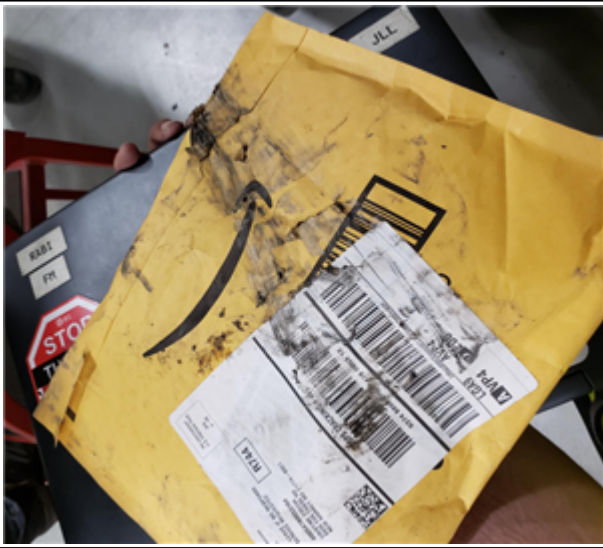
Figure 34

Jiffy bag was found by conductor rail 14:
(see Figure 34)

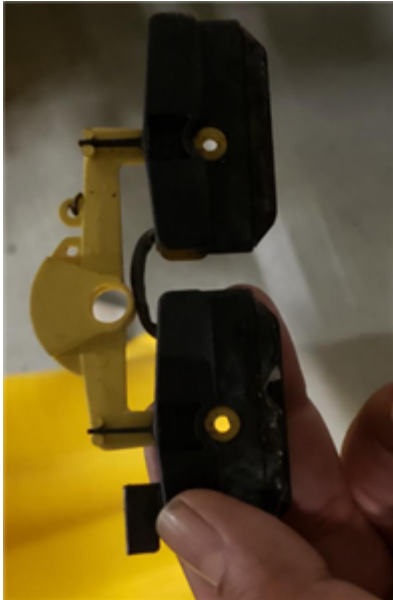
Figure 35

Missing fin found:
(see Figure 35)

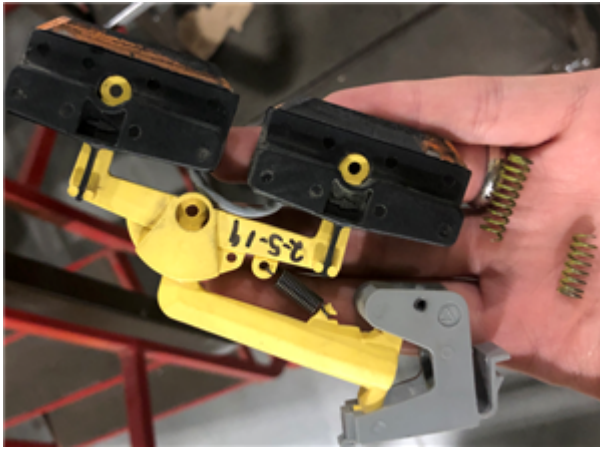
Figure 39

carrier 556 lower brush spring failure:
(see Figure 39)

site believes to have found a bad brush at carrier 556

site is going to replace this brush (which was replaced in February)
