1769 CompactLogix Packaged Controllers, Revision 18

Controller Catalog Numbers 1769-L23E-QB1B, 1769-L23E-QBFC1B, 1769-L23-QBFC1B

Publication 1769-RN013B-EN-P - November 2010

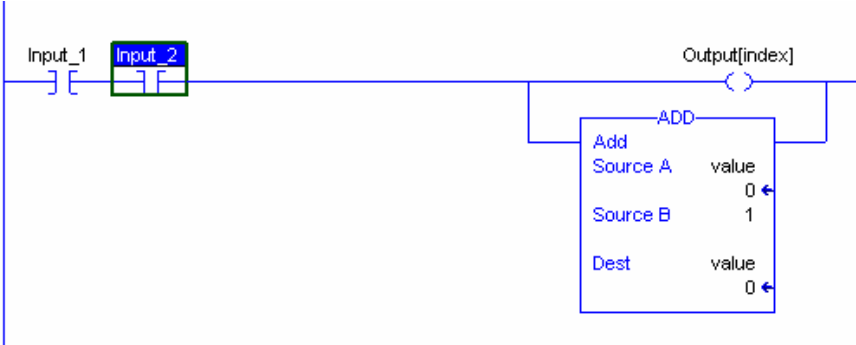
Cat No.	Description
1769-L23-QBFC1, 1769-L23E-QB1B, 1769-L23E-QBFC1B	<p>CORRECTED: Fault handlers can be defined at the controller and program scope levels. These fault handlers are typically used to handle major recoverable faults that can occur during runtime execution of an application due to programming errors. A typical example of this would be handling indirect addressing that has gone out of range; <code>MyTag[index]</code>, where <code>index</code> is larger than the size of the array.</p> <p>Faults can also be handled by the controller during pre-scan of the controller program on the transition to Run mode. Again, for example, the handling of indirect addressing that has gone out of range.</p> <p>There is an anomaly when these methods attempt to handle a fault.</p> <p>These are the possible ways the anomaly can manifest itself:</p> <ul style="list-style-type: none">• The controller will experience a Major Nonrecoverable Fault (MNRF). I/O goes to their configured safe state, and the user application is cleared from memory. At this point, a Code 1 Type 60 or 61 Major Recoverable Fault will be logged in the controller. This requires you to re-download the application.• Tag data corruption.• Online saving or uploading failures.• Anomalous program execution. <p>For example, if a rung is being scanned false and there is an instruction that has false execution, the fault handler executes so the remainder of the rung will scan true. In the example below, the OTE instruction has an index out of range. After returning from the fault handler, the ADD instruction will execute, even though the rung input conditions are false.</p>

<p>Lgx00105703, Lgx00100144, Lgx00101800, Lgx00102339, and Lgx00104782</p>
