# 1769 CompactLogix Packaged Controllers

Catalog Numbers 1769-L23E-QB1B, 1769-L23-QBFC1B, 1769-L23-QBFC1B

Publication 1769-RN022B-EN-P - May 2012

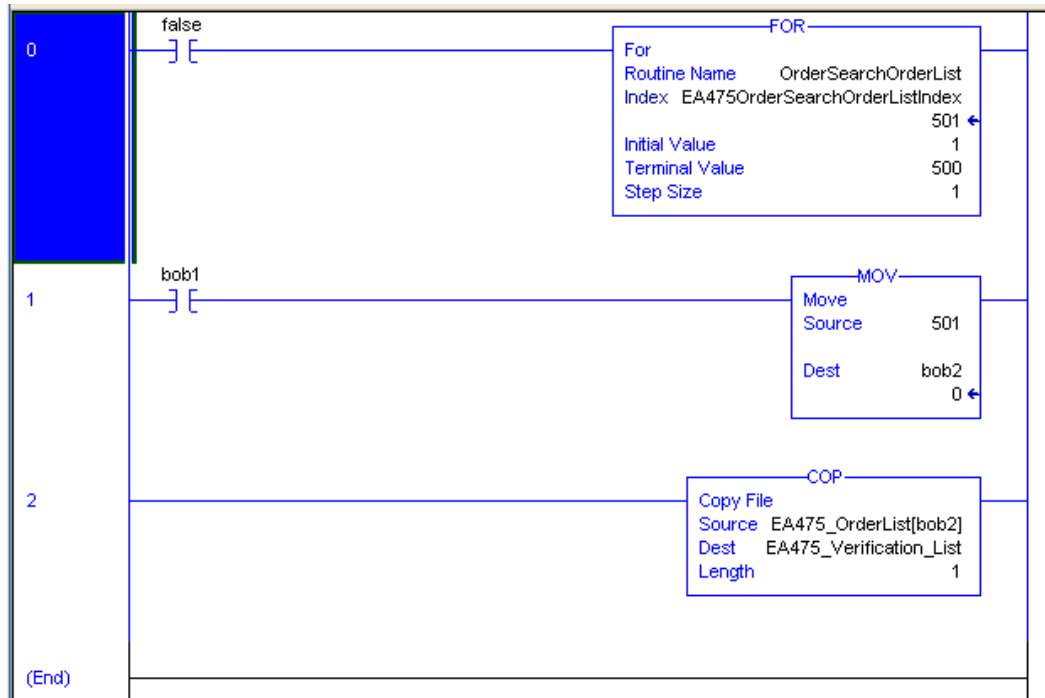
Cat. No.	Description																								
1769-L23E-QB1B 1769-L23-QB1BFC 1769-L23E-QB1BFC	<p><b>CORRECTED:</b> If a FOR instruction is scanned true and an instruction has an index out of range that references a UDT or multi-dimensional array, the controller will fault. Clearing the fault and returning to run mode will cause a nonrecoverable major fault.</p>

<p style="text-align: right;">Lgx00118589, Lgx00113423</p>																								
	<p><b>CORRECTED:</b> When producing a UDT that ends with a single BOOL data type and is consumed as a unicast connection, the values in the produced tag are not seen by the consumer and a 203 connection timeout error is shown.</p> <p style="text-align: right;">Lgx00118911, Lgx00116634</p>																								
	<p><b>CORRECTED:</b> Even though the message path is incorrect, messages to the CompactBus will complete. For example, a path of 1,3,10,3 would go to the Compact I/O™ module in slot 3 when it should error. The path should have been 1,3,1,3.</p> <p style="text-align: right;">Lgx00122439, Lgx00120959</p>																								
	<p><b>CORRECTED:</b> When performing indirect addressing of Boolean arrays that are inside UDTs, only Boolean arrays are affected. This figure is an example of a UDT that contains a Boolean array.</p>

<p>If application code utilizes indirect addressing to manipulate bits in Boolean_Array, it is extremely important to keep indexes within valid limits. If application code uses an index greater than 63 for Boolean_Array, a major recoverable fault of Type 04/Code20 should occur. However, in this scenario, the controller will not fault. Instead, the data will be written to the next tag below Boolean_Array. For example, if the index is 64, it will actually manipulate the member Test_Bit. If the value of index is greater than 64, it will then begin affecting the member Dint_Value. The major recoverable fault Type 04/Code 20 will be logged if the value in the indirect address causes the code to write outside the UDT.</p> <p style="text-align: right;">Lgx00122441, Lgx00120456</p>	Members:		Data Type Size: 16 byte(s)			Name	Data Type	Style		Boolean_Array	BOOL[64]	Decimal		Test_Bit	BOOL	Decimal		Dint_Value	DINT	Decimal	10P 010			
Members:		Data Type Size: 16 byte(s)																							
	Name	Data Type	Style																						
	Boolean_Array	BOOL[64]	Decimal																						
	Test_Bit	BOOL	Decimal																						
	Dint_Value	DINT	Decimal																						
10P 010
