# The Therac 25

## A case study in safety failure

Nancy Leveson and Clark Turner, “The Investigation of the Therac-25 Accidents”, Computer, 26, 7 (July 1993) pp 18-41.

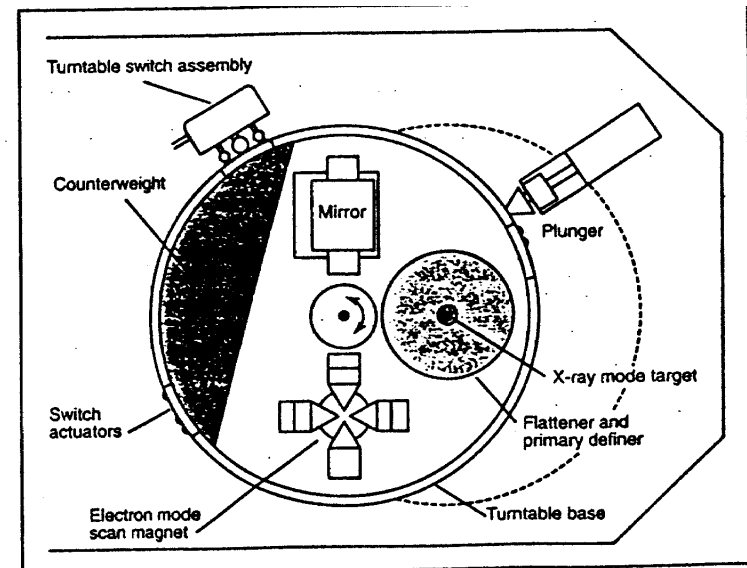
Figure B. Upper turntable assembly.

- Electron mode
  - 5-25 MEV
  - Magnets spread beam
  - Ion chamber monitor
- X-ray mode
  - 25 MEV electrons hit target
  - “Beam flattener” attenuates
  - 100x beam current
  - Ion chamber monitor
- Field-light mode
  - No current
  - Mirror & light used to check alignment
  - No ion chamber (since not treating)

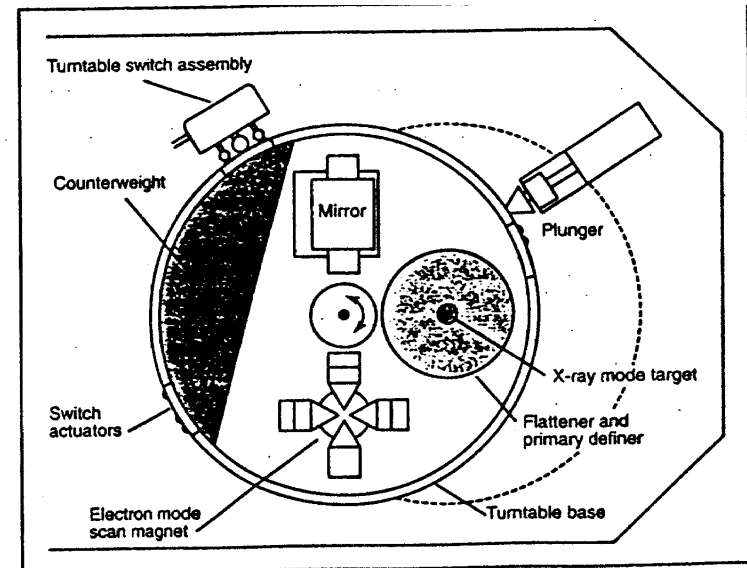
Figure B. Upper turntable assembly.

- Computer adjusts turntable position
- Microswitches detect turntable setting
- 3-bit binary code used to encode turntable setting
- Software checks replace hardware interlocks

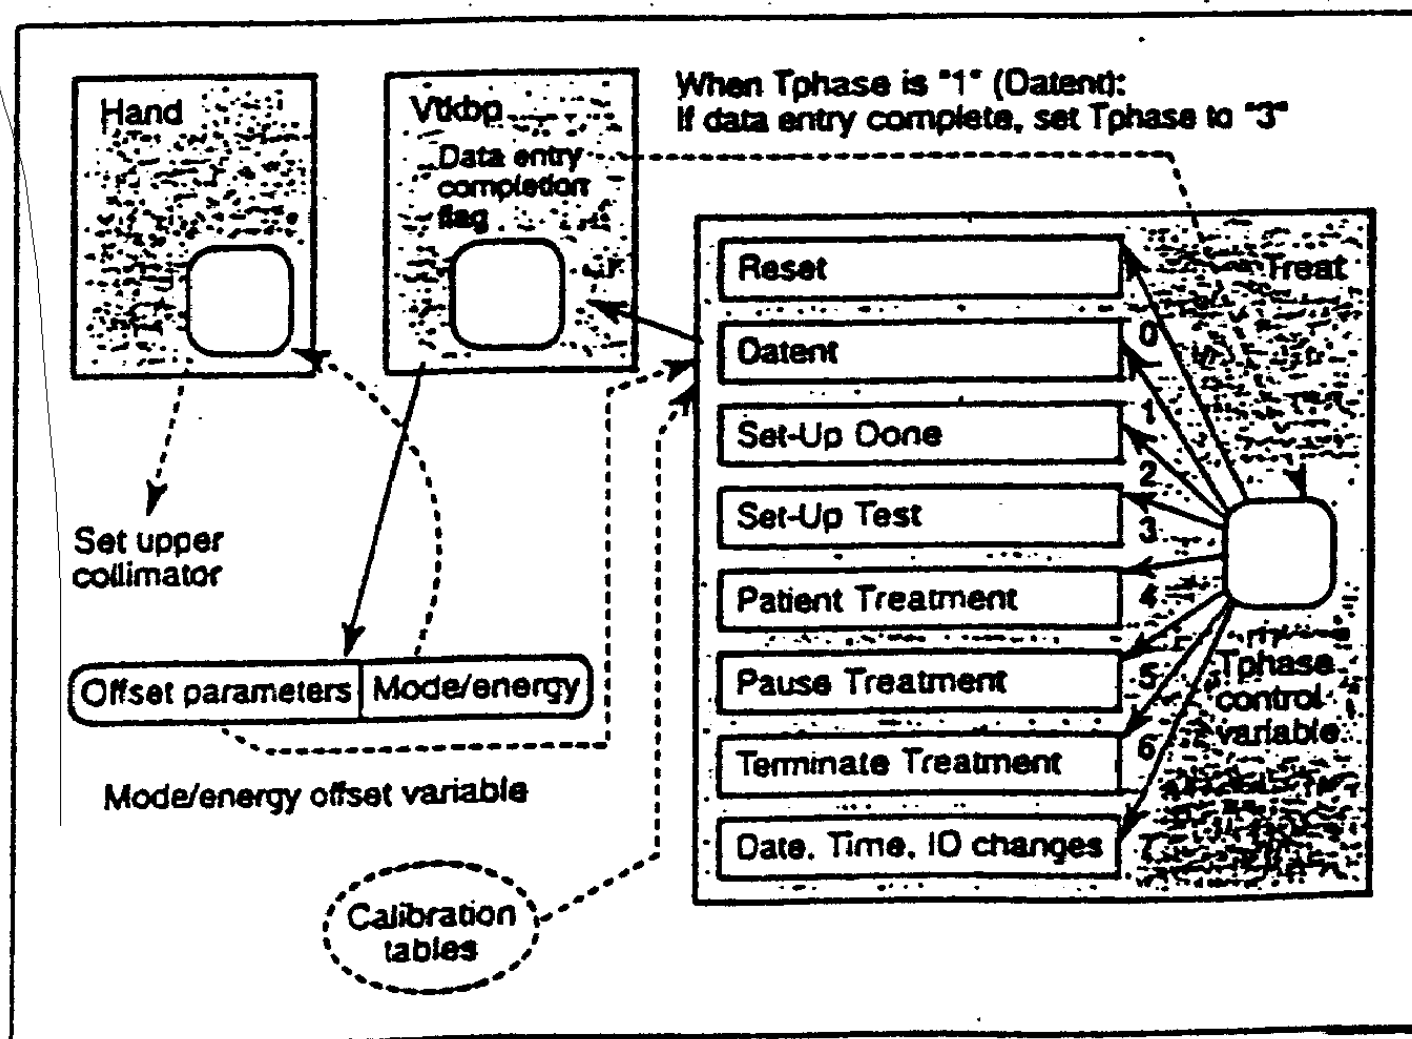
Figure 2. Tasks and subroutines in the code blamed for the Tyler accidents.

- History of 500 patients treated successfully
- Prescribed: 22MeV electrons, 180 rads
- Operator selected x-rays by mistake, used cursor keys to change to electrons
- Machine tripped with “Malfunction 54”
  - Documentation explains this is “dose input 2” error
- Operator proceeded; machine tripped again

- Prescription 10 MeV, area 7 x 10 cm
- Operator used cursor keys to change x-rays to electrons, saw “beam ready”, and turned machine on
- Loud noise, shutdown, malfunction 54
- Patient in great pain
- Patient died three weeks later

- Machine taken out of service
- ETCC eventually reproduced malfunction 54
  - Data entry speed critical factor
  - Observed 4000 rad dose
- AECL later measured 25,000 rads
- In lawsuit, earlier “cursor up” problems reported, which AECL believed to have been fixed

- Numerous hardware and software changes
- All interruptions related to dosimetry not continuable
- independent hardware & software shutdowns
- potentiometer on turntable
- hardware interlocks
- “dead man switch” motion enable
- Fix documentation, messages, & user manuals
- etc

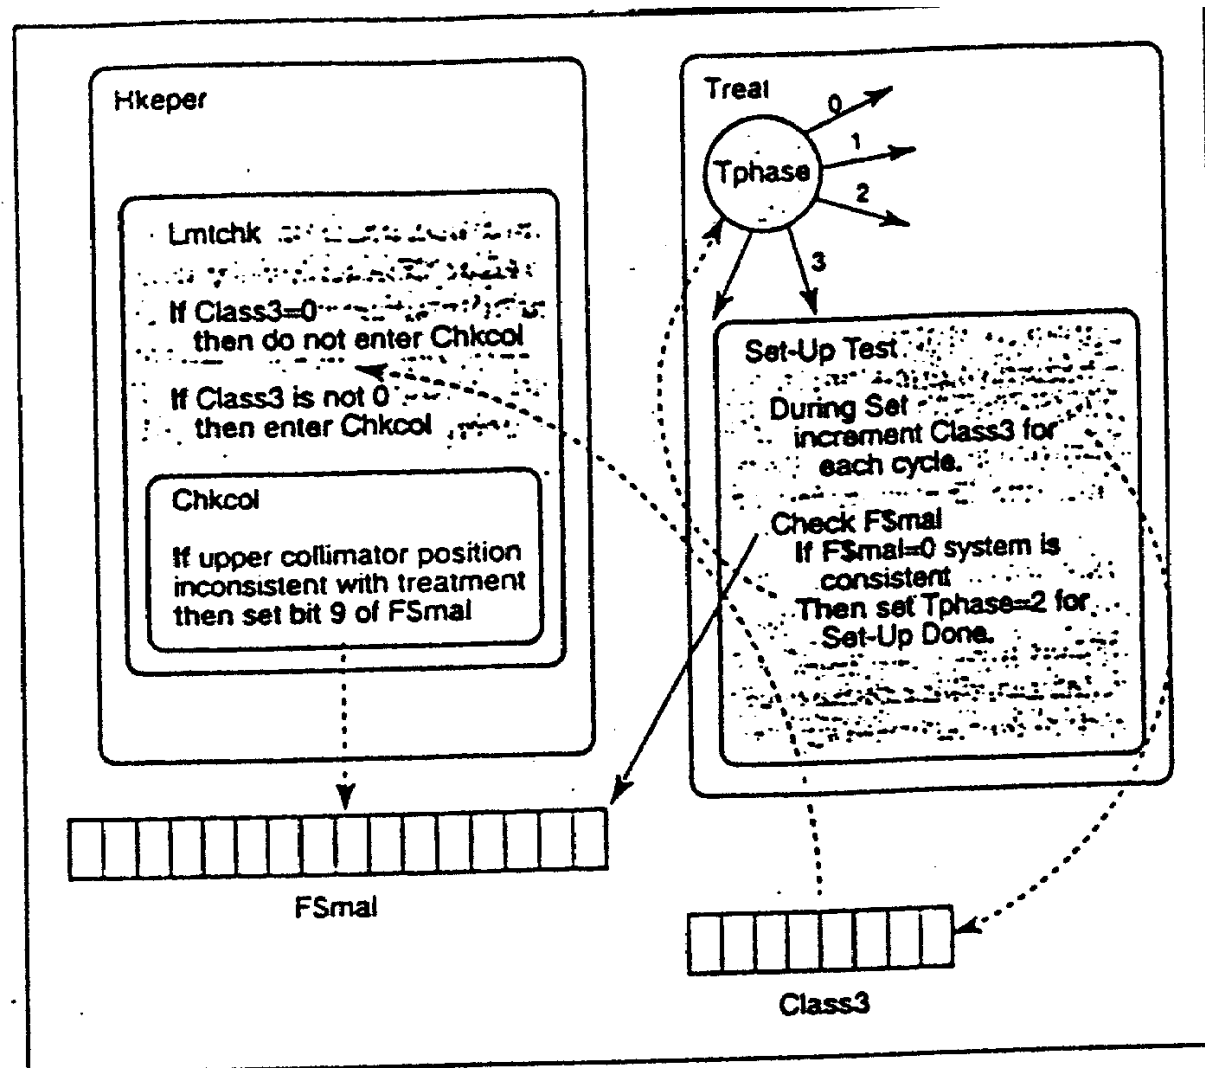
Figure 4. Yakima software flaw.

- Plan: 2 film verification exposures (3 & 4 rads) + 79 rad photon treatment
- Performed two film exposures
- Operator used hand controls to rotate table to field-light position & check alignment
- Operator set machine but forgot to remove film
- Operator turned beam on, machine showed no dose & displayed fleeting message
- Operator proceeded from pause

- After another machine pause, operator reentered room.
- Patient complained of burning sensation
- Patient developed severe striped burns
- Patient died in April
- Hospital obtained similar pattern on film by running machine with turntable in field light position
