SERVICE BULLETIN

SERVICE BULLETIN		No.: MSB-99E55-503		
		Date: 1999-12-15	<Model> (EC,EXP) L200 (K00)	<M/Y> 97-10
Subject: OMISSION OF DISASSEMBLY / REASSEMBLY OF A/C COMPRESSOR ASSEMBLY				
Group: HEATER, A/C & VENTILATION		Draft No.: 99SY060115		
CORRECTION	INTERNATIONAL CAR ADMINISTRATION OFFICE	T.NITTA - PROJECT LEADER AFTER SALES SERVICE & CS PROMOTION		
1. Description: Omission has been rectified of a description of the disassembly / reassembly of the A/C compressor assembly under Compressor and Tension Pulley.				
2. Applicable Manuals:				
Manual		Pub. No.	Language	Page(s)
'97 L200 Workshop Manual Chassis		PWTE96E1	(English)	55-5, 32
		PWTS96E1	(Spanish)	
		PWTF96E1	(French)	
		PWTG96E1	(German)	
3. Details: '97 L200 Workshop Manual Chassis, page 2,3,4,5

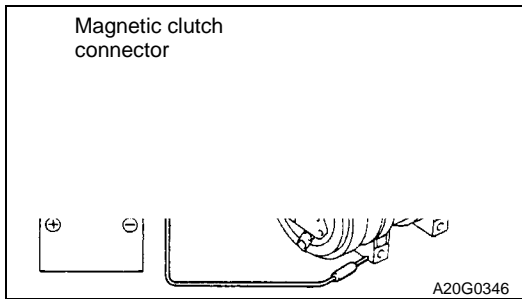
55200850105

COMPRESSOR MAGNETIC CLUTCH OPERATION CHECK

Connect the battery (+) terminal to the compressor side terminal, and earth the battery (-) terminal to the body of the compressor. The condition is normal if the sound of the magnetic clutch (click) can be heard.

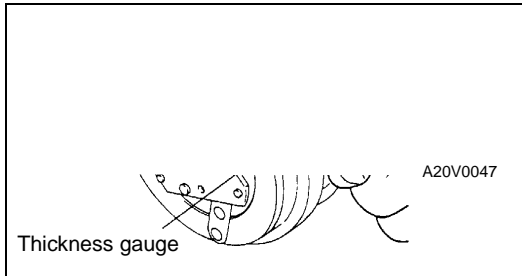
55201110011

COMPRESSOR MAGNETIC CLUTCH AIR GAP CHECK

Check whether or not the air gap of the clutch is within the standard value.

Standard value: 0.3 – 0.6 mm

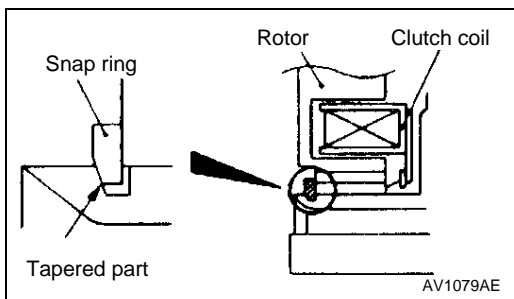
▶ A ▶ SNAP RING INSTALLATION

Install the snap ring so that the tapered surface is at the outer side.

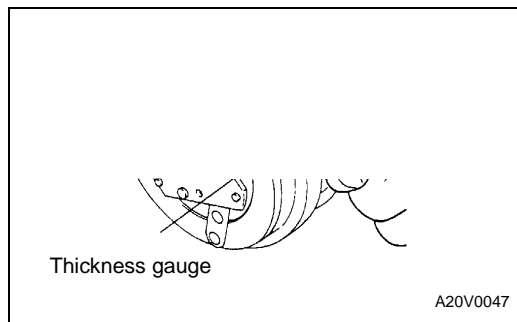
►B◄ AIR GAP ADJUSTMENT

Check whether or not the air gap of the clutch is within the standard value.

Standard value: 0.3 – 0.6 mm

If there is a deviation of the air gap from the standard value, make the necessary adjustment by adjusting the number of shims.
