## THE 2019 E-DEFENSE SHAKE-TABLE TEST OF A LARGE-SCALE 3-STORY DISASTER MANAGEMENT CENTER

**Abstract:** In December 2019, shake-table tests of a 3-story disaster management center were performed at E-Defense in Japan as part of the Tokyo Metropolitan Resilience Project. This large-scale test was a collaboration between universities and research institutes in Japan and the US NHERI Natural Hazards Reconnaissance (RAPID) facility. Research objectives include validating resilient structural and non-structural element detailing and verifying the accuracy of a newly proposed structural health monitoring technique.

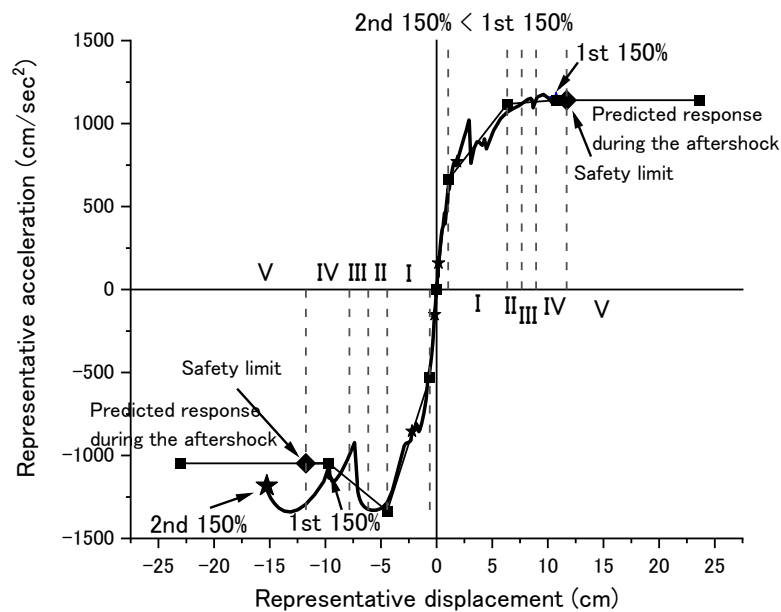
Figure 3. Response prediction point at the first 150% input and response at the second 150% input.

Figure 3 shows the performance curve measured at the second 150% input, the tri-linear model estimated at the first 150% input, the predicted maximum response point for the maximum aftershock, the maximum response point at the first 150% input, and the evaluated damage classes according to the method proposed by Pan and Kusunoki (2020). In the first 150% input, both the positive and negative sides were determined to be severely damaged (IV), and from the response point to the predicted maximum displacement during the aftershock, it was estimated that the building would collapse (V) due to the aftershock. In fact, on the second 150% input, the maximum response displacement on the negative side exceeded the limit point that the building could withstand (called the safe limit point) and reached the level of collapse, indicating that the judgment was on the safe side.

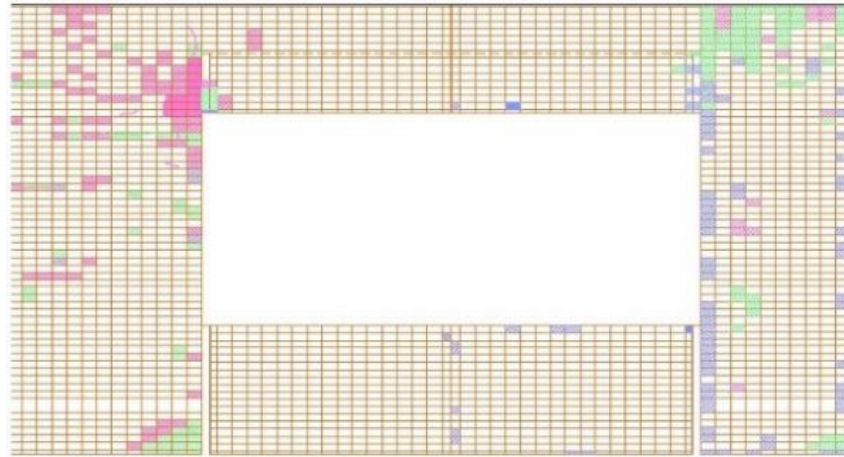
Figure 4. Tile deterioration status after final vibration of each day. Blue: Dec. 3, Green: Dec. 4, Red: Dec. 6,

As a result of the shaking table test, it was found that the deterioration of the tiles was concentrated around the bottoms of the column and structural gaps where structural cracks tend to occur, and that in addition to spalling, cracks that penetrated the tiles occurred in the areas with mortar adhesive. It was found that there were no spalling or cracks in the elastic adhesive-covered area, but a large number of peelings occurred. An example of tile deterioration is shown in Figure 4.

The hatch, fill, and solid line indicate the location of peeling, spalling, and crack, respectively.

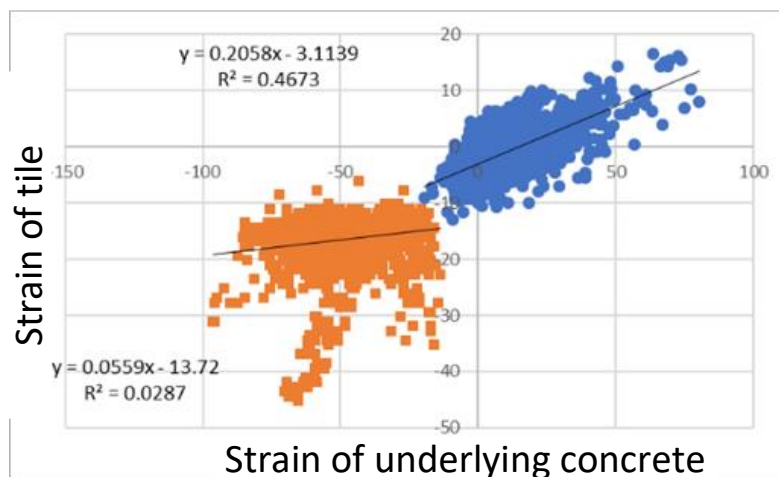
Figure 5. Strains of tile and underlying concrete.

In addition, an optical fiber sensor near the peeled tile observed a significant strain difference between the tile and the underlying concrete and a phenomenon in which the followability of the tile decreased before and after peeling was confirmed, as shown in Figure 5. It was confirmed that it is possible to instantly determine the risk of peeling of exterior tiles by using optical fiber sensors.

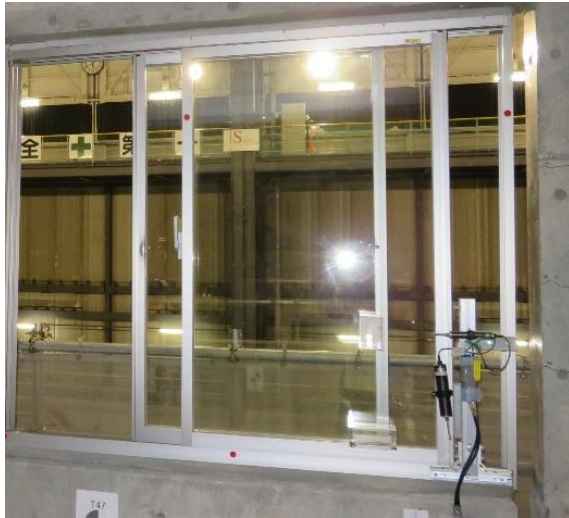
(a) Sliding window on the 3<sup>rd</sup> floor (160%)

After 100% input, slight cracks were confirmed in the mortar filled between the window and the frame, and the crescent of the sliding window was beginning to open. After 150% input, cracks in the mortar progressed, and the sashes of both the sliding and double-sided windows were slightly damaged. However, the way the sash breaks differs on each floor, with the sash on the second floor having damage, such as the central corner breaking, and the sash on the third floor having a gap at the joint between the horizontal and vertical members of the window. The seal on the window was broken. After 160% input, cracks in the mortar progressed and some of the anchors supporting the sash were exposed. Additionally, the sash joints were severely damaged, and the seals were broken in various places. During the second 150% input, the crescent of the sliding window on the second floor was damaged, and when the input was 160%, the crescent of the third-floor sliding window was damaged and fell off (Figure 7 (a)). Furthermore, after the crescent came off, the sliding window was moving freely during the shaking. Additionally, the upper left side of the window on the 2nd floor was broken when facing the indoor side, and the upper left side of the window on the 3rd floor was broken in the same way as the 2nd floor, and cracks also appeared on the diagonal (Figure 7 (b)).

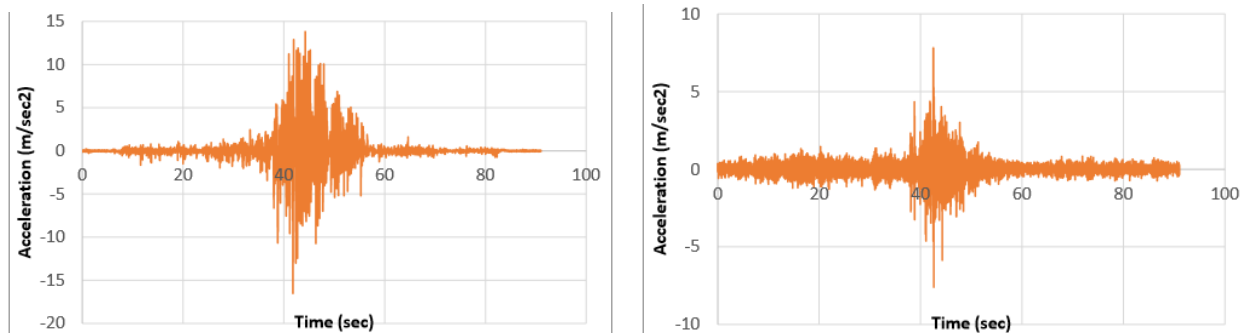
(a) 2<sup>nd</sup> floor(b) 3<sup>rd</sup> floor*Figure 10. Accelerations measured at the center of the ceiling (100%).*

Figure 10 shows the measurement results of the accelerometer attached to the center of the ceiling at 100% input. Although the floor acceleration is higher on the third floor, the ceiling acceleration is lower on the earthquake-resistant ceiling on the third floor. At 150% input, the peak acceleration of the ceiling on the second floor reached over  $60\text{m/sec}^2$ , so it is thought that the end collided with the beam.

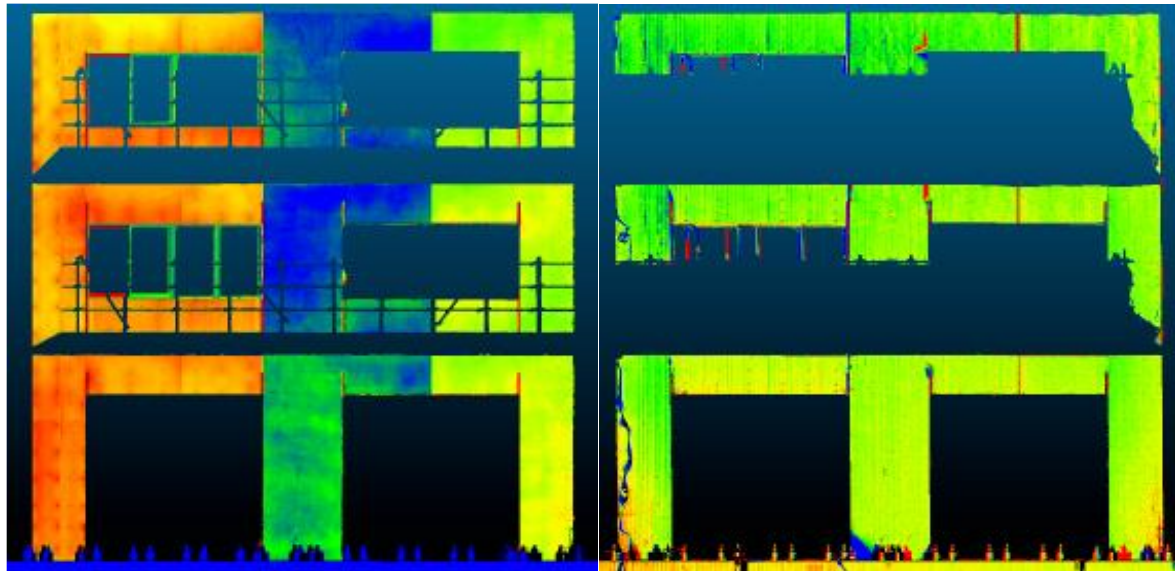
(a) After the shaking

After pre-processing the point cloud data according to the items mentioned above, it was investigated whether damage evaluation could be performed by taking the difference between the point group data before and after the shaking. Figure 15 (a) shows the state of the south frame of the test specimen that was damaged after shaking. The exterior walls of the specimen were finished with tiles, and it can be seen that the finish was uneven even before the shaking. For example, the left half of the center column and right beam are shown in blue, indicating that the depth direction's thickness differs due to different construction methods. If the damage to evaluate is a deformation within this construction accuracy, this data is unable to be used for assessing the damage. On the other hand, Figure 15 (b) shows the results obtained by subtracting the data before and after the shaking of the specimen. This figure shows that the colors are almost the same (green) except for the floating tile on the base of the central column on the 1st floor (blue) and the peeling-off tile at the structural gap on the right beam on the 2nd and 3rd floors (red). As such, it is possible to see where the damage occurred. There is a red vertical line in the center of the right beam, which is the location of the red lines at the stepped part between regions where the different adhesives are used to fix the tiles. It can be seen that the width of the red line is getting wider on the upper floors because of the larger residual deformation on the upper floors. Based on the above, it has been shown that the deformation of RC structures can be efficiently evaluated by implementing the series of processes shown here.
