NASA Mars Climate Orbiter Project Failure (1999) REPORT

Requirement Engineering
Under the guidance of Mr. Upendra Athipola

Submitted by Azka Naheem (UWE: 18030375)
23rd of March 2020

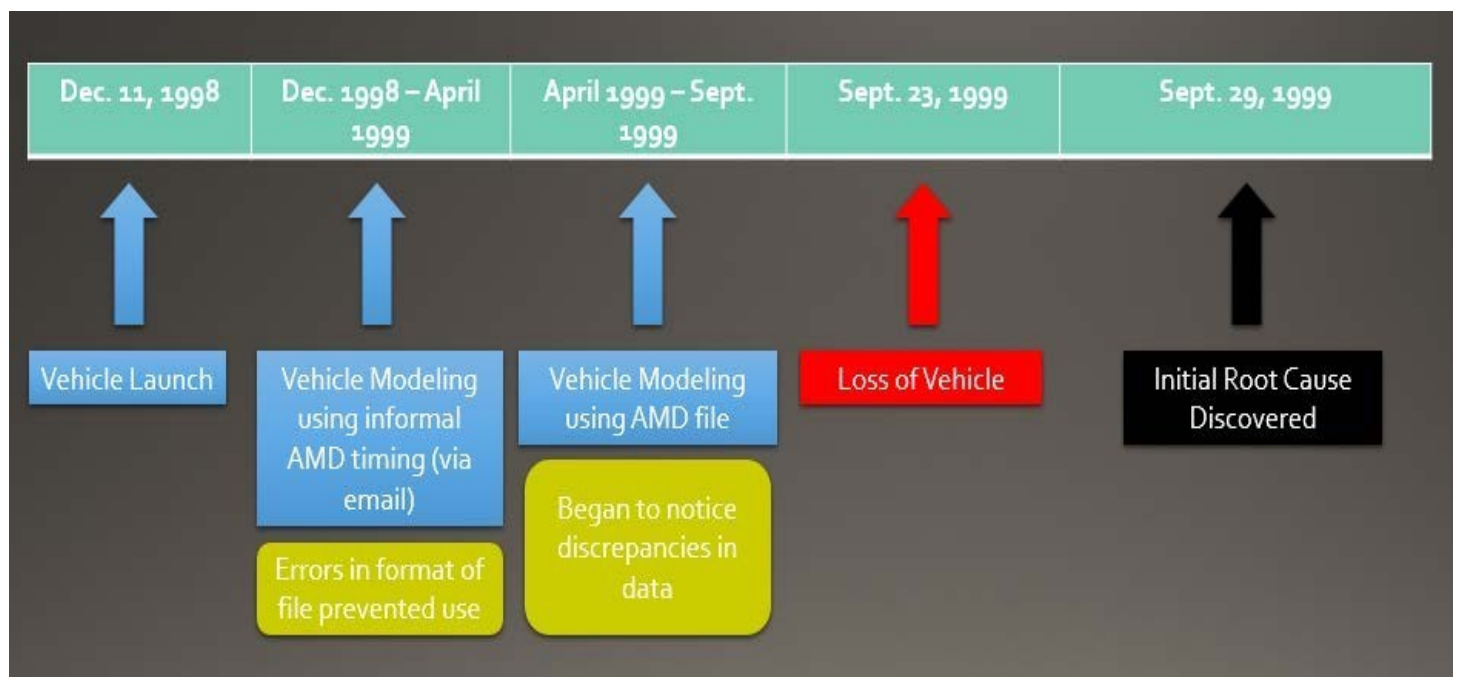
Figure 1: MCO Project Timeline

The MCO Mission objective was to orbit Mars as the first interplanetary weather satellite and provide a communications relay for the MPL which is due to reach Mars in December 1999. The MCO was launched on December 11, 1998, and was lost sometime following the spacecraft's entry into Mars occultation during the Mars Orbit Insertion (MOI) maneuver. The spacecraft's carrier signal was last seen at approximately 09:04:52 UTC on Thursday, September 23, 1999.

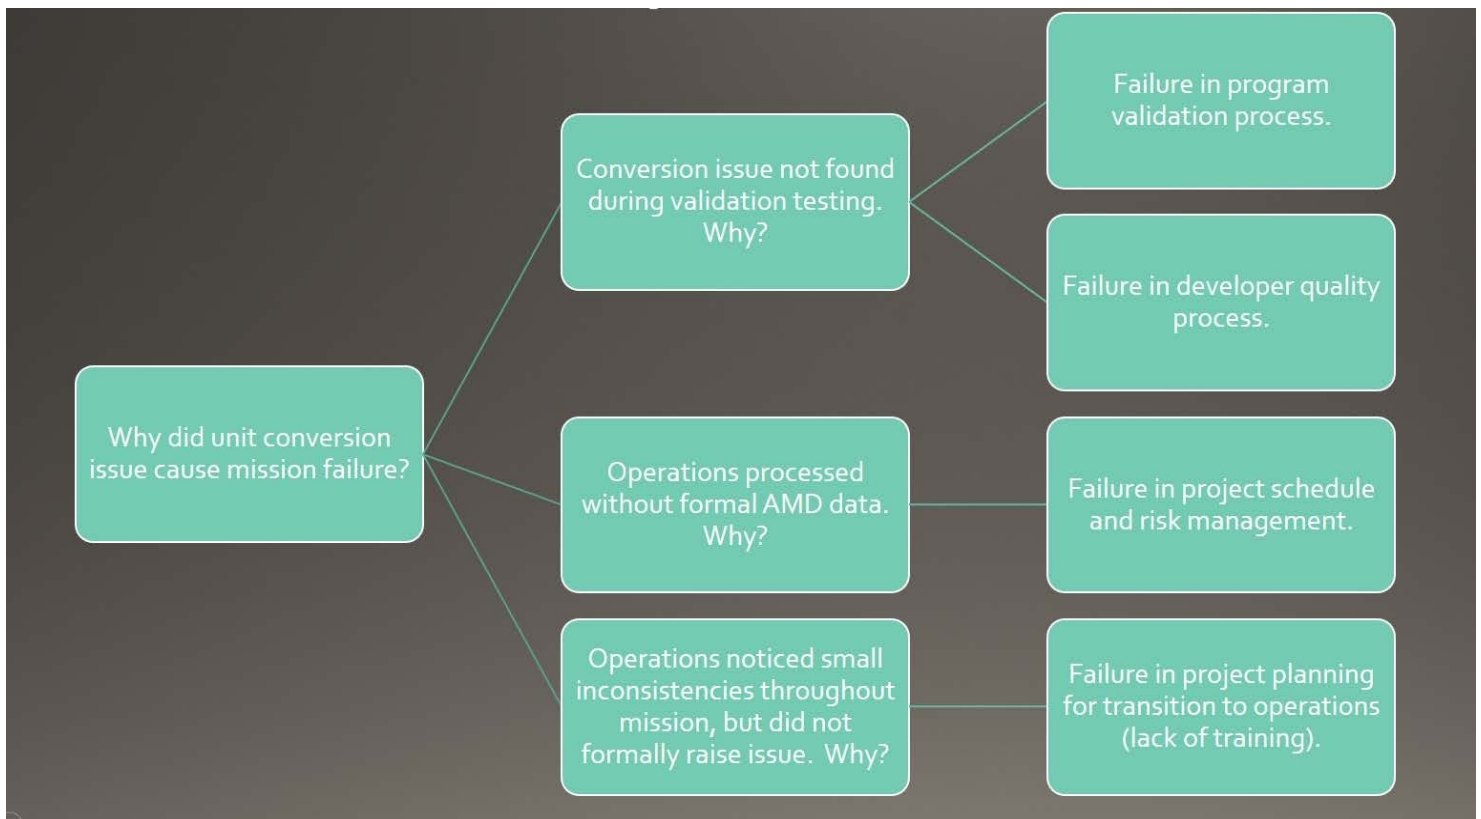
Figure 2: Root Cause Analysis

The MCO Mishap Investigation Board (MIB) has determined that the root cause for the loss of the MCO spacecraft was the failure to use metric units in the coding of a ground software file used in trajectory models. Specifically, thruster performance data in English units rather than metric units were utilized in the software application code titled SM_FORCES (Small Forces). A file called Angular Momentum Desaturation (AMD) contained the output data from the SM_FORCES software. The data within the AMD file was required to be in metric units per existing software interface documentation, and therefore the trajectory modelers assumed the data was provided in metric units per the requirements.

This asymmetric effect significantly increased the Sun-induced (solar pressure-induced) momentum buildup on the spacecraft. The increased AMD events coupled with the fact that the angular momentum (impulse) data was in English, rather than metric units, resulted in 7 small errors being introduced in the trajectory estimate throughout the 9-month journey. At the time of Mars insertion, the spacecraft trajectory was approximately 170 kilometers lower than planned. As a result, MCO either was destroyed in the atmosphere or re-entered heliocentric space after leaving Mars' atmosphere.

- Causes for this hazard can be stated in the terms of Poor Requirements Engineering & Software Engineering Practices as follows.
- **Problem 1 – Failure in the Program Validation Process**

- *System integration testing failed to validate that the interface of the AMD file was satisfied correctly.*
- **Problem 2 – Failure in the Developer Quality Process**

- *The developer had a clear specification that indicated the units required for the AMD file. But the quality process needed to have enforced some sort of review that would catch something as critical as the requirements of the interface.*

- **Problem 3 – Failure in the Project Schedule and Risk Management**
 - *Project Management attempted to mitigate the late schedule of the developer providing an AMD (Angular Momentum Desaturation) file with a manual interaction.*

- *Given the criticality of this system function, it was not clear that the risk was properly quantified.*
 - *Mitigation plan was not thorough enough to require validation of AMD interface upon receipt of late system function.*

- **Problem 4 – Failure in the Project Planning (Lack of Training) for transition to operations**
 - *Operations team responsible for utilizing AMD interface was not part of original program development.*

- *Thorough background training on the specifications of the system was not provided.*
 - *This lack of background knowledge contributed to the issue of operations noticing minor inconsistencies in the data without realizing the larger consequence to the system.*

- **Make Tests Fundamental**

- *In a big project, it's sufficient to thoroughly test each individual part of a machine, instrument or software. It's crucial to also test the way each component interacts with the others. We can't skimp on tests. A failure to detect an issue could compromise the whole project.*

- **The more complex the project is, the more we should worry about the communication between the teams**

- *In big projects, it is difficult to have a global vision of what's going on. To avoid inconsistencies, it's really essential to share information between the involved teams.*
