82545EM Gigabit Ethernet Controller Specification Update

June 6, 2006

The 82545EM Gigabit Ethernet Controller may contain design defects or errors known as errata that may cause the product to deviate from published specifications. Current characterized errata are documented in this Specification Update.

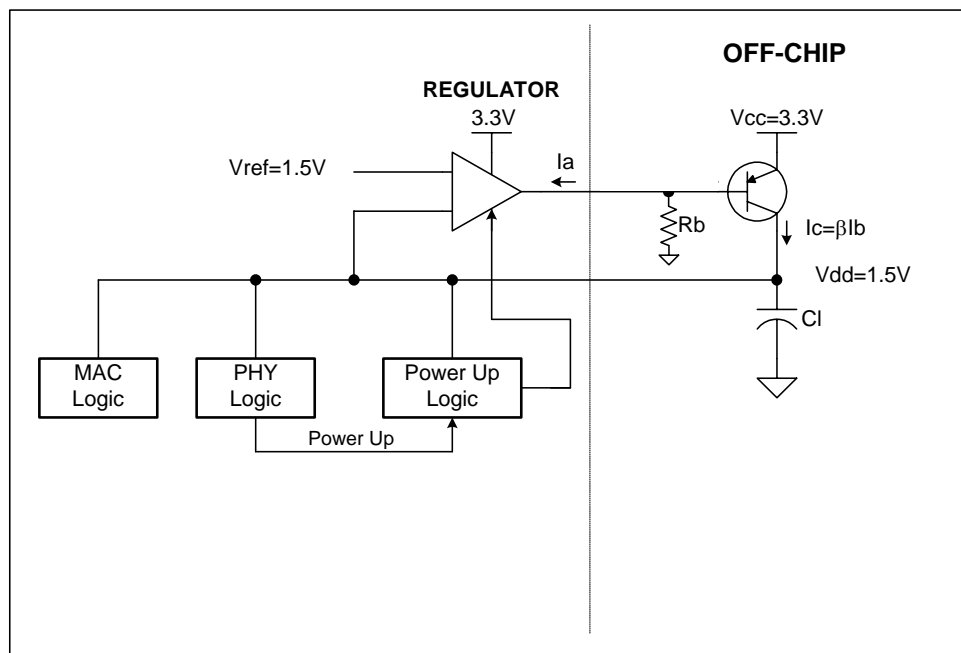
- Implication:** When drive is absent on the CTRL_15 output, only leakage current from the CTRL_15 output will be present. Depending on the amount of leakage current and the gain (Beta) of the external PNP transistor, there may be insufficient collector current ($I_C = I_B * \text{Beta}$) to adequately supply the 1.5V rail, and the 1.5V regulator circuit may not turn on. The 1.5V rail requires a minimum collector current of 5 mA to be generated and a 1.5V rail voltage of at least 600 mV to ensure that the digital portion of the circuit turns on correctly.

- When the 1.5V regulator control output fails, the 2.5V regulator control output(s) may also fail, driving the 2.5V supply toward either 0V or the 3.3V rail. The absence of one or both of the 1.5V and/or 2.5V supplies prevents the Ethernet controller from operating correctly.

- Workaround:** The regulator control output is Ball A18 on the 82545EM controller. Intel's original reference designs showed two external resistors, R1 and R2, in this circuit. The workaround completely removes R2 and replaces it with another resistor, Rb, connected between the CTRL_15 output and ground.

- For the 82545EM A-1 step: $R_b = 15\text{ K}\Omega$ with a $\pm 5\%$ tolerance.
- Systems that generate 1.5V without using the Ethernet controller's onboard regulator control (for example, at a central power supply) do not need a workaround. No changes are required for the 2.5V regulator circuit.

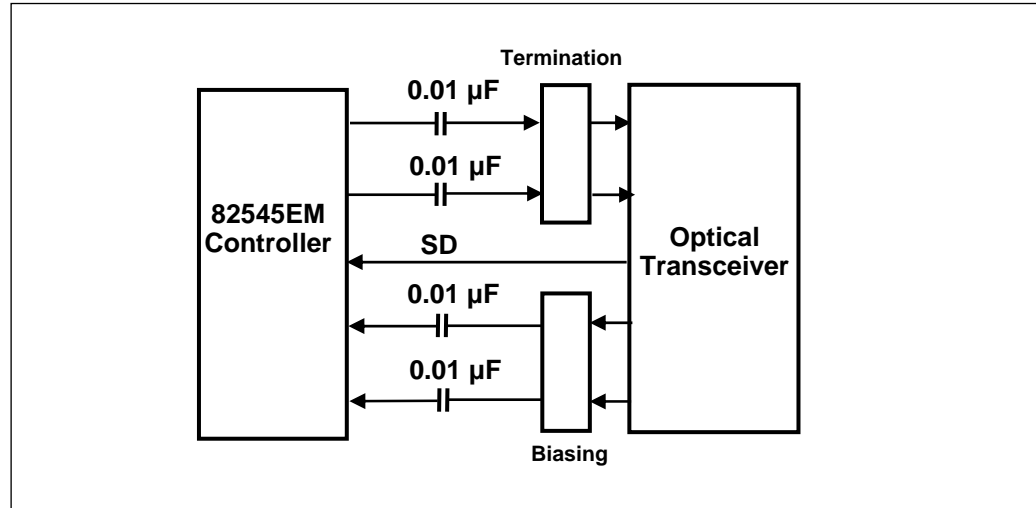
Problem: Intel added new SERDES functions to the 82545EM controller. SERDES stands for Serializer-Deserialzer and is a circuit that converts Ethernet packet data from a parallel TBI format to a 1.25 GHz bidirectional serial stream. For 1000BASE-SX or 1000BASE-LX fiber applications, SERDES integration typically saves the designer the expense and board space of a 64-lead external device. The 82545EM controller contains one SERDES. A '10' needs to be written in ICW3 bits 1 and 0, respectively, in order to enable this feature.

The datasheet for the 82545EM Controller will change to define pins as follows:

Signal Name	Type	Name and Function
TX +/-	I	SERDES Receive Pair. Differential receive signal pair for 1.25 GHz serial interface. For serializer-deserialzer operation, couple the inputs to ECL signal levels. If the SERDES interface is not used, leave RX +/- unconnected.
RX +/-	O	SERDES Transmit Pair. Differential transmit signal pair for 1.25 GHz serial interface. For serializer-deserialzer operation, the outputs drive LVPECL voltage levels. If the SERDES interface is not used, leave RX +/- unconnected.
SIG_DETECT	I	Signal Detect. Indicates that a signal has been detected by an optical transceiver connected to the 1.25 GHz serial interface. If the SERDES interface is not used, connect SIG_DETECT to ground through pulldown resistors.

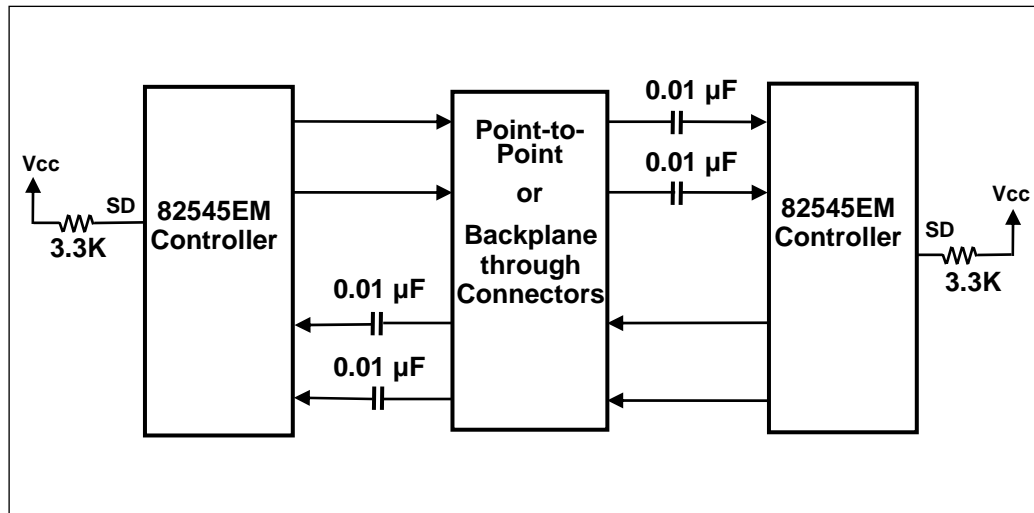
Alternatively, the 82545EM may be used in short haul gigabit backplane data applications without transceivers and optical fibers. No special termination is required because the 82545EM device is internally terminated. The figure below illustrates a gigabit backplane or point-to-point circuit based on either the 82545EM device:
