Inspection Report

Property Address:
2246 Parkview Dr.
Longmont CO. 80504

Shawnee Inspection Services

Date: 2/20/2017	Time: 09:00 AM	Report ID: SB2017-1
Property: 2246 Parkview Dr. Longmont CO. 80504	Customer: Carson Holmes Jill Holmes	Real Estate Professional: Suzy Williamson

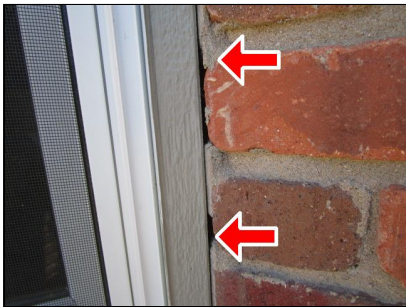
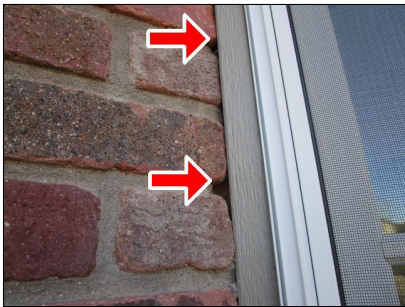
(4) Caulking is inadequate or missing where the brick veneer butts the trim boards. Have a qualified contractor seal all areas of siding junctions to help reduce the risk of water penetration.

3.0 Caulk Missing (Example)

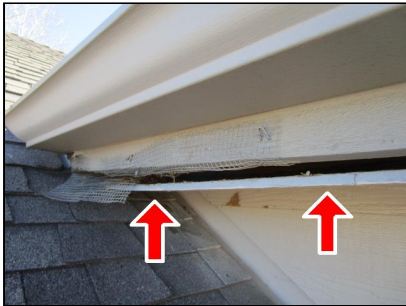
(2) The soffit board is loose over the garage. Secure or replace the board to prevent water penetration or pest intrusion in to the attic area.

3.1 Soffit Loose

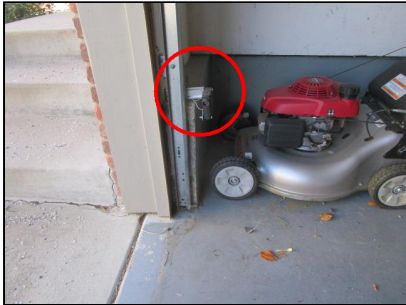
(2) The electronic sensor for the reverse mechanism on the single car garage door opener is installed at the wrong height. The beam should be installed four to six inches from the floor to perform properly for safety. Have a qualified garage door specialist properly install the electronic sensor.

3.3 Sensor Too High

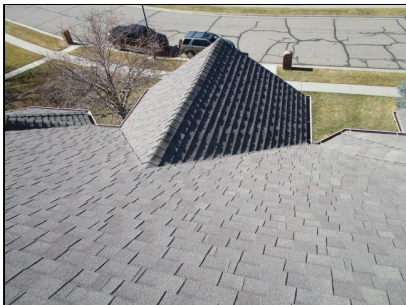
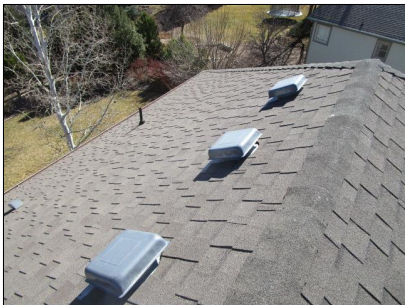
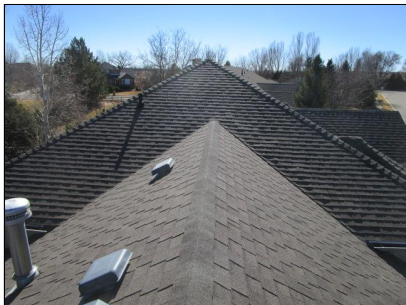
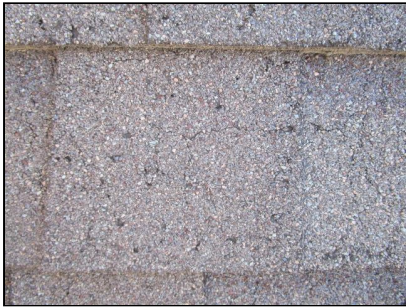
The roof covering is old, worn, cracked and blistered with very little remaining useful life. Have a roofing contractor replace the roof materials. All existing layers should be removed prior to replacement. You should consider augmenting the attic ventilation when the roof materials are replaced.

4.0 Main Roof - Average Condition

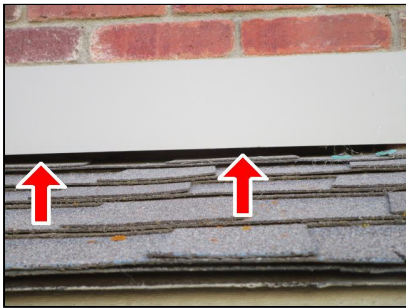
Although a counter flashing is present over the fireplace bump-out, a wall flashing is missing. Ensure a wall flashing is installed when the roof is replaced.

4.1 Wall Flashing Missing

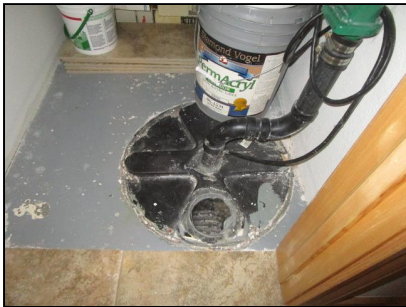
The cover to the sump pit is sealed and could not be removed for inspection. The pump's condition and ability perform its function is not represented in this report.

5.4 Sump Pit and Pump - Lid Sealed for Radon Mitigation

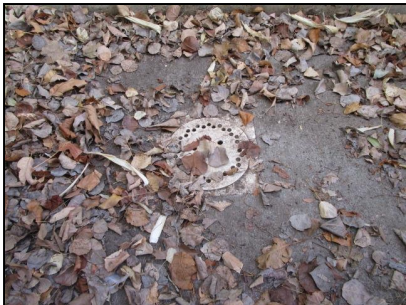
5.5 Stairwell Drain

The basement stairwell drain will need periodic cleaning. Significant back up and flooding may result if it cannot perform its intended function during heavy weather.

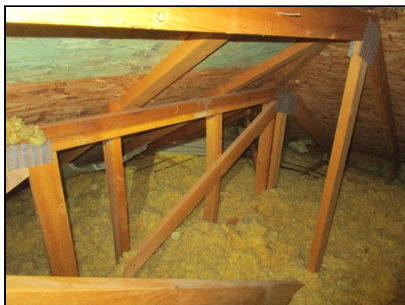
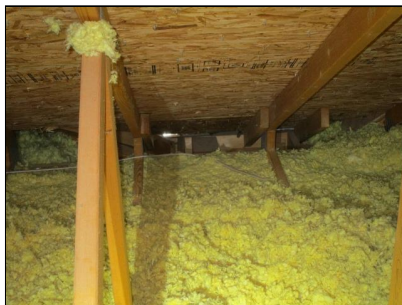
The attic insulation has been disturbed in areas, mainly around the perimeter and is significantly compressed. Compressed insulation reduces the R Value. Install additional insulation where needed as an energy conservation upgrade.

7.0 Compressed Insulation
(Example)

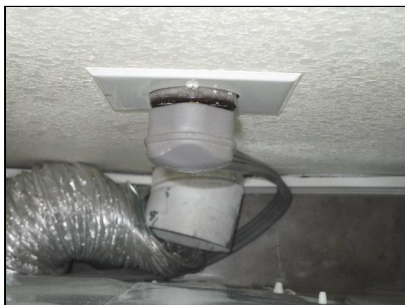
(2) The clothes dryer is not connected to the vent. Ensure the vent is connected to prevent moisture and lint from accumulating inside the home.

7.6 Dryer Vent Not Connected

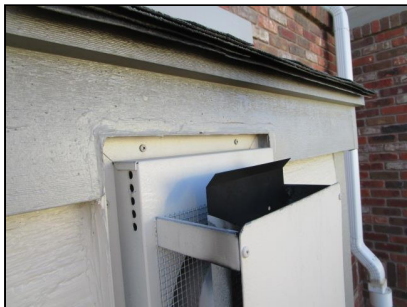
There is an excessive amount of soot built up on the exterior vent for the gas fireplace. This usually indicates faulty combustion. Have the fireplace serviced and adjusted as needed for proper and safe operation.

8.6 Soot Build-Up at Vent

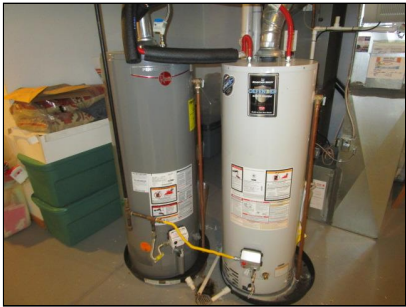
10.5 Water Heaters - Both 2 Years Old

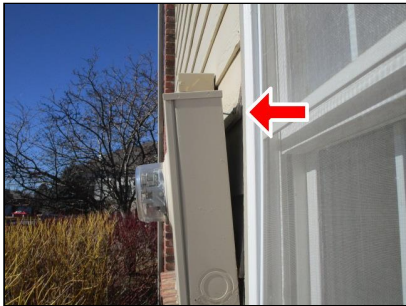
The meter box is loose from the exterior wall. Have the Electrical Service Company re-secure the meter box and inspect for loose wiring within.

11.10 Meter Box Loose

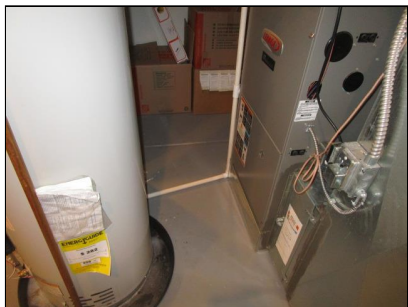
(3) The second water heater is encroaching in the required 30" of working space in front of the furnace. Have the water heater re-located to provide space for routine maintenance and inspection of the furnace.

12.0 Poor Clearance In Front Of
Furnace

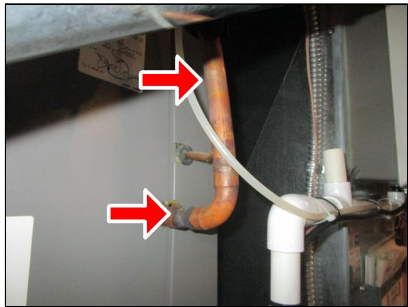
(2) The insulation on the suction line is short where it enters the evaporator. Install insulation to help prevent dripping condensation on the furnace.

13.0 Insulation Short

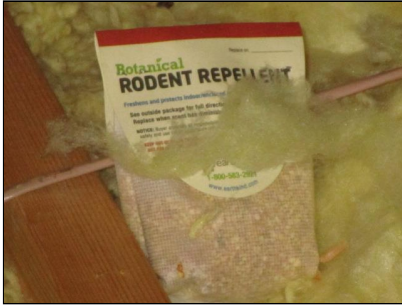
There are signs of rodent activity in the attic. Have a pest control contractor discover and seal all potential entry points and eradicate any live animals.

15.1 Signs of Rodent Activity in Attic

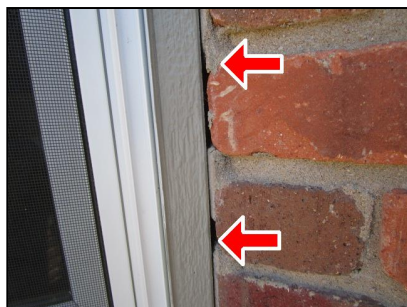
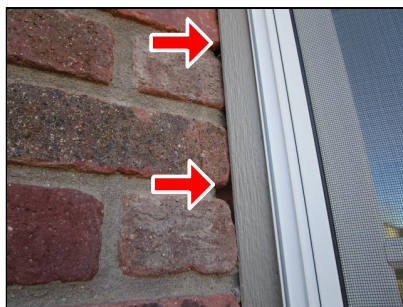
(4) Caulking is inadequate or missing where the brick veneer butts the trim boards. Have a qualified contractor seal all areas of siding junctions to help reduce the risk of water penetration.

3.0 Caulk Missing (Example)

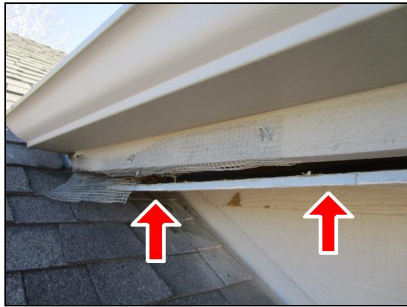
(2) The soffit board is loose over the garage. Secure or replace the board to prevent water penetration or pest intrusion in to the attic area.

3.1 Soffit Loose

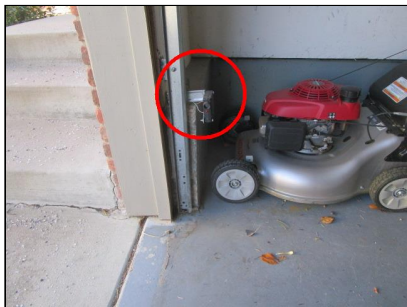
(2) The electronic sensor for the reverse mechanism on the single car garage door opener is installed at the wrong height. The beam should be installed four to six inches from the floor to perform properly for safety. Have a qualified garage door specialist properly install the electronic sensor.

3.3 Sensor Too High

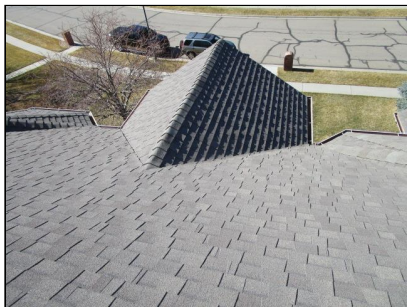
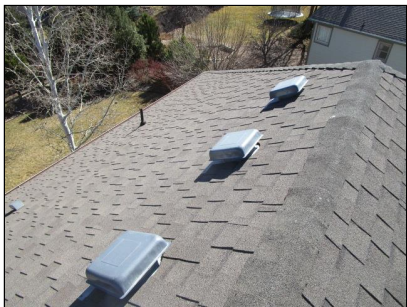
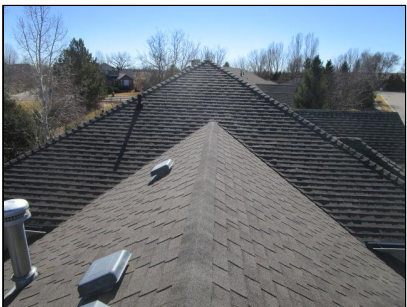
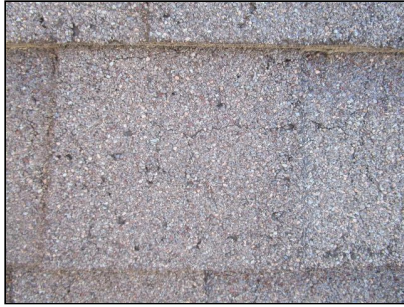
The roof covering is old, worn, cracked and blistered with very little remaining useful life. Have a roofing contractor replace the roof materials. All existing layers should be removed prior to replacement. You should consider augmenting the attic ventilation when the roof materials are replaced.

4.0 Main Roof - Average Condition

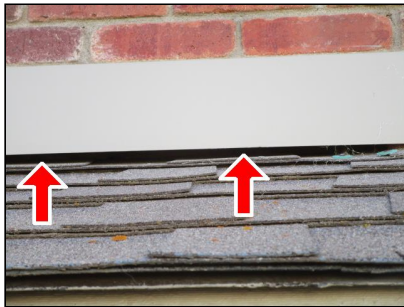
Although a counter flashing is present over the fireplace bump-out, a wall flashing is missing. Ensure a wall flashing is installed when the roof is replaced.

4.1 Wall Flashing Missing

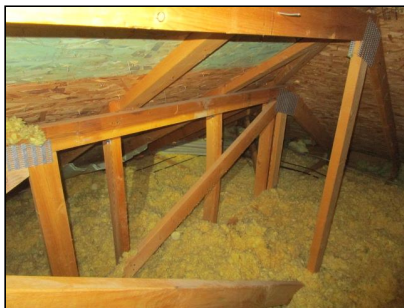
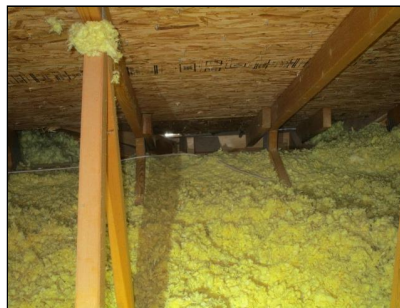
The attic insulation has been disturbed in areas, mainly around the perimeter and is significantly compressed. Compressed insulation reduces the R Value. Install additional insulation where needed as an energy conservation upgrade.

7.0 Compressed Insulation (Example)

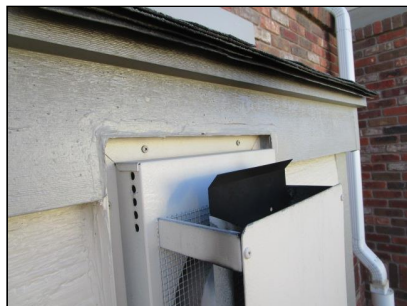
There is an excessive amount of soot built up on the exterior vent for the gas fireplace. This usually indicates faulty combustion. Have the fireplace serviced and adjusted as needed for proper and safe operation.

8.6 Soot Build-Up at Vent

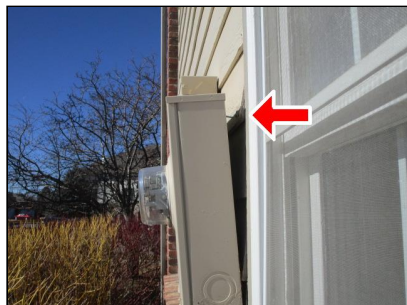
The meter box is loose from the exterior wall. Have the Electrical Service Company re-secure the meter box and inspect for loose wiring within.

11.10 Meter Box Loose

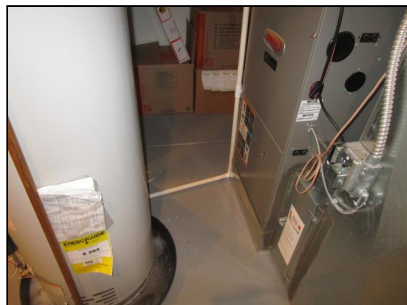
(3) The second water heater is encroaching in the required 30" of working space in front of the furnace. Have the water heater re-located to provide space for routine maintenance and inspection of the furnace.

12.0 Poor Clearance In Front Of
Furnace

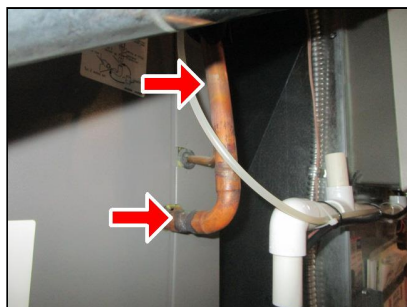
(2) The insulation on the suction line is short where it enters the evaporator. Install insulation to help prevent dripping condensation on the furnace.

13.0 Insulation Short

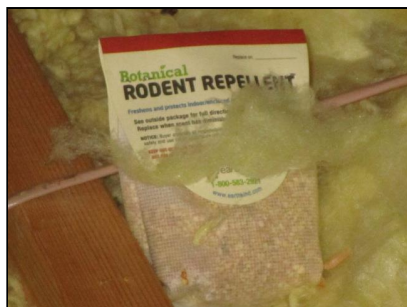
There are signs of rodent activity in the attic. Have a pest control contractor discover and seal all potential entry points and eradicate any live animals.

15.1 Signs of Rodent Activity in
Attic
