here's a quick follow up report on the legacy shower issue The temperature was originally set to app. 125 deg and today the average was about 135 degree which may shift shower # 6 out of a decent temperature control range.

“Legacy BC showers water temp increase”

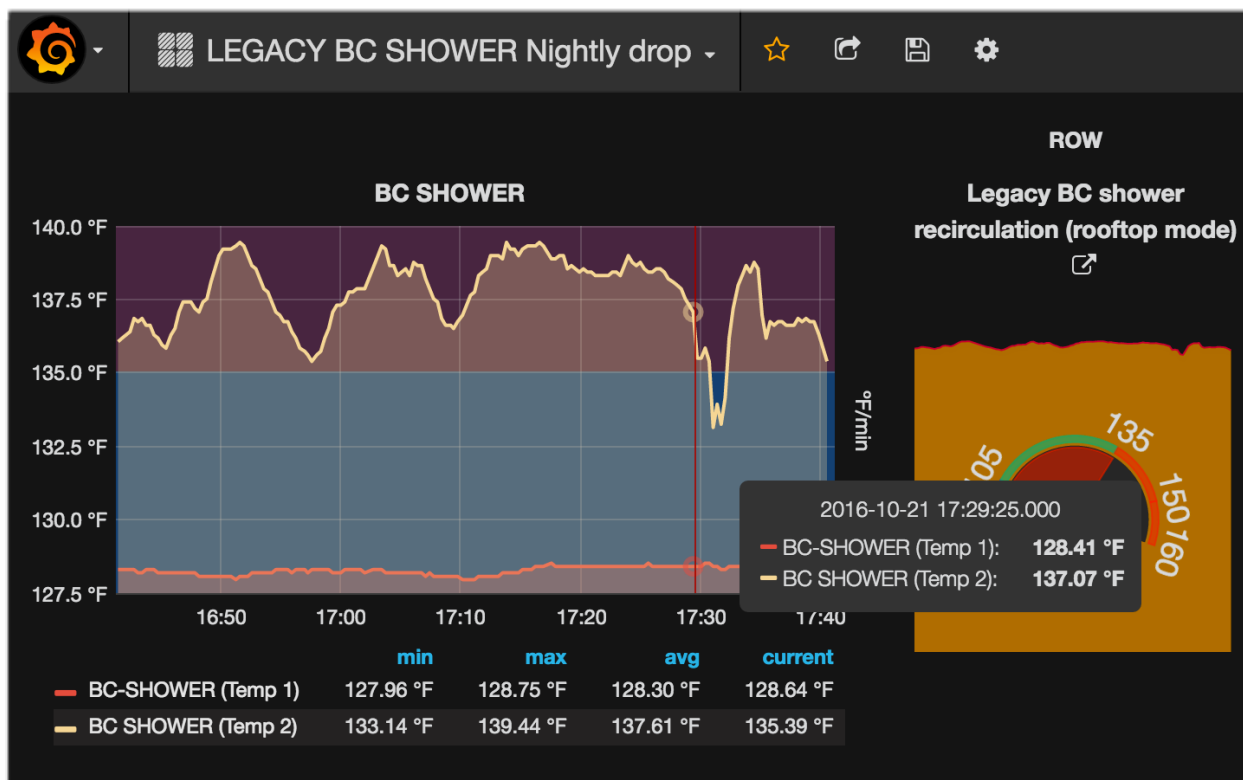
Here you can see before the "work" being performed (Temperature his above 135 deg F and should be no higher then 125 deg F).

We "attempted" to fix it Friday night by precisely adjusting the the temperature on the mixer and the hot water flow on the horizontal bypass valve.

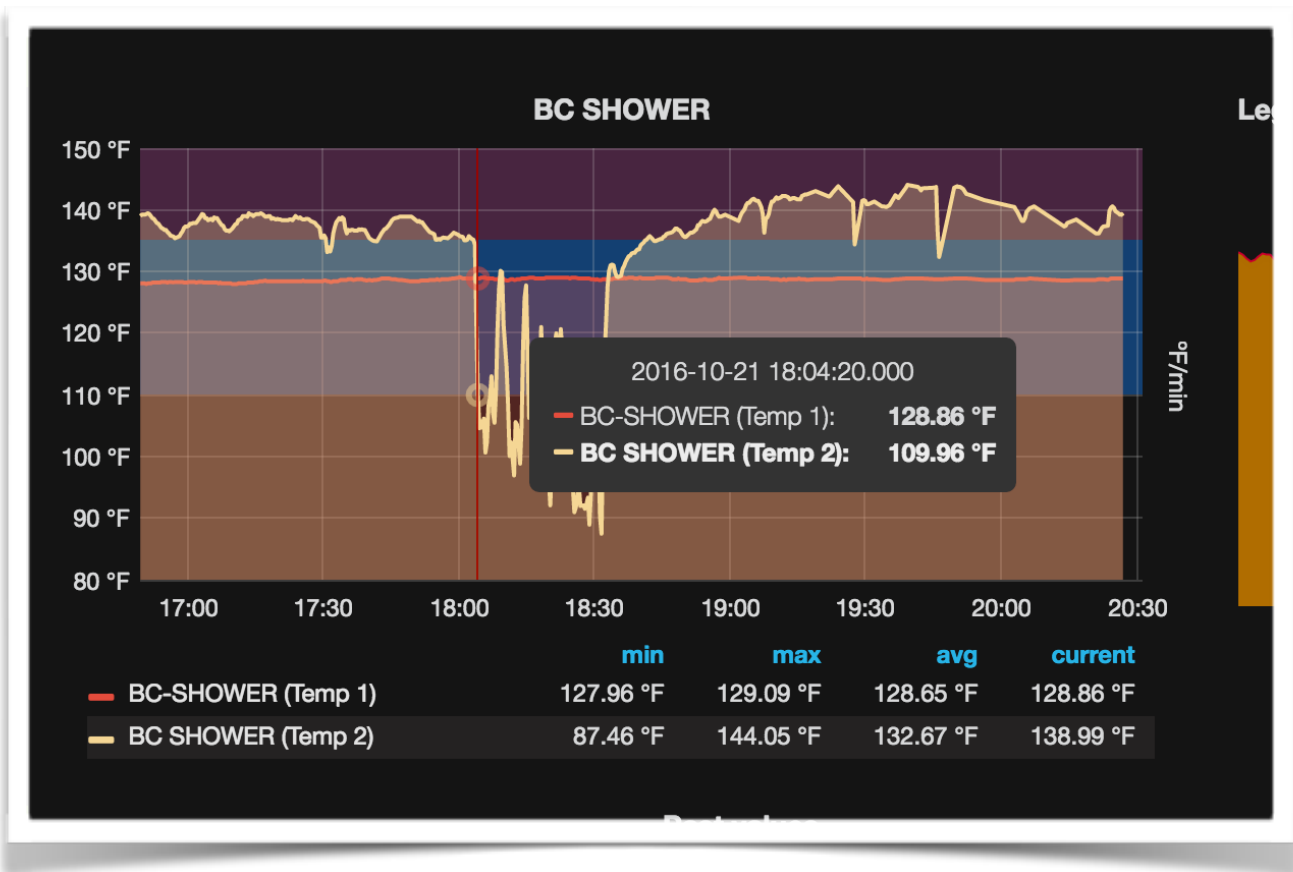
We changed the median temperature between hours 18:00-18:30 to app. 120.

But shortly after Phillip left the temp went back to 135 up to 140.

This indicates a lack of cold water pressure at the mixing valve. No cold water -> no temperature control and the mixing valves if each shower are setup for app 120 deg and not for 140! The cold water supply is directly coming from LAWA.

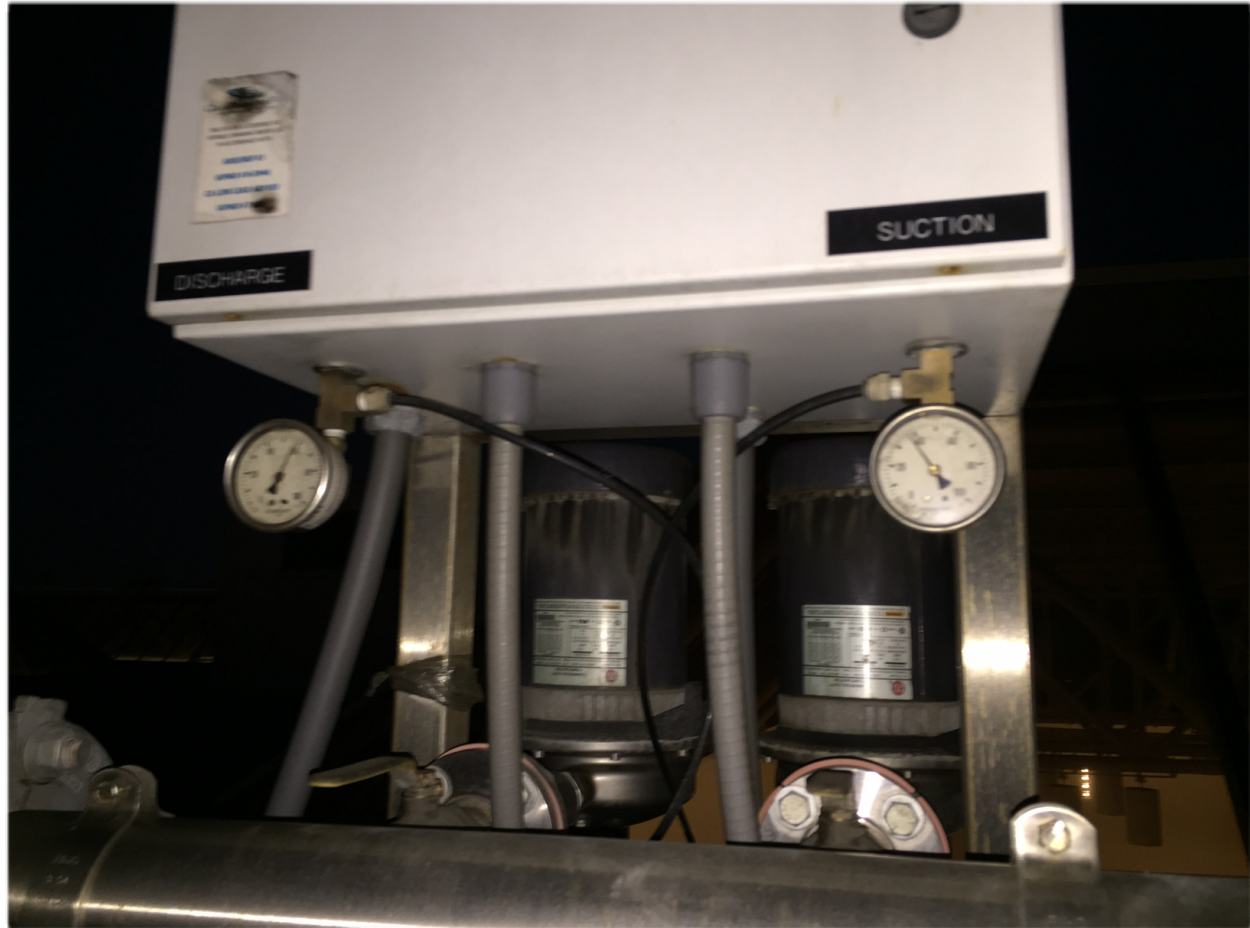
So I sent Phillip up on the roof to check the Quantum Flow pressure boost system and he found it working to maintain boost pressure at 60 psi.

However, he reported huge fluctuations on the cold water feed pressure from LAWA between 20 and 40 psi.

The mixer (TMV) in the legacy shower is pressure compensated BUT NOT ABLE TO ACCOMMODATE large swings in either cold or hot inputs. The hot is boosted by the Quantum flow and the water heaters circulation pump to at least **60 psi + head** (distance from rooftop of app 20 ft) will add another 10 psi.

At the cold supply it is likely not from a boosted source and **may be as low as 20 + 10 psi** (head) and inadequate to operate the mixer at this a large variation

Call it another design flaw and getting away with it. Cold and hot need to be at app. the same supply pressure or boosted equally or it cannot work reliably with a poor water feed from the source.

Remedy : long term , pressure needs to be equalized, instantly there are 3 options:

- we can reduce the rooftop water heater set point from 150 to 135 and the legacy showers are then running at the preset intended without mixing required.
- we can set the temperature on all 9 showers to work with the higher feed temp of 135-140. This will be fairly easy too but eliminates the possibility to fall back on the low temp LAWA backup supply they are not as ware off or guarantee for.
- we switch the legacy showers back to LAWA supply and hope for a reliable supply period. It can last for months or days.

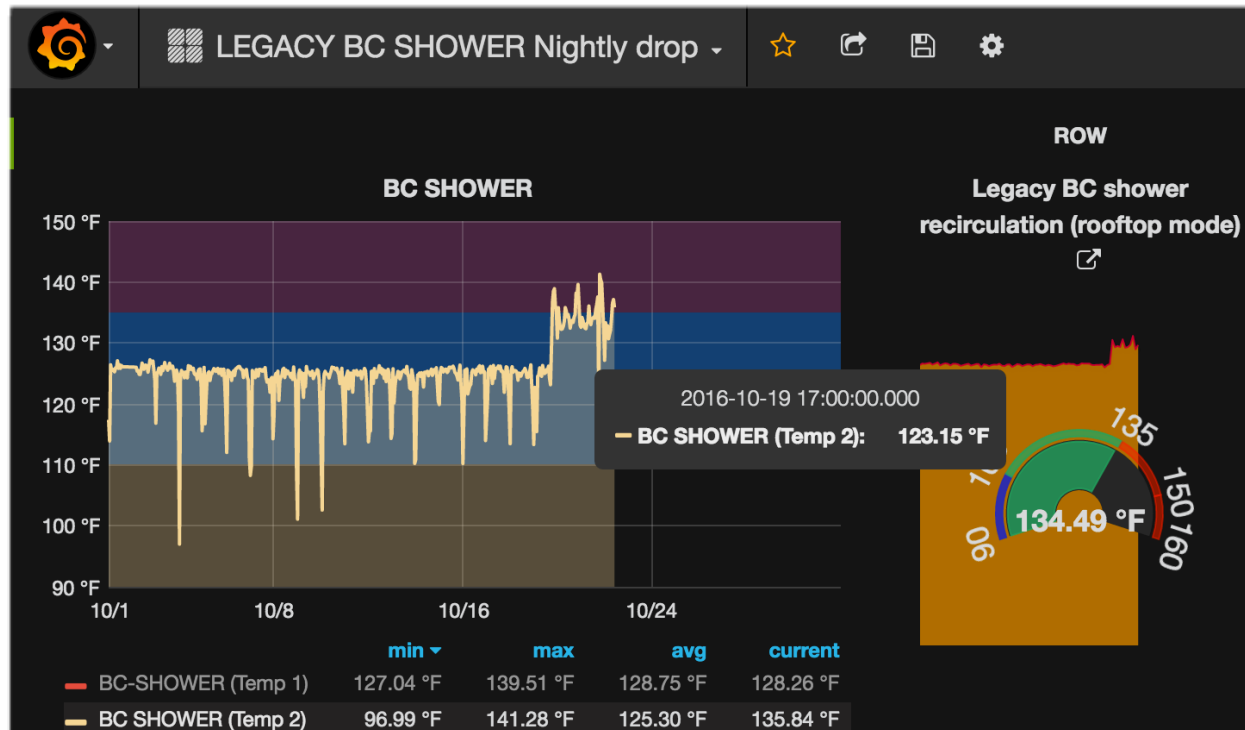
I made one more important observation: looking at historic data (see image below) everything was fine until 10/19/2016 at 17:30. As seen below, the max temperature was well controlled and capped at 125 deg F before and suddenly changed by 10 deg F to 135 . Does anybody know what happened on that day ?
