Degradation analysis of a photovoltaic generator after operating for 15 years in southern Brazil

José Eduardo Ferreira da Fonseca*, Fernando Schuck de Oliveira, César Wilhelm Massen Prieb, Arno Krenzinger

Federal University of Rio Grande do Sul, Brazil

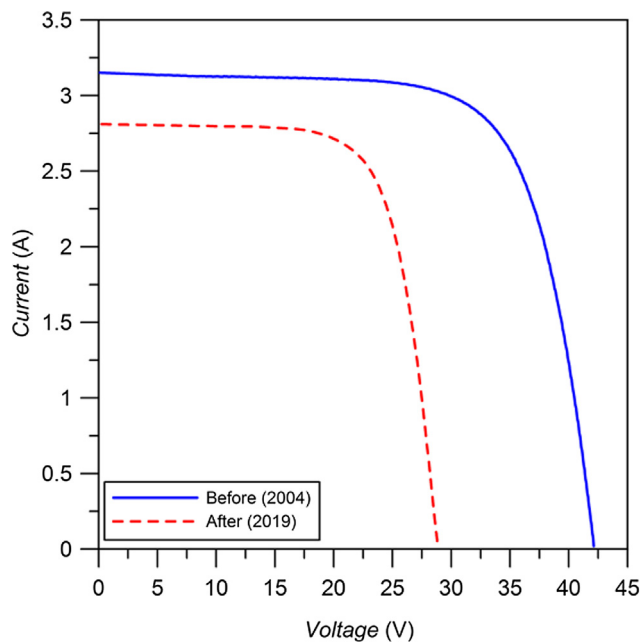
Analyzing the histogram of V_{OC} in Fig. 3, one can notice a module that has a much lower voltage, about 2/3 of the other modules. This particular module, which I - V curve is shown in Fig. 4, was found to have two of its six series of cells inactive due to a failure in an internal connection. This failure was probably caused by moisture penetration, since this particular module (identified as EL6, the sixth module of the lower east string) had its junction box detached from the backsheet. Thus, for the analysis of degradation after 15 years of operation, this module was discarded and only 47 modules were considered.

Fig. 4. Measured I-V curves of module EL6, as new and after 15 years of operation.

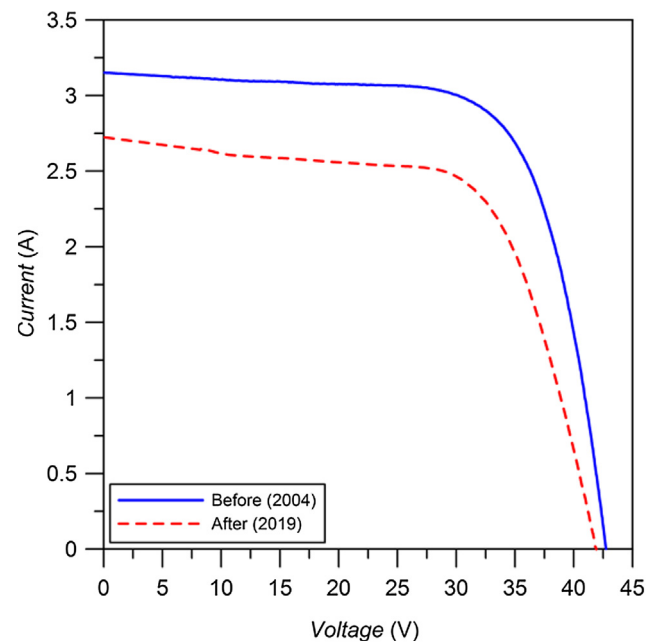
Fig. 6. I-V curve of the module CL1 that presented largest power reduction.

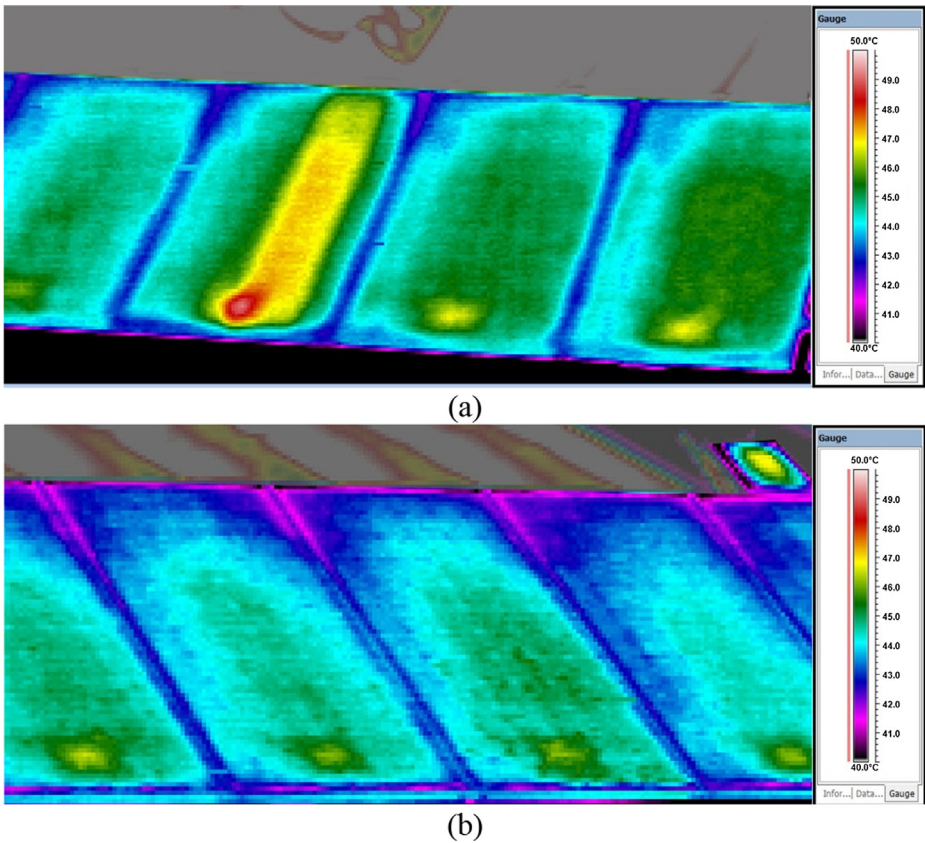
Fig. 8 shows thermographic images of the lower West string. During the days of the inspection, the temperature difference from cell to cell was less than 3 °C, except for the region over the junction boxes. The same behavior was also observed in the other modules of the system. Given the homogeneous temperature distribution over the modules, measuring the temperature at a single point of the module did not introduce significant errors. Due to the low system voltages (under

In Fig. 8, the temperature gauge was fitted from 40 °C to 50 °C, the temperatures on the glass cover were corrected using the methodology presented by Krenzinger and de Andrade (2007) ranging from 43 to 49 °C. A hotter area can be observed in one of the modules. This module (EL6), presented an inactive area as revealed by its I - V curve (Fig. 4).

Fig. 8. Thermographic images of inferior arrays, (a) East and (b) West.

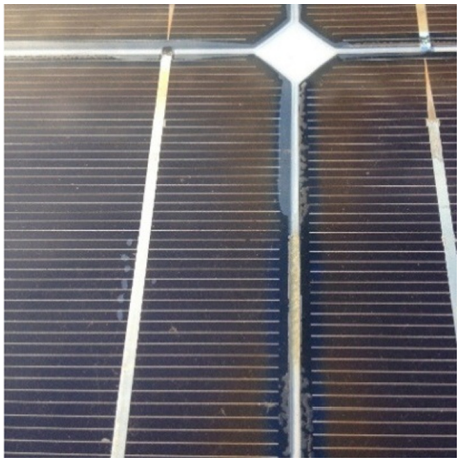
Fig. 9 details a region of CH3 module, featuring frontal delamination and early formation of milky pattern. Fig. 10 shows the region of module CL6 with formation of milky pattern. These occurrences are similar to those identified in (Bouraiou et al., 2015; Sánchez-Friera et al., 2011).

Fig. 9. Detail of CH3 module presenting frontal delamination and early formation of milky pattern.

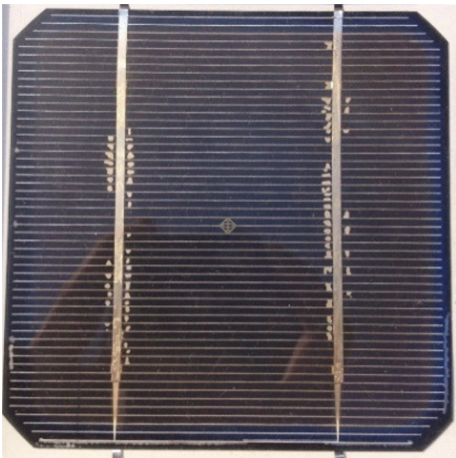
Fig. 10. CL6 module seriously affected by milky pattern formation.

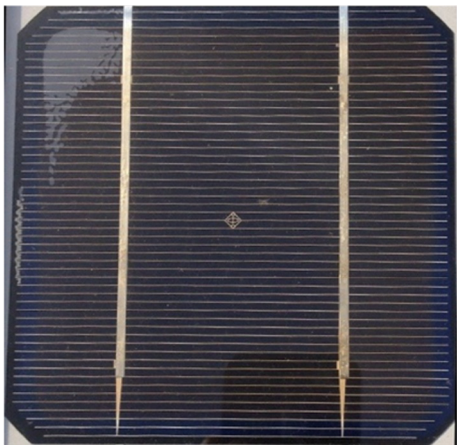
Fig. 11 shows the delamination between glass and encapsulant in module CL7. This defect is similar to that shown in Tang et al. (2006). Fig. 12 shows deterioration of the anti-reflective layer at the edges of one module WH3 cell, other important effect that occurs as a

Fig. 11. Delamination between glass and encapsulant in module CL7.

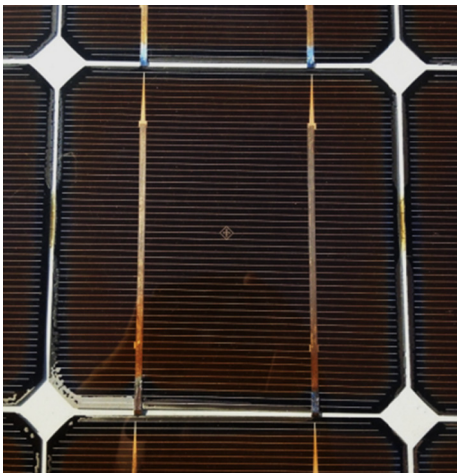
Fig. 12. Deterioration of the anti-reflective layer at the edges of a WH3 module cell.

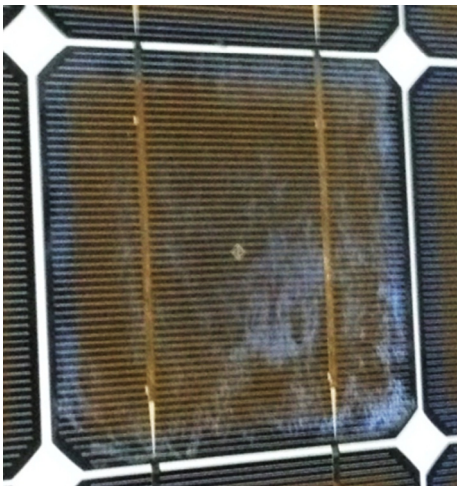
Fig. 13 shows the deterioration of the anti-reflective layer on a WL6 module cell, similar as found in Munoz et al. (2011).

Fig. 13. Deterioration of the anti-reflective layer in a WL6 module cell.

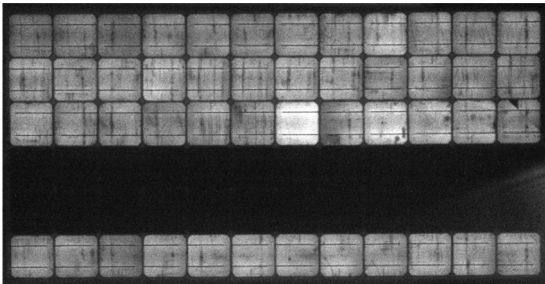
Fig. 14. EL image of module EL6.

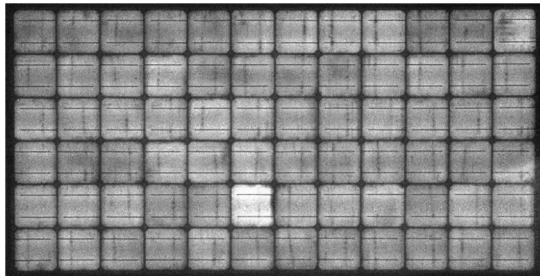
Figs. 15 and 16 show the EL images of modules WL1 and WL3, respectively, in which can be observed cells with operational mismatch in relation to the others. This effect can be detected from the higher intensity of emitted radiation, due to the fact that the defective cell has a smaller active region. In Zhu et al. (2016), a similar effect was demonstrated when observing EL images of modules submitted to damp heat test.

Fig. 15. EL image of WL1 module.

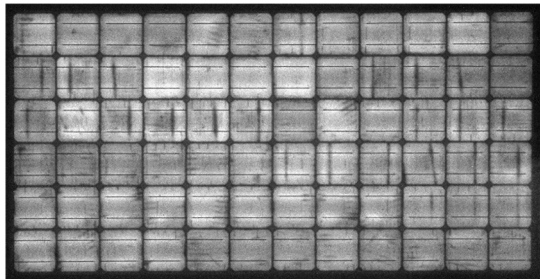
Fig. 16. EL image of WL3 module.

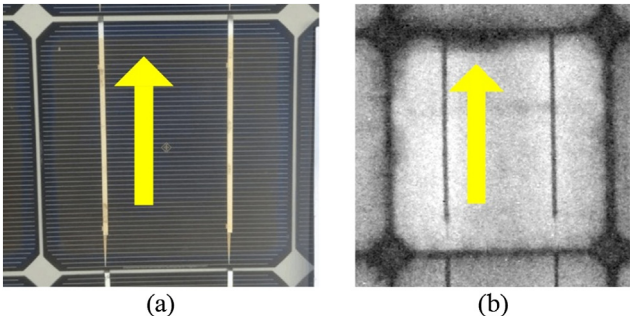
Fig. 17 depicts ordinary and EL images of the brightest cell of WL1

module. The regular photograph (a) shows no apparent indication of a problem in the cell that justifies the inactive region shown in the EL image (b).

Fig. 17. Regular and EL images of WL1 module's brightest cell.
