FAILURE DIAGNOSIS ON PHOTOVOLTAIC MODULES USING THERMOGRAPHY, ELECTROLUMINESCENCE, RGB AND I-V TECHNIQUES

ABSTRACT: Different techniques can be used to detect and quantify PV modules anomalies, as visual inspections, electrical tests like the I-V curve test, infrared thermography (IRT) or electroluminescence (EL). PV plants operators usually apply only one or two of them within the Operation and Maintenance (O&M) activities. Additionally, researchers usually studied them separately. However, these methods provide complementary results, glimpsing interesting information about the PV site state. The main strength of the research performed is the simultaneous study of all these inspection techniques, studying the correlation between them. Results confirm that, EL and IRT under current injection on modules are closely correlated, while IRT under normal operation (sun exposure) reveals complementary information not detected in EL but existing in the visible spectrum. In conclusion, it is advisable using as many techniques as possible to characterize the actual state of the module and to explain its I-V curve.

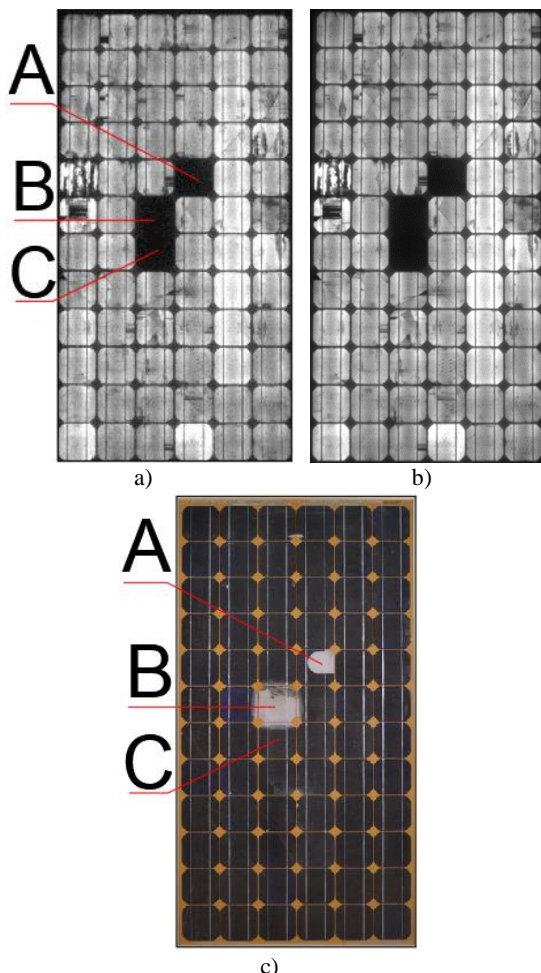
Figure 4: First (a) and last (b) EL images of S-E1 module and its RGB appearance (c).

In this visual image, it can be seen an EVA delamination failure in the cell labelled as A, and a burn area, combined with delamination, in cell B. Apparently, cell C does not present important failures detected visually, but failure B apparently is extended in the upper

area of cell C. However, these three cells are inactive, as it can be seen in the EL images, appearing completely black, as they do not emit. Therefore, it can be concluded that these cells are short-circuited, allowing the current passing but not producing energy. Although cell C visually does not present any relevant defect, the failure B has extended affecting likewise cell C. This fact is also revealed in the IV Curve, which can be seen in Figure 5. In this figure are showed two different test performed at different irradiance and temperature conditions and extrapolated to Standard Test Conditions (STC). Its main parameters are compared with the nominal data of the module in Table 2. It can be seen an open circuit voltage (V_{oc}) drop of 3,45V, which correspond with the contribution of the three inactive cells in addition to other partial inactive cells, as it can be seen in the EL images in Figure 4. The short circuit current (I_{sc}) does not significantly fall because the rest of cells are almost fully active (in the sense of cell area working).

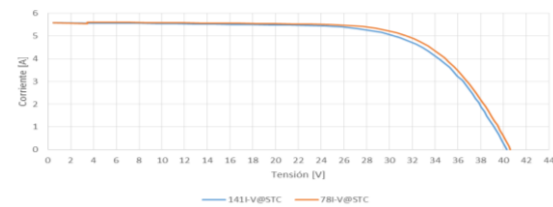
Figure 5: IV Curve of the S-E1 module in STC.

during ordinary operation of the modules is not direct, as some active areas appears as hot spots but they can be covering up by delamination, which causes a different emissivity value. Finally, it has been explained how total inactive cells are revealed as a Voc drop in the IV curve, maintaining the curve shape if they are not mixed with other kinds of defects.

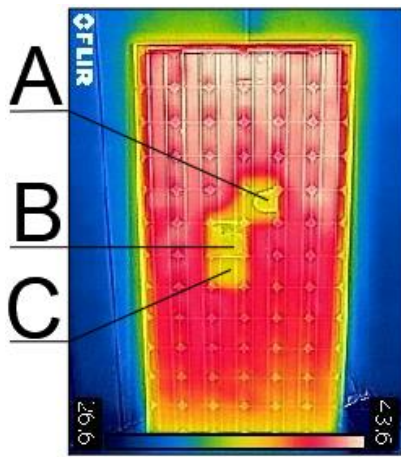
Results presented in Figure 6 show how total inactive cells remains cooler than active areas during the current injection for the EL test. Additionally, it has been observed that when there is an inactive area within a cell partially active, the active area is revealed as an overheated area. Therefore, it can be concluded that thermographic images during the EL tests also gives complementary information. In Figure 7, the module S-E1 is in landscape mounting mode, with its connection box in the right side of the image. The long hotter area in the right part of the module is the reflection of the anemometer post, which can be seen in the RGB image (Figure 7 b). The three Failures A, B, and C that have been analysed during this paper are also revealed in operation, as hot spots whose defects make them work in the second quadrant. However, the delamination that the module present in A and B, produces a change in the material emissivity value with respect the rest of the glass, responsible of covering up the hot spots, as the delaminated areas appear cooler than their actual temperature.

Figure 6: Thermographic image of S-E1 in the fourth quadrant during the EL test.

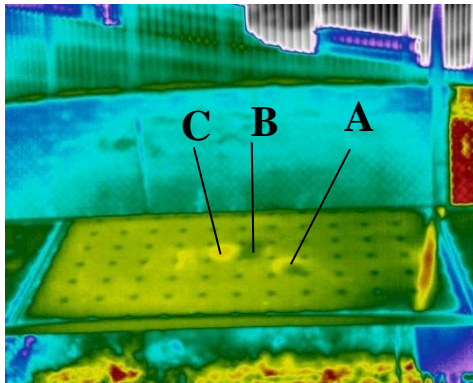
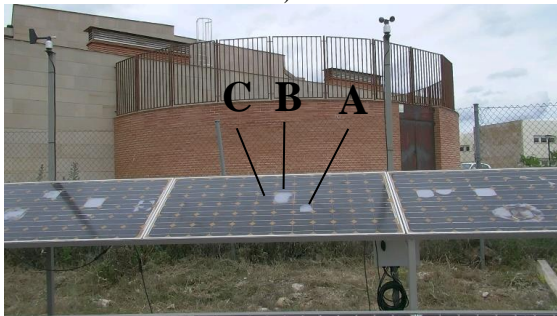
Figure 7: Thermographic (a) and visual (b) images of S-E1 outdoor in ordinary module operation.
