Title: **Analysis and characterization of PV module defects by thermographic inspection**

Authors: Sara Gallardo-Saavedra, Luis Hernández-Callejo and Óscar Duque-Pérez

The PV site that has been analyzed is located in Spain, in Castilla y León region and it has a capacity of 3 MW, with 17,142 monocrystalline modules, model STREAM 175 W, and was commissioned in 2008. Each PV structure is composed of thirty-two modules, divided electrically in two arrays of sixteen modules, which are connected in parallel in the combiner box. PV structures have fixed 30° tilt structure and a general view of them can be seen in Figure 2. Each module has 72 cells (12x6).

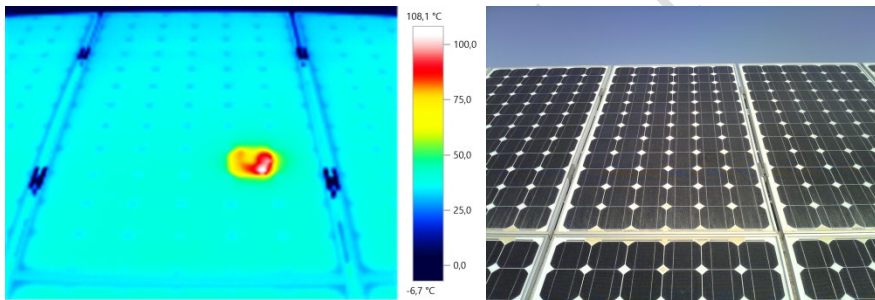
**Figure 4** Hotspot located in the third string of a module, with a  $\Delta T$  of 71°C.

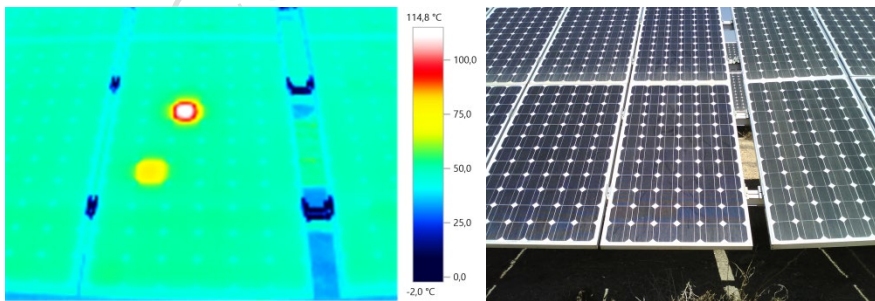
**Figure 5** Two overheated cells within a module, one in the first bypass circuit and the most overheated in the second circuit, with a  $\Delta T$  of 63.5°C..

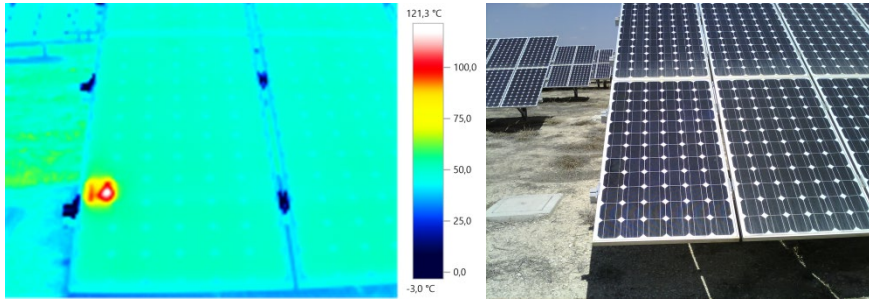
**Figure 6** Overheated cell in the first bypass circuit next to the module frame, with a  $\Delta T$  of 71.2°C..

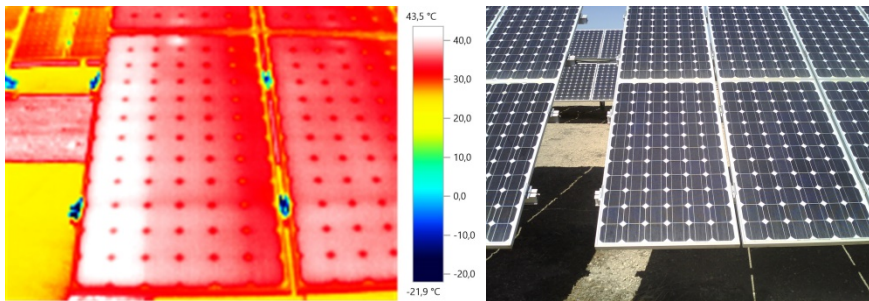
The thermographic and visual image of one bypass circuit overheated with a temperature difference of  $5.7^{\circ}\text{C}$  between the healthy area and the overheated bypass is presented in Figure 8.

**Figure 8** Bypass circuit overheated with a  $\Delta T$  of  $5.7^{\circ}\text{C}$ ..

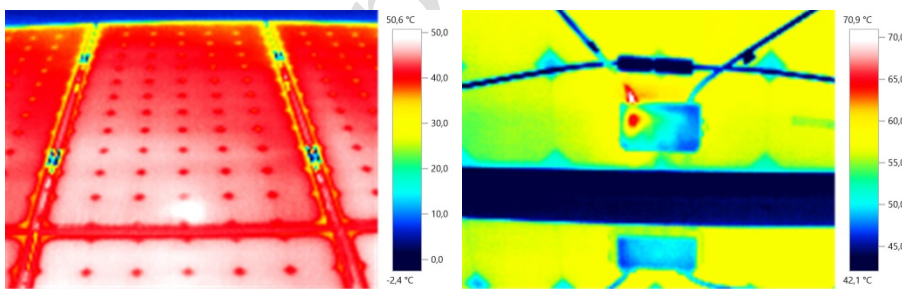
**Figure 11** Front site of a module with a bypass diode overheated and of the junction box at the back of the module.  $\Delta T$  is 6.7°C and 22.6°C respectively.

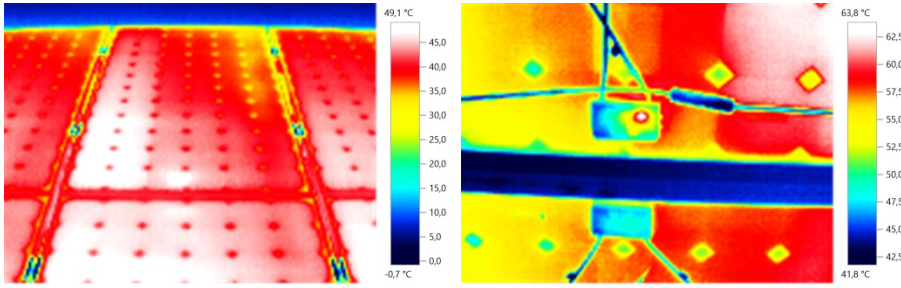
**Figure 12** Front site of a module with a bypass diode overheated and of the junction box at the back of the module.  $\Delta T$  is 9.3°C and 17.2°C respectively.

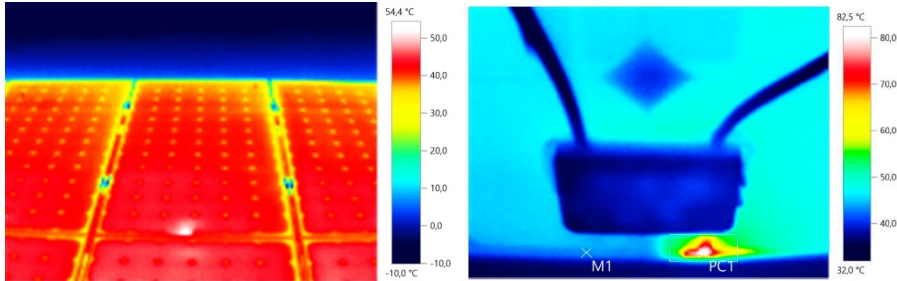
An example of an overheated connection found during the analysis is introduced in Figure 14. As it can be seen, the overheated area is not in the junction box, but in the connection between bus ribbon or bus wires and the box.

**Figure 14** Overheated connection between the bus ribbon or bus wires and the junction box with a  $\Delta T$  of 11.7°C and 35.8°C, at the front and back side respectively.

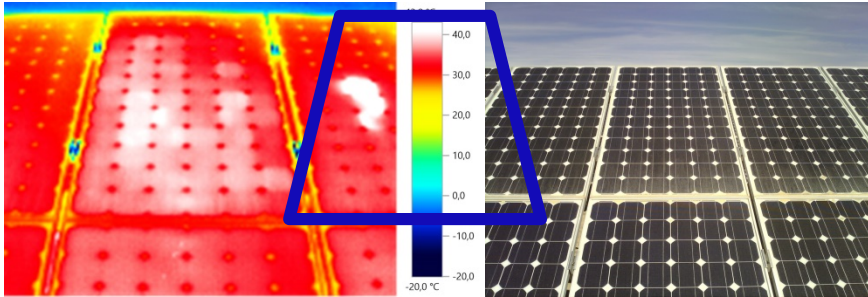
**Figure 16** Overheated module with a  $\Delta T$  of 10.5°C between the mean temperature of the adjacent modules and the mean temperature of the overheated module surrounded in the figure.

It has been noticed that differences in temperature between a module and the rest of modules of the same row or string could be due to an erroneous connection between them, mismatching or to internal defects of the module affecting all the bypass circuits. This kind of defect can be automatically detected as a difference of the mean temperature of one module with respect to the rest of the modules of the same PV structure.

If one module or several modules connected in series have a higher temperature than the rest, the modules may not be connected to the system and the wiring should be checked. Figure 16 shows the only defect in the whole module detected during the site inspection.
