International Conference on Materials for Advanced Technologies 2011, Symposium O

## Why Do PV Modules Fail?

Claudio Ferrara\* and Daniel Philipp

*Fraunhofer Institute for Solar Energy Systems, Heidenhofstrasse 2, 79100 Freiburg, Germany*

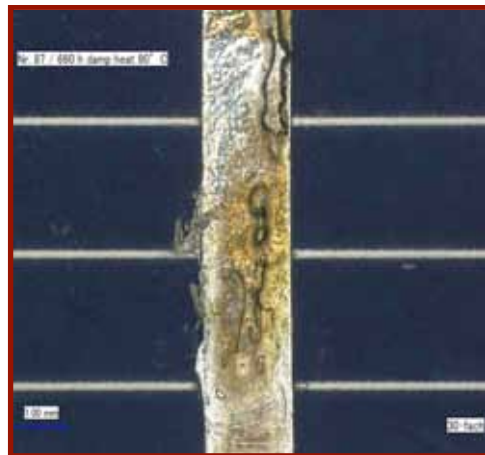
Fig. 1. Details of a connector after an exposing time of 660 h at 90°C and 85% r.H.

Here, the corrosion process was caused by humidity penetration of the sealant in combination with high temperature. Additives of polymers can also cause corrosion, e.g. acetic acid ( $\text{CH}_3\text{COOH}$ ), which cannot evaporate because of a non-permeable back sheet. Mechanical loads, resulting from snow or wind, can cause distortion of the metal frame which as a consequence leads to a weakening of the static systems

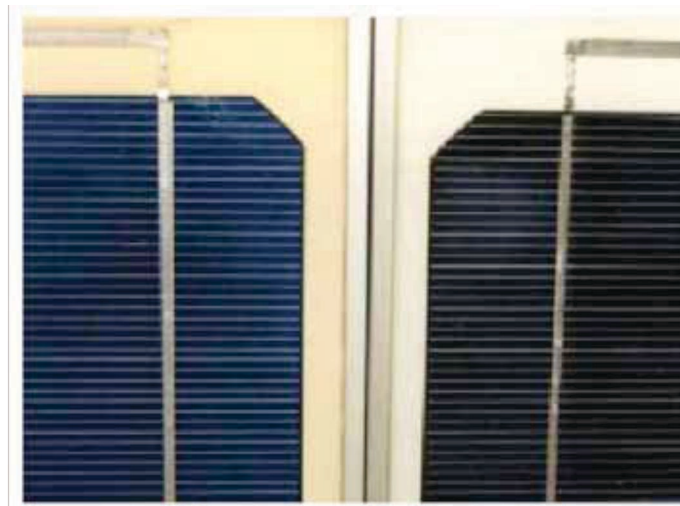
Yellowing or browning of encapsulation and polymeric back sheets can be caused by heat, humidity and UV irradiation (see Fig. 2). Until today there is no clear relation between the yellowing level and the electrical performance, see e.g. Ref. [9]. Heat and humidity are also reasons for blistering and, in an extended form, for delamination. This is a process where the different polymeric and/or other layers are not adhesive anymore. The reduction of adhesion of adhesives e.g. for the junction box causes by UV irradiation, heat and humidity can result in a detachment of it. If water vapour and/or gases penetrate the sealant, it can cause chemical changes of the polymers. UV irradiation is a reason for the bleaching respectively fading of the module, e.g. cable envelope. Dry heat like in a desert climate can lead to exsiccation of the polymer material and as consequence to embrittlement and at the end to cracks in the polymer surface.

Fig. 2. Aged PV module after damp heat test (left) and unaged PV module as reference (right).

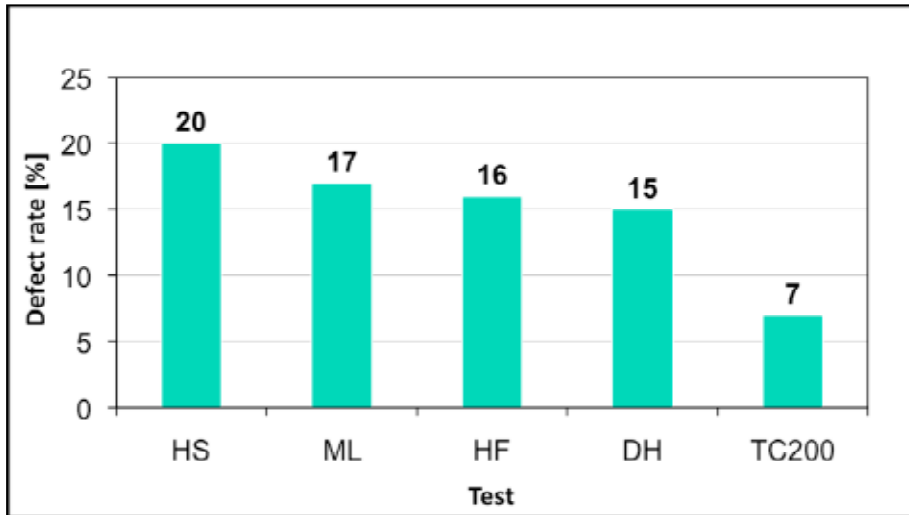
During the years 2006-2009 we performed 297 tests projects for certification. In 105 projects of this 297 at least one of maximum 11 PV modules failed in one test. These are 35% of the performed projects, which have contained 7% PV modules with thin-film technologies and 93% crystalline technologies (35% mono-crystalline wafer, 58% polycrystalline wafer). The diagram (Fig. 3) shows a more detailed view on the test where PV modules failed during the certification testing. The most severe tests for PV modules in these projects were the hot spot test (HS) with a failure rate of 20%, followed by the mechanical load test (ML) with 17%. The climate chamber tests are responsible for roughly 40% of the failures during testing, in detail: humidity-freeze test (HF) with 16%, damp heat test (DH) with 15% and finally the thermal cycling test with 7%. All five tests are responsible for 75% of all PV modules with failures in the 105 certification projects.

Fig. 3. Defect rate related to the performed test: Hot spot test (HS), mechanical load test (ML), humidity freeze test (HF), damp heat test (DH), thermal cycling with 200 cycles (TC200). From Ref. [11]

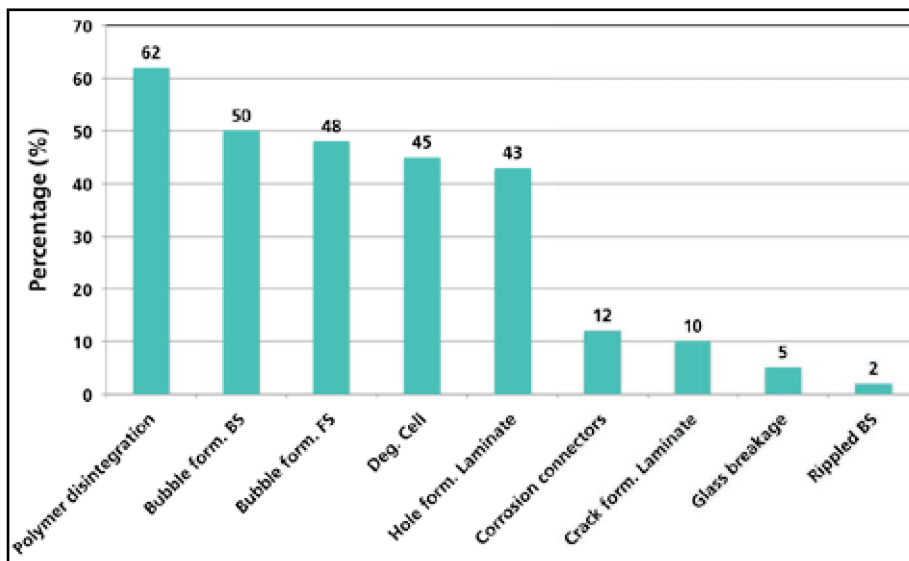
Fig. 4. Percentage of defects modes observed after hot spot test. From Ref. [11]

Further analysis, e.g. after the hot spot test (which is the test most failures were detected in), show that defects are mostly on polymers. The reasons for the failures are the high temperatures produced during the hot spot test. These high temperatures, with an average of 240°C, cause multiple failure modes simultaneously. An analysis of failure modes observed after the hot spot test is shown in Fig. 4. Figures 5(a) to 5(c) present examples of the first most found failures after the hot spot test. These are the disintegration of polymers (62%) and the formation of bubbles at the back (50%) and the front side (48%), caused by the high temperatures during the hot spot test. These high temperatures are causing also degradation of the

solar cell (45%), formation of holes in the polymers (43%). Failure modes with less occurrences are corrosion of the connectors (12%), crack formation of the laminate (10%), glass breakage (5%) and rippling of the back sheet (2%).
