Lessons Learned from a Lady

Source: *Science News*, Vol. 130, No. 25/26 (Dec. 20-27, 1986), pp. 392-395

Lessons Learned From a Lady

The recent Statue of Liberty restoration provided some unique research opportunities

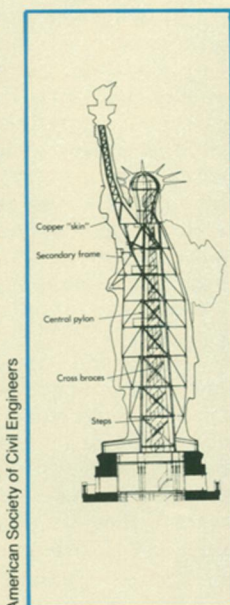
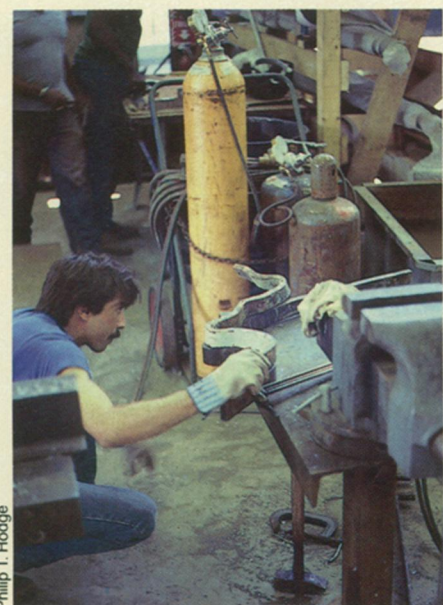
Eiffel tried to solve the problem by inserting an insulating layer of asbestos between the iron ribs and the copper skin. But his solution was ineffective. Because copper is such a good electrical conductor, even a single contact point with iron is enough to spoil the insulating effect. The iron armature system ended up rusting so badly that all the bars had to be replaced during the restoration.

In Eiffel's innovative design, a central pylon with a secondary framework reaches out to the Statue of Liberty's copper skin (left). The copper sheets are attached to iron ribs (right) in such a way that the skin is free to shift slightly. Because of corrosion, the ribs had to be replaced with new stainless steel bars that were shaped to match the contours of the old bars (center).

In the end, two were chosen. One was ferallium, a high-strength, steel-aluminum alloy used by the British Navy as a bronze substitute. However, because this alloy tends to be springy, metalworkers have difficulty bending it into shape. It was used only for the flexible flat bars that connected the ribs to the iron framework. The alternative, 316L stainless steel, is easier to shape and was used for the armature bars themselves.

Backing tape, consisting of a glass-fiber web coated with Teflon, replaced the asbestos liner between the copper and stainless steel. The tape not only reduces the chance of galvanic corrosion occurring but also works as a lubricant. It allows Liberty's copper skin to slide across the stainless steel without sticking when the statue expands and contracts due to temperature changes during the day.

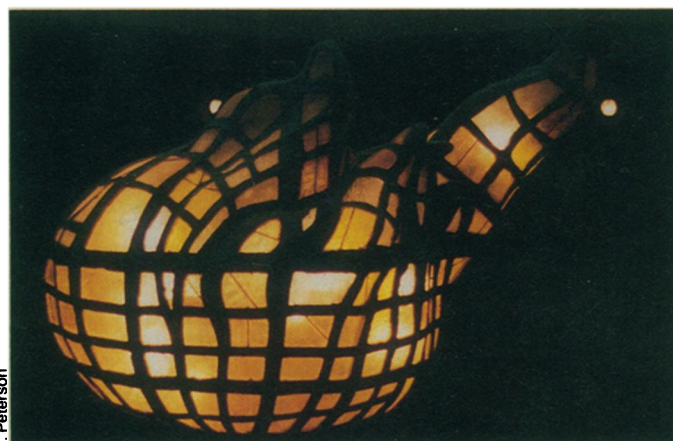
The Statue of Liberty's original torch and flame, shown here, had to be replaced because of extensive corrosion damage. Holes cut into the copper flame to create windows allowed moisture to leak into the statue's arm. The original torch is on display in the museum.

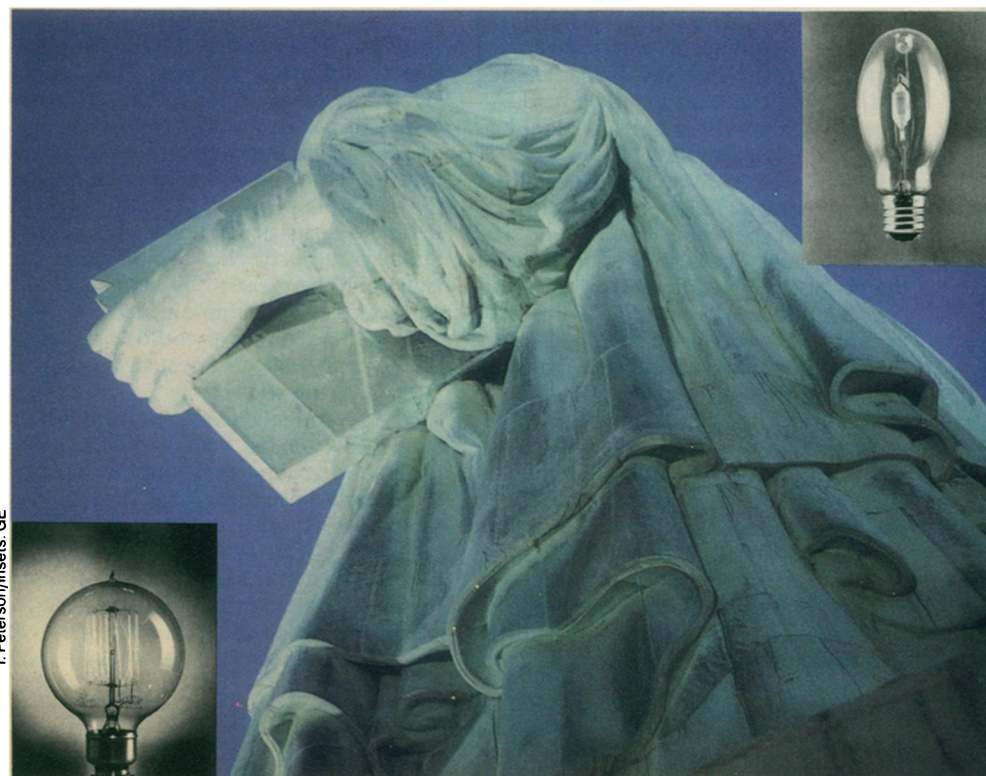
The new Statue of Liberty lighting scheme is designed to capture the quality of natural daylight. Researchers had to invent two new metal-halide lamps (upper right) to provide the right colors. The original 1916 lighting scheme used 246 bulbs (lower left); the new one uses only 42.

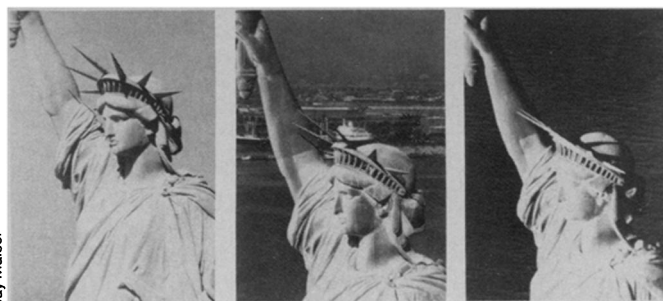
However, sections of the patina itself may be changing. Large areas on the left side of the statue's surface appear to be getting darker, as if the green patina were washing away to reveal the black oxide and sulfide layer underneath. Baboian blames the effect on acid deposition and the severe weather patterns that come from the northeast (SN: 6/29/85, p.404). Other researchers contend that fine, wind-blown sand may be the culprit. Most of the change seems to have occurred since 1965.

Baboian suggests that acid rain could be causing that kind of transformation. As a result, this antlerite-loaded green patina may be washing away, especially in areas exposed to the prevailing winds.

Curiously, at least one copper sheet, located on the statue's torch-bearing arm, is staying green while its neighbors are darkening. "It must have something to do with the metallurgy of the copper," says Baboian. The unaffected copper seems to be much softer and purer than the darkening copper, he says. Samples from the darkening copper sheets contain large clumps of copper oxide.

The Statue of Liberty's left side has been getting darker, as shown in these photos taken in 1965 (left), 1974 (center) and 1983 (right). One copper plate on the arm seems to be resisting this change.
