# A Case History of Shore Power Transformer Taps Arcing during No-Load Condition

Dev Paul, PE  
AECOM

Kor Yan, PE  
Port of Oakland  
IEEE Member

This paper describes a case history of no-load primary taps arcing of a 7.5 MVA, 12.47 kV – 6.6Y/3.81 kV transformer. Underground 12.47 kV duct-banks with proper electric vaults brought power from the Port main substation to Berth 37. The main substation consisted of 115 kV dual transmission lines connected to two utility-owned power transformers with wye connected 12.47 kV solidly grounded secondary. Two separate 12.47 kV metal-clad switchgears at the main substation

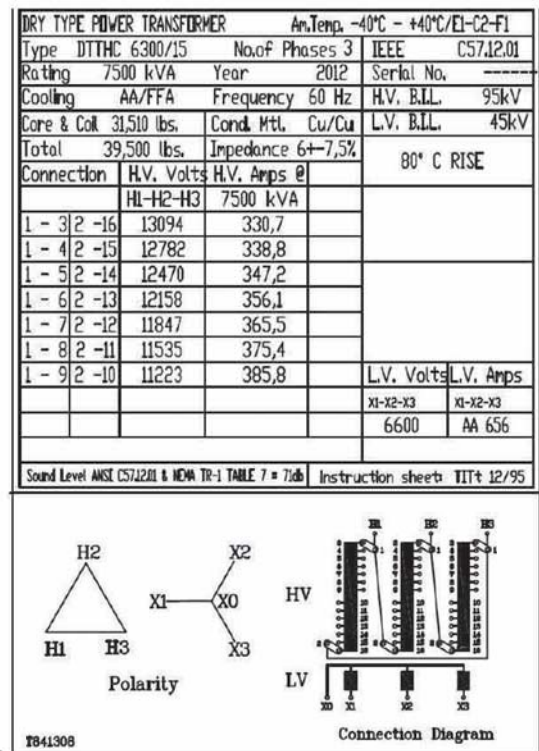
Fig. 1 Transformer nameplate

no-load taps, 1 through 16, with taps set at 1-6 and 2-13, which correspond to a voltage rating of 12.158 kV as seen in Fig. 1. A Delta connected primary connection diagram is also seen in Fig. 1.

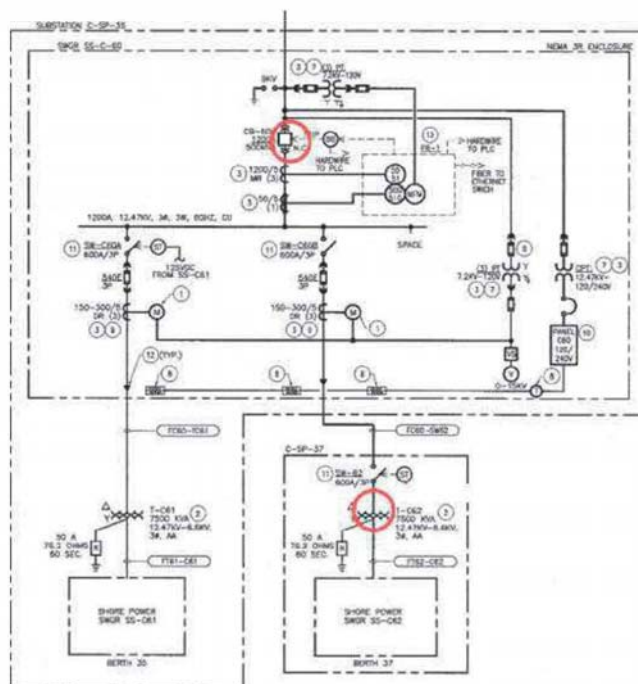
Fig. 3 Berth 37 substation One-line Diagram

The Berth 3/ cold ironing substation power supply one-line diagram is shown in Fig. 3 where the 12.47 kV power supply comes from Port's main substation by underground duct banks. Two red circles in Fig. 3 represent the power circuit breaker and transformer, respectively.

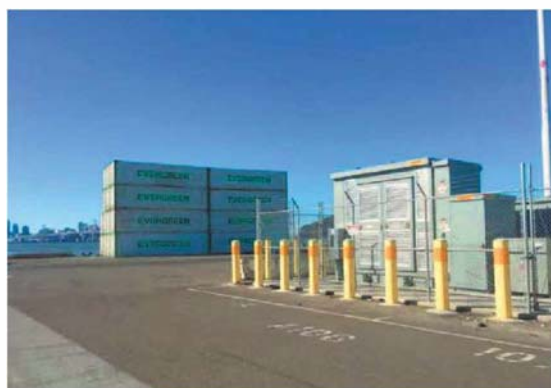
Fig. 4 Berth 37 substation layout photo

This section includes Fig. 4, which shows substation layout with bollards to protect the enclosure from vehicle traffic. Fig. 5 shows the transformer outdoor enclosure with louvers where on one side there is a close-coupled no-load disconnect switch and on the other side a transformer secondary neutral grounding resistor. These photos are very important in understanding that coastal weather and wind can enter the enclosure and hamper the insulation integrity of the air dielectric. The transformer taps, tap bushings, and grounded metallic support inside the enclosure can then cause phase-to-ground arcing during bad weather conditions.

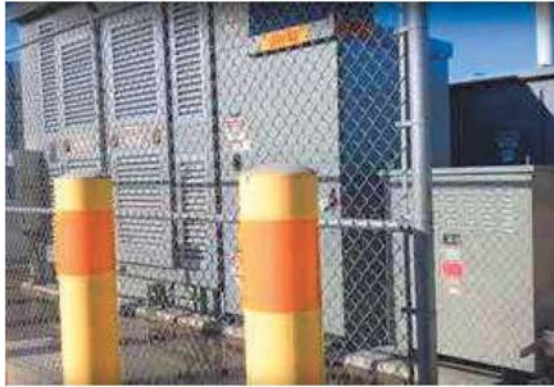
It is known that the dielectric strength of the air decreases with dampness and is affected by air pressure, conductive dust and salt particles, and other coastal weather contaminations. Transformer enclosures are subject to infiltration caused by direct and indirect prevailing winds coming over the ocean/bay water. Such winds can change direction and can penetrate through enclosure openings thereby directly hitting the transformer taps. This can lead to a damp contaminated condition of tap holes, like the transmission line insulators in the coastal area, which causes insulator flashover. The damp contaminated condition is the most common cause of flashover because most contaminants are electrically conductive when damp or wet [8].

The most probable cause of transformer taps arcing during wet weather conditions can be correlated to the conductive layer of contaminants over the uninsulated tap holes. Manufacturers of transformers for such coastal locations should review this case history of taps arcing to avoid such occurrences by a) providing removable insulating boots and caps to fit over the tap-connections, b) increasing distance from taps to grounded enclosure members, or c) a combination of both a) and b).

Fig. 5 Substation transformer outdoor enclosure

1) The typical outdoor transformer enclosure has an issue with avoiding rainy or dusty wind hitting the transformer tap locations causing arcing, especially when louver design is not suitable for the site environment. An alternative to enclosure design improvements is installing removable insulating boots and caps on tap-connections, making greater clearances from grounded metallic support members, and installing water/dust proof filters behind louvers.

2) The manufacturers of cold ironing power substation transformer enclosures must provide removable insulating boots and caps to cover the tap connections and unused tap connection holes to ensure adequate dielectric air strength is maintained during wet weather conditions.

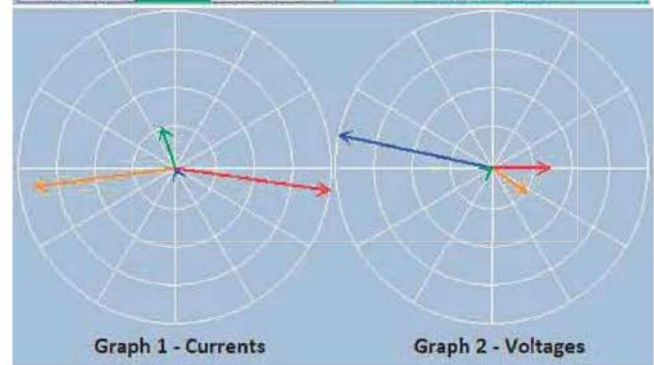
Fig. 6 Current and voltage phasor diagram during arcing fault

Fig. 6, Graph 1 indicates very high fault currents on phase A (F1-1A) and phase B (F1-1B), whereas the very small current in phase C (F1-1C) and the vector sum of these three unbalanced currents resulted in a very high ground fault current (F4-1G). Graph 2 in Fig. 6 indicates close to nominal line-neutral voltage (F7-VC) on phase C and much reduced voltages of phase A (F5-VA) and phase B (F6-VB).

CHANNEL		GRAPH	MAGNITUDE / ANGLE
F1-1A		Graph 1	5.753 kA -8.57°
F2-1B		Graph 1	5.240 kA -172.49°
F3-1C		Graph 1	2.75 A -248.95°
F4-1G		Graph 1	1.812 kA -252.26°
F5-VA		Graph 2	2.782 kV 0.00°
F6-VB		Graph 2	2.098 kV -36.50°
F7-VC		Graph 2	7.579 kV -192.16°
F8-VN		Graph 2	11.06 V -327.17°

This concludes that there was an arcing ground fault from transformer delta that connected winding H2 (phase B) and H3 (phase C) to ground. Fig. 7 shows 60Hz currents and voltages before, during, and after the fault.

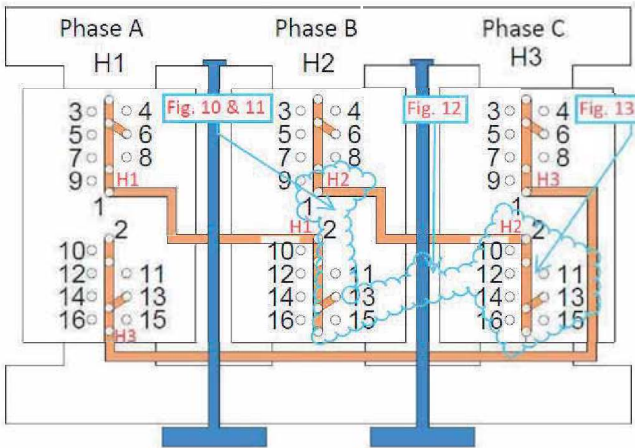
To determine the cause of breaker tripping, the transformer enclosure was opened for inspection. Signs of arcing were observed on the taps, tap connectors, and outer surface in the middle of phase B coil and the bottom of phase C coil as shown in Fig. 8. A few of the voltage tap-connection bolts and bolt holes were melted as a result of arcing fault. The arrangement of taps and tap connections for delta primary voltage may vary from the manufacturer of the transformer depending upon the winding construction. However, Fig. 8 and Fig. 9 show actual configuration of taps and tap connections for this paper.

Fig. 8 Signs of arcing on overview of the all three windings layout drawing

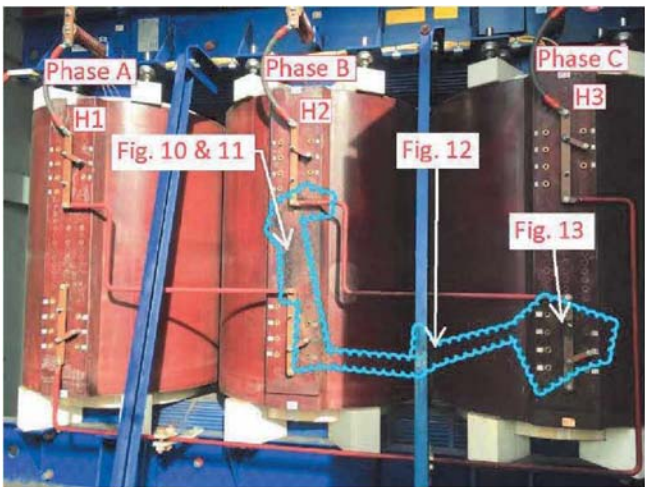
Locations of taps for the arcing of phases A and B are shown in Figures 10, 11, 12, and 13. The grounded support member between the coils for phases B and C, (shown in blue color in Fig. 9) was eventually breached over by the arcing on phases A and B taps connections located on the surfaces of phase B and C coils. Again, as stated earlier, it can be seen from Fig. 8 and Table I line 307 that tripping of the circuit breaker occurred by the ground fault relay.

Fig. 9 Areas showing signs of arcing on phases B and C

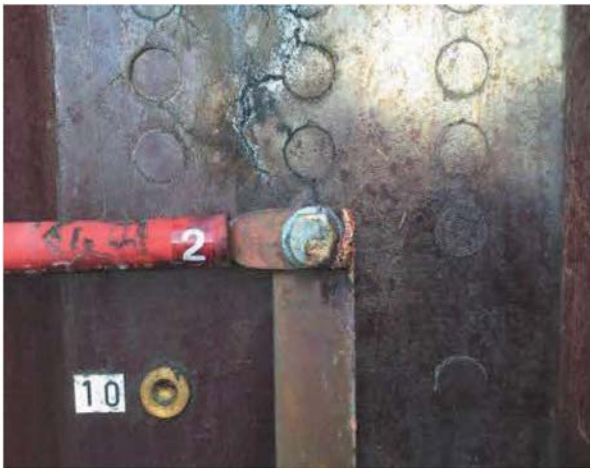
Fig. 10 Tap 10 and connector 2 on middle leg (phase B) arcing signs

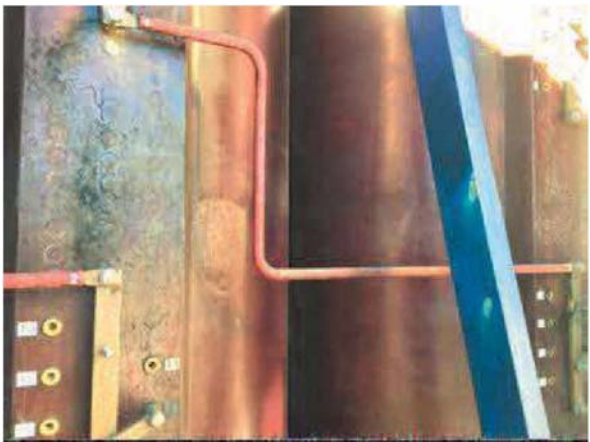
Fig. 11 Connector 1 to connector 2 on middle leg (phase B) arcing signs

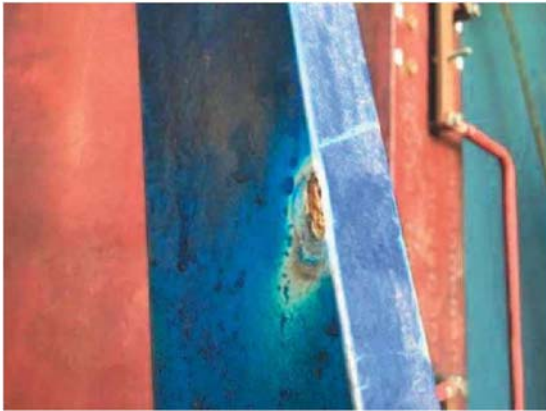
Fig. 12 Signs of melting below grounded support member on phase B

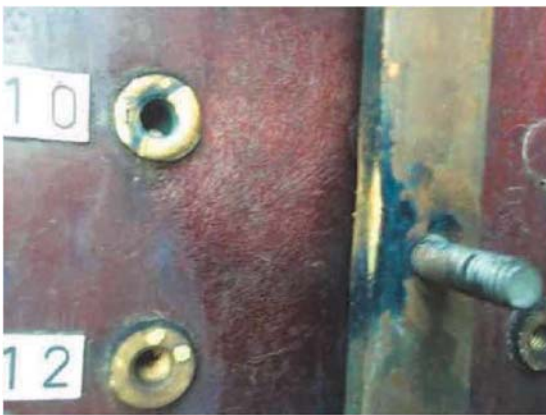
Fig. 13 Taps 10 and 12 and outer surface show signs of arc fault

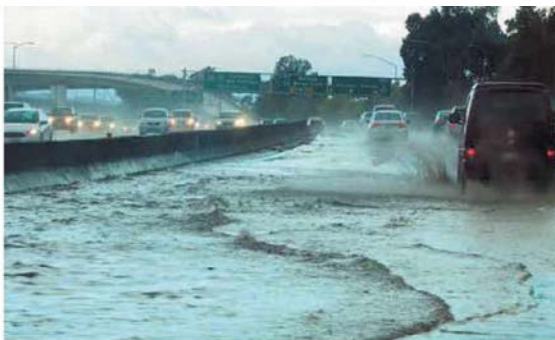
The weather reported during tap arcing included rain and a storm. The evidence of arcing showed rainwater intrusion through the ventilation louvers. The dirt that collected inside the transformer and the water intrusion created a tracking path for arcing current, which tripped the breaker by protection relays. The evidence of rain is seen in Fig. 14, which is a photograph taken from the flooded freeway (courtesy of local newspaper).

Fig. 14 Flooded freeway – rain during transformer taps arcing
