TECHNICAL SERVICE BULLETIN

Number: TSBUMTS-005(PC Card Adaptor RF Int.)

Description Summary: PC Card Adaptor RF Interference

Documented: January 10th 2007

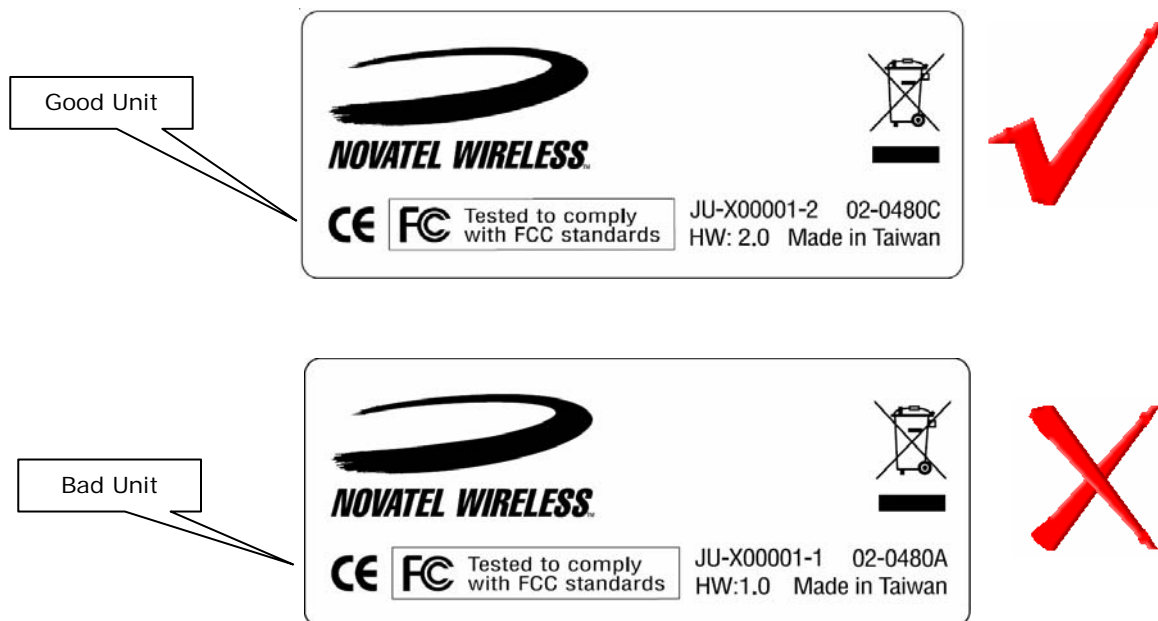
The Part numbers are visible on the label as shown.

The solution is to replace the PC Card Universal Adaptor XCA-2, Part Number JU-X00001-1 with PC Card Universal Adaptor XCA-2 Part Number JU-X00001-2
