Applicability

This document applies to the part numbers of STM32L476xx and STM32L486xx devices listed in [Table 1](#) and their variants shown in [Table 2](#).

[Section 1](#) gives a summary and [Section 2](#) a description of workarounds for device limitations, with respect to the device datasheet and reference manual RM0351.

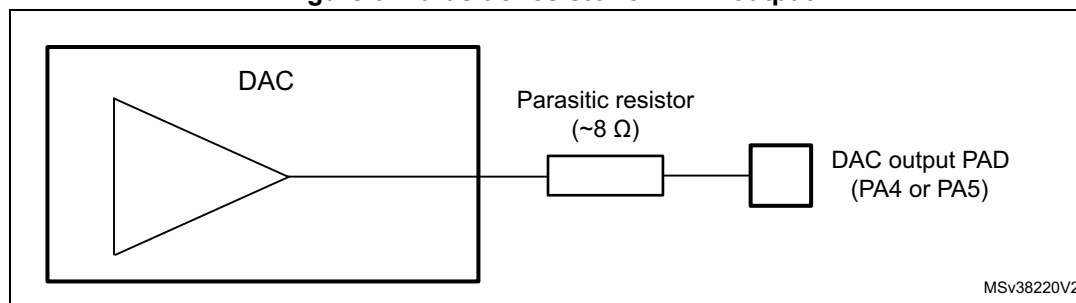
Figure 3. Parasitic resistor on DAC output

Resistor value between DAC outputs and I/O (PA4 or PA5) is greater than expected: 8 Ω typical, as shown in [Figure 3](#). As a consequence, the DAC characteristics can be impacted depending on the current sunk on DAC output.

Workaround

None.

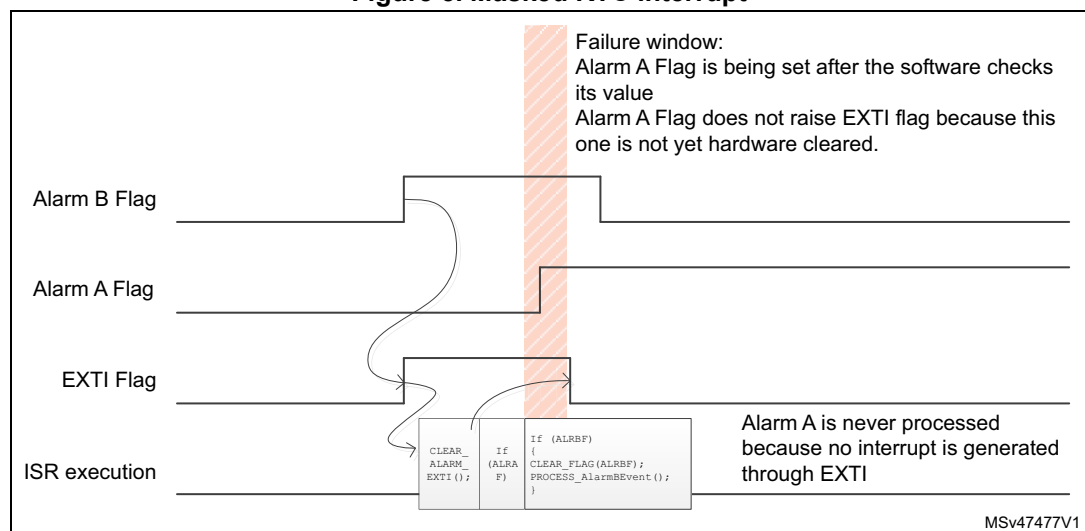
Figure 5. Masked RTC interrupt

The following code example and figure illustrate the failure mechanism: The Alarm A event is lost (fails to generate interrupt) as it occurs in the failure window, that is, after checking the Alarm A event flag but before the effective clear of the EXTI interrupt flag by hardware. The effective clear of the EXTI interrupt flag is delayed with respect to the software instruction to clear it.

Workaround

In the interrupt service routine, apply three consecutive event flag checks - source one, source two, and source one again, as in the following code example:
