Wafer Defect Analysis Report

Analysis ID:	bd1fd190-3933-4a85-9080-ae00c245122a
Wafer ID:	N/A
Batch ID:	N/A
Date:	2025-11-22 20:56:13
Total Defects:	9
Severity Score:	0.50

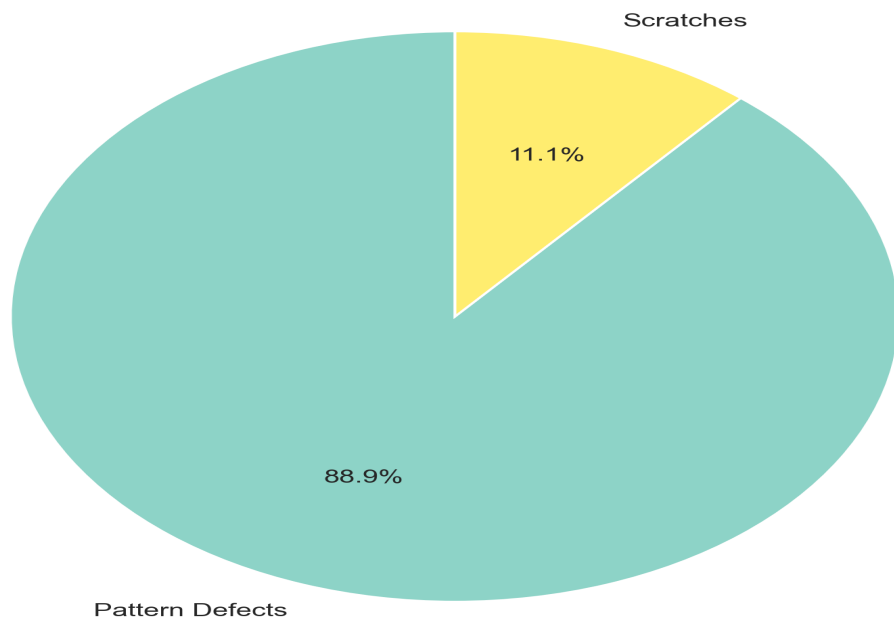
Defect Type Distribution

Defect Type	Count
Pattern Defects	8
Scratches	1

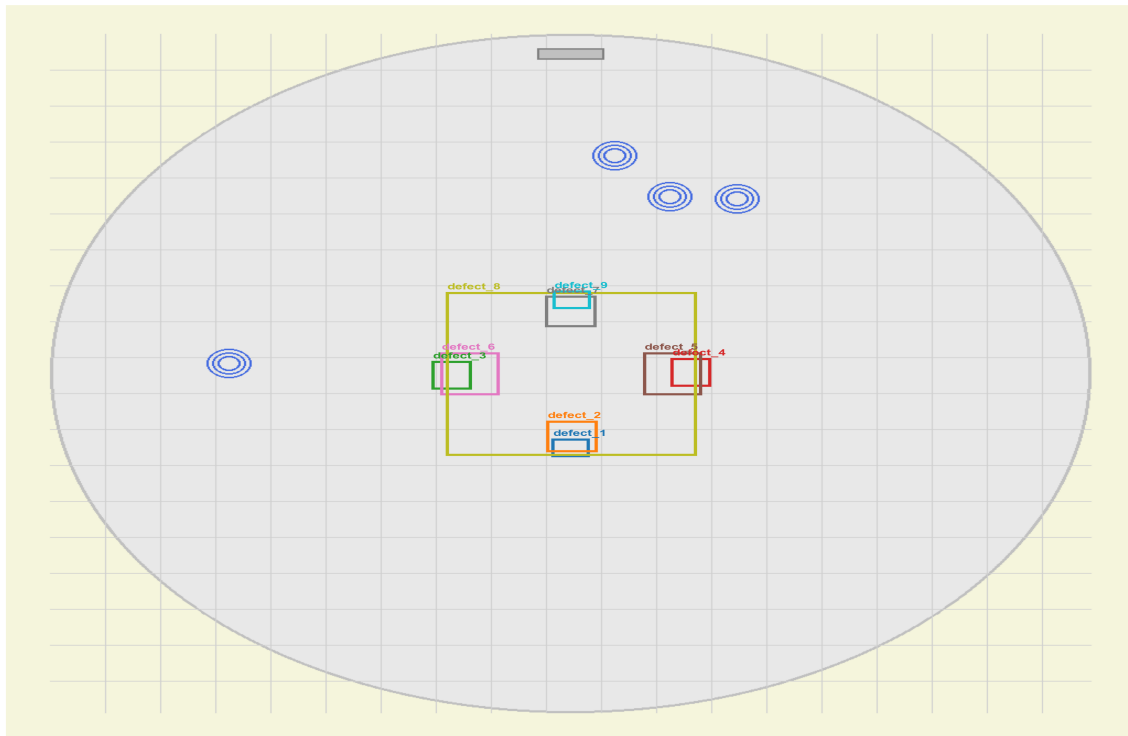
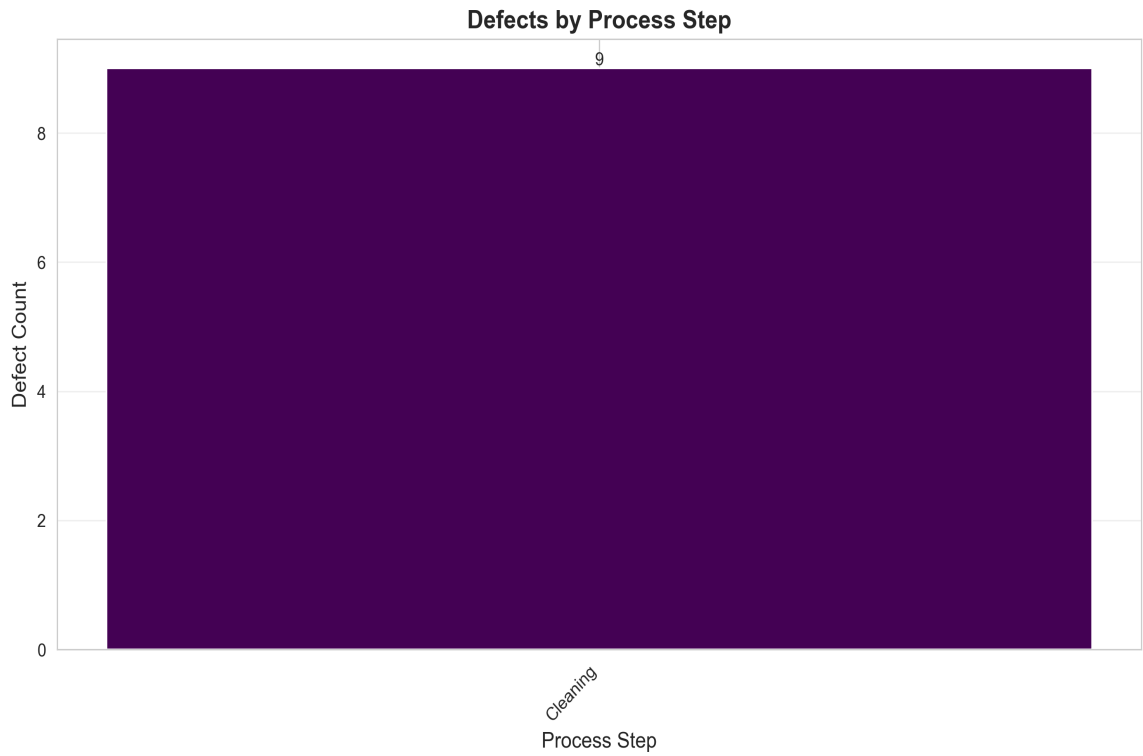
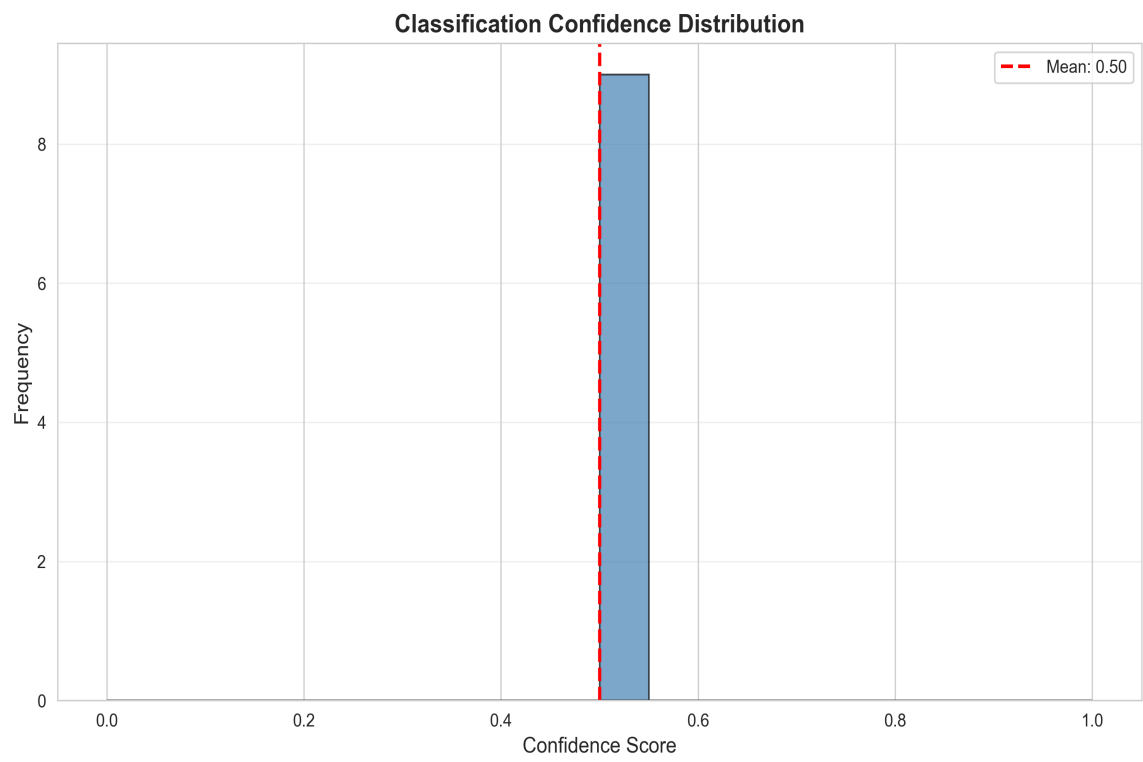
Defect Locations on Wafer

This analysis identified 9 defects on the wafer with a severity score of 0.50 (HIGH). The most common defect type is Pattern Defects.
