# Seismic Screening of Public Facilities in Oregon's Western Counties

Nathan M. Wallace, M.ASCE<sup>1</sup>; and Thomas H. Miller, M.ASCE<sup>2</sup>

**DOI:** 10.1061/(ASCE)1084-0680(2008)13:4(189)

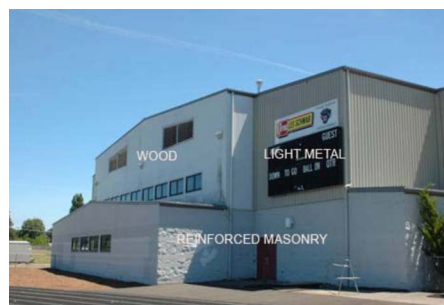
**Fig. 1.** Building with W2, RM2, and S3 structure types; RM2 is the controlling structure type

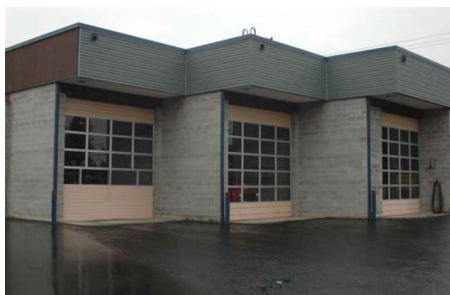
**Fig. 2.** Reentrant corners as plan irregularities, moderate severity
