[SHAD-2] During execution of PTL-903900 for Osprey Battery Life testing, unable to download the database from one of the units

Status:	Risk Assessment
Project:	System and Hardware Anomaly/Defect
Component/s:	None
Affects Version/s:	None
Fix Version/s:	None

Problem Statement: During the execution of PTL-903900, it was observed that one of the 120 Maxell units was unable to complete the "Database Download" command with Quasar (SW10886). The unit was able to connect to Quasar and provide some information, but was unable to maintain a connection during the database download. The NFC tool was used to communicate with the device. The command, "0xAC" was sent to the transmitter and the response, "0xac 0x80 0x23 0x3c 0x1e 0x00 0x17 0x00 0x00 0x00 0x00 0x00 0x00 0x94", indicates that an unrecoverable error occurred on day 22 of the session and the unrecoverable error was caused by a hard reset. The unit's part number is MT-26023-72 with SW14531 v 57.192.109.37. The Serial Number is 511917828029. The transmitter was built in ER24-522.

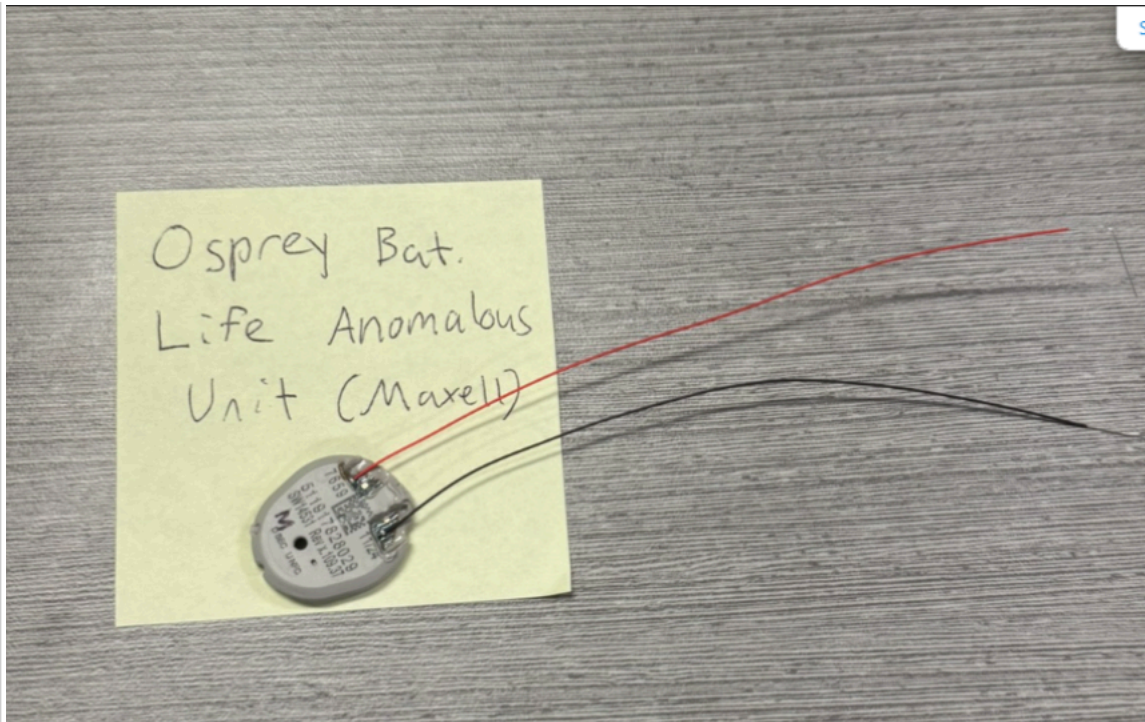
Database was downloaded after connecting power supply to transmitter.

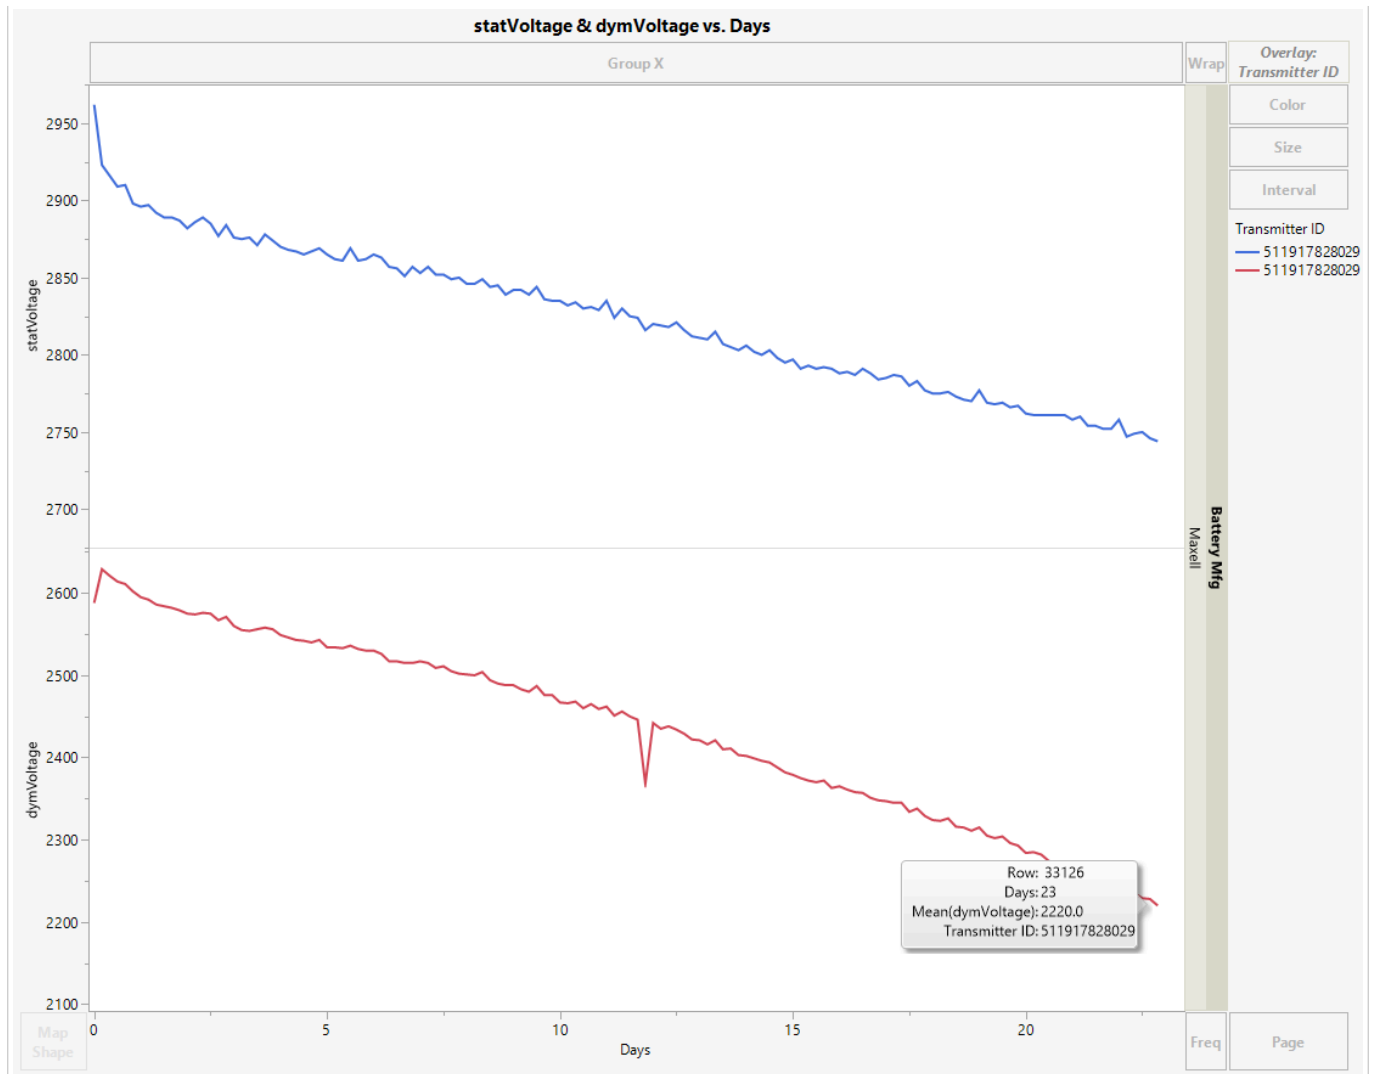
From Jeff Stanton: "this has the hallmark of a brown out reset (hard reset). The spread between static/dynamic battV was ~ 500mV which shows the battery had some higher IR. The POF event happened just before the brown out but before it could run an ADC batt measurement."

Static Voltage compared to DynVoltage over time

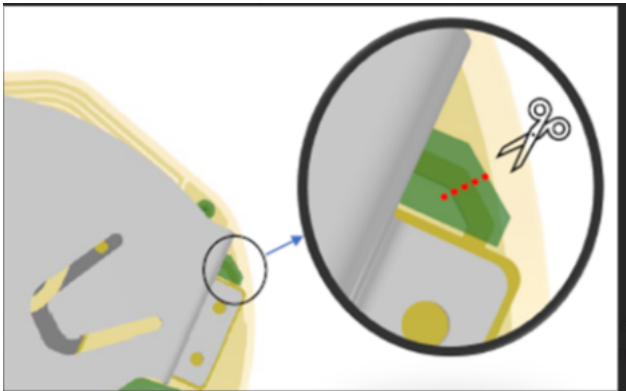
1. Rework to sever the battery trace was successful. For reference the trace that is cut is shown below:

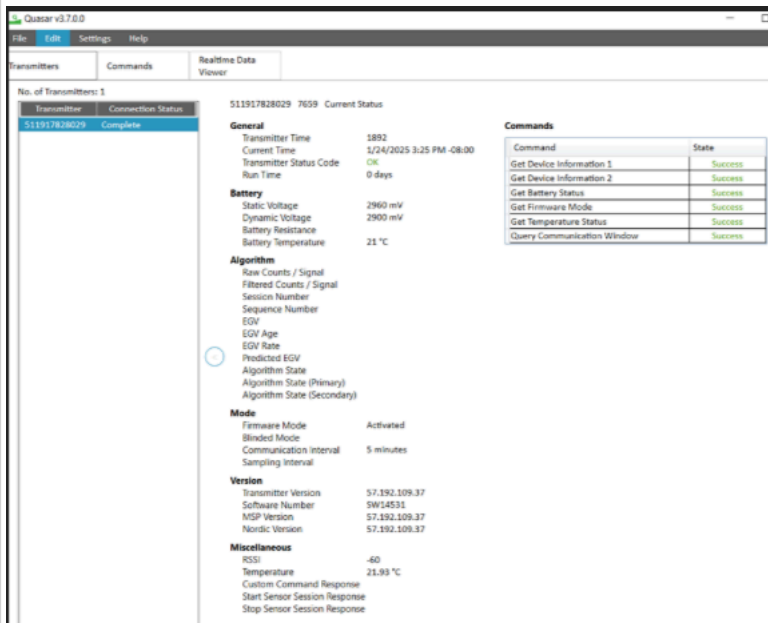
3. Restarted unit into a session - Connected to Quasar and got first battery measurement (see image below). This is still with the external bench supply which is why there is not much difference between static and dynamic voltages. I'm going to let the unit run over the weekend and download on Monday to see if there is any indication of trouble. At that point I think we should reconvene and discuss/reconfirm the next step. E.g. whether we should move forward with the characterization

per PTL-903900 prior to battery extraction and whether that should be done with a bench supply or by attaching a battery externally.
