PS3 POWER CONTROL TOPOLOGY

(Part 1: UVLO Circuit)

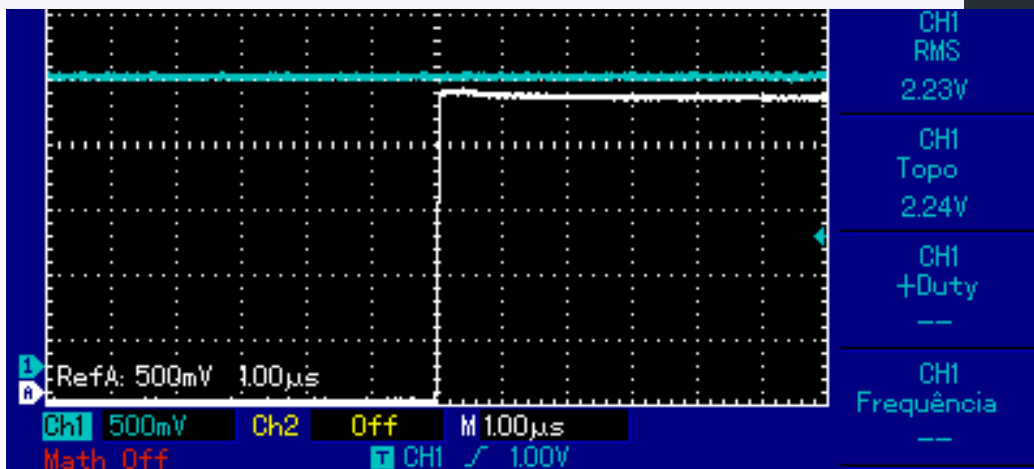
First thing I notice is that the Drive pin is low when it should be high (blue = Bad RSX tokens | WHT = Good Tokens):

The controller's drive signal tells the buck converters to switch on and power the processor. It does so through an AND Gate, but only when both PWRGD and Drive signals are present!

This gives us a new thing to test. If Drive and PWRGD are high on the input side of that AND gate (IC6107/IC6204 for CPU/RSX VRM respectively), then output should be high! Check it has all the correct voltages. Replace if not.

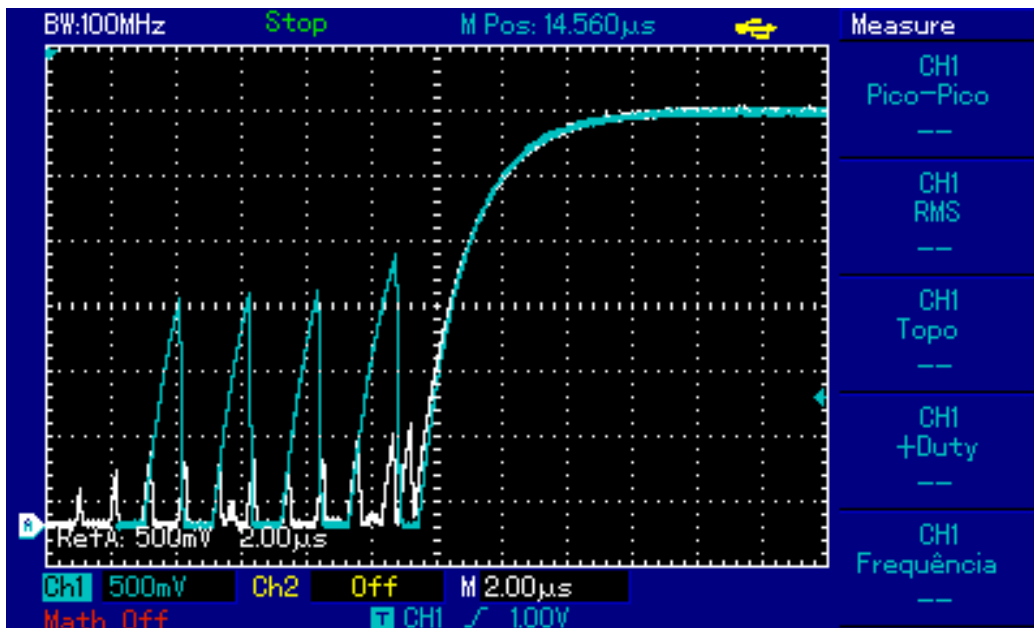
PWRGD is also interesting (Blue = Bad Tokins | WHT = Good Tokins)...

PWRGD (AKA reset) notifies the system when voltage falls out of regulation. It has protection built in that prevents false triggering due to voltage spikes/noise from transient loads. So PWRGD "shouldn't" go low without cause.

That jagged startup to the PWRGD signal has higher amplitude (bigger/wider peaks) in the console with bad tokins. I wonder if that is used to gauge the extent of the ripple. Say it's higher than half the final 3.3v PWRGD signal, maybe that over the threshold for triggering a 1002. Say it's more than 75%, then maybe it's over the threshold for triggering 3004. Of course it could be 25% and 50% respectively, IDK. It's just a hypothesis, but it makes sense there would be some mechanism for generating a standard voltage ripple/noise pulse during the check. I'm wondering if that's what those spikes are before PWRGD goes high.
